# Existing Conditions

The Original Building is a 2 story, steel frame and brick veneer building which was constructed in 1968. The Building is approximately 72,000 sf and houses grades three, four and five as well as a Kindergarten after school program as part of the "Tiger's Den" program.

Littleton Public Schools - Feasibility Study for Russell Street School

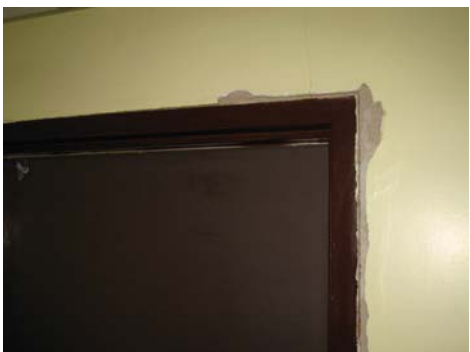
Interior walls are generally of two types, Concrete Masonry Unit Construction is used at the Gymnasium, Kitchen, Tigers Den Rooms (formerly Shower Areas for the Gymnasium) Janitor's Closets, Incinerator Room, and at the Stair off the Main Entry Lobby. Also, the exterior wall's interior surface is painted CMU which is the back-up wall for the exterior brick veneer. The other general interior wall type is plaster on metal stud partitions. The plaster finishes are damaged in numerous areas, most significantly at window and door jamb and head details.

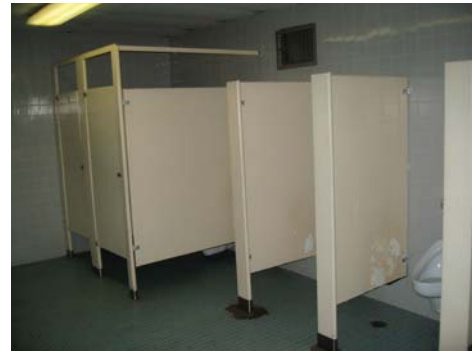
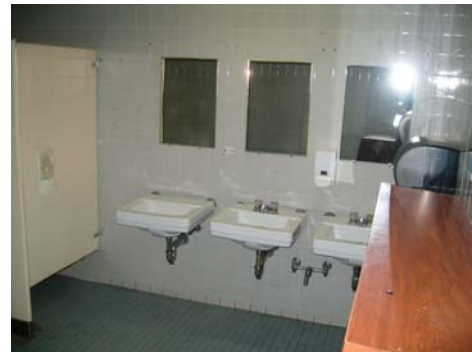
Generally, Ceramic tile flooring and walls are in poor condition. In addition to discoloration of the tiles and grout, there is degradation of the grout and unsightly patches in both the floor and walls where toilet partition and accessory modifications have been made over the years. The faucets on the sink are manual, the water closets and urinal appear to have electronic flushometers but are inoperable and require manual operation to activate. There are no handicapped accessible toilet facilities, stalls, lavatories or grab bars. The toilet partitions are in very poor condition, dented, discolored and badly corroded creating unsanitary conditions.

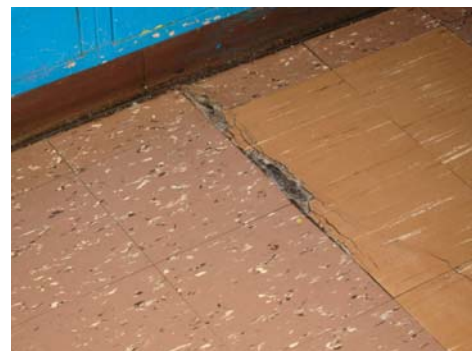
Flooring throughout the entire facility is 9" x 9" vinyl asbestos tile (VAT). Most of the tile is in good condition and has worn well given its extended age. There are several areas that were observed on the first floor where the material has cracked, presumably following expansion or settlement cracks in the concrete that have evolved over time. Other flooring material are present throughout the facility, carpeting is installed at both the Large Group Instruction Room and in the Library. Carpeting and area rugs are used at other areas throughout the facility. Kitchen Flooring system is quarry tile and the flooring in the gymnasium is a

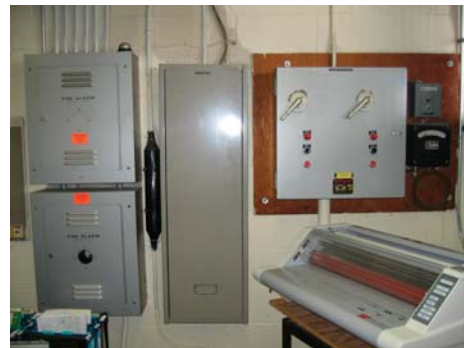
- C. ELECTRICAL
1. The building is served by a 2000A 277/480V fused switch and switchboard assembly fed from utility source transformers, and related distribution and branch panelboards. The capacity of the service reflects the electric heat serving the building and its load. For branch receptacle loads and circuits, there are several (8) step down transformers located in the building to provide 208/120V power.
2. The switchboard and all branch and distribution panels noted are original to the building. While these panels and associated breakers are in usable condition, they are beyond their normal service life. Breaker capacity in many of the panels has been taken up leaving no viable spare spaces for additional loads.
3. The existing switchboard, distribution panels, feeders and associated wiring should be replaced under any major renovation scope of work.
