Littleton FY19 Outfall Inventory and Dry Weather Screening Field Effort Summary

To: Chris Stoddard, PE, Director of Public Works
COPY: Town of Littleton Stormwater Management Program Files
FROM: Christian Boisvert and Andrew Gaughan, Engineering Technicians
Reviewed by Tighe & Bond
DATE: January 25, 2019

This memorandum presents a summary of the stormwater mapping effort and the third round of outfall investigation field work and findings conducted by Christian Boisvert and Andrew Gaughan, Engineering Technicians (Techs) for the Town of Littleton, Massachusetts.

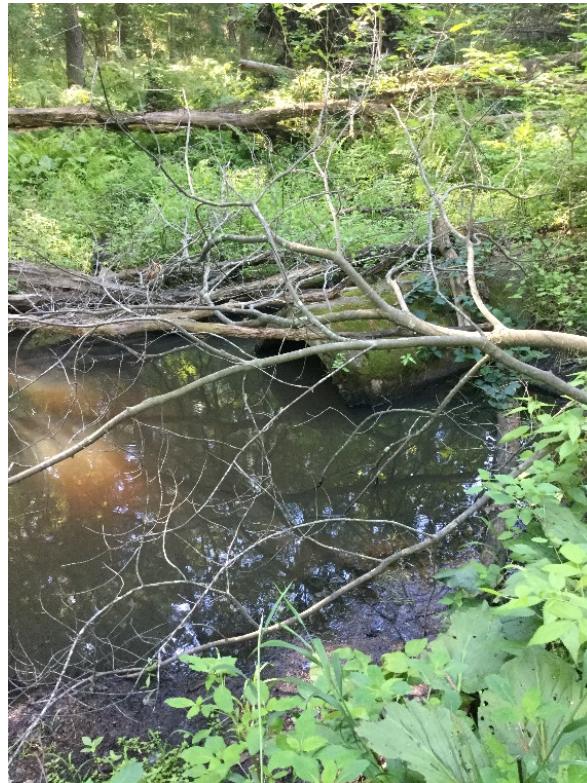
Outfall ID	Street	Notes
Middlesex-1	Queen Road	Fully submerged, possibly due to rise in Long Lake water level
Whitcomb-1	Whitcomb Avenue	Partially submerged
Newtown-5	Newtown Street	Partially submerged
Newtown-6	Newtown Street	Partially submerged
Gristmill-2	Grist Mill Road	Partially submerged
Tahattawan-3	Tahattawan Road	Partially submerged, overgrown
Tahattawan-4	Tahattawan Road	Partially submerged, overgrown
Gristmill-2	Grist Mill Road	Partially submerged, Covered in Debris
91	Florence Street	Partially submerged
Gilson-3	Gilson Road	Partially submerged, needs maintenance
Mill-3	Mill Road	Partially submerged
Dahlia-1	Dahlia Drive	Partially submerged
King School-4	King street	Partially submerged
Shaker School-2	Shaker Lane	Partially submerged, overgrown
Newtown-7	Newtown Road	Partially submerged
Maplehurst-1	Maplehurst Road	Partially submerged
Westchester-1	Westchester Drive	Partially submerged

Gristmill-2 Partially submerged outfall

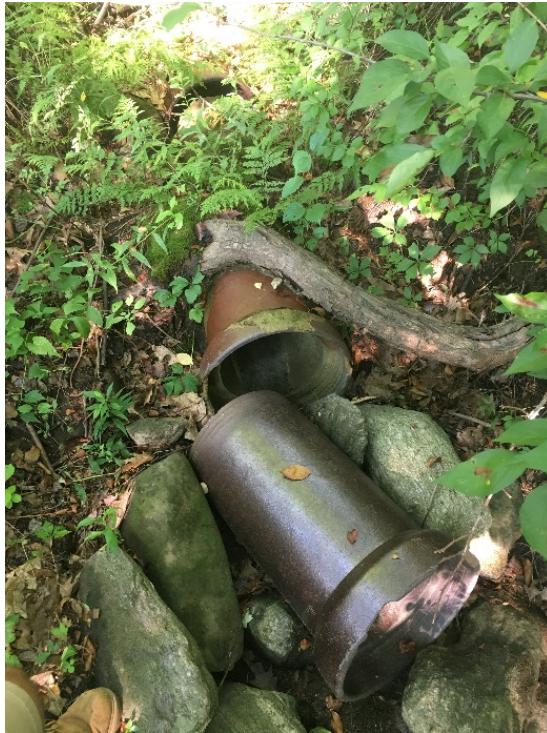
Outfall ID	Street	Reason
Gilson-5	Gilson Road	Partially buried
Ernies-1	Ernies Drive	Overgrown and difficult to access
Tahattawan-2	Tahattawan Road	Old clay pipe, may need repair
Birch-1	Birch Road	Needs to be cleaned out and give a path for water to flow
Foster-1	Foster Street	Located under heavy brush and thorns. Difficult to reach.
Oak Hill-9	Oak Hill Road	Partial submerged in debris and water.
Foster-9	Foster Street	Tree fallen on top, becoming buried into the hill.
Oak Hill-10	Oak Hill Road	Partially buried with sediment
Oak Hill-5	Oak Hill Road	Completely covered in leaves
Oak Hill-1	Oak Hill Road	Partially buried with sediment and leaves
Shattuck-1	Shattuck Street	Partially buried with sediment
Gilson-2	Gilson Road	Partially buried with leaves
Spectacle Pond-2	Spectacle Pond Road	Partially buried with sediment
Spectacle Pond-1	Spectacle Pond Road	Partially buried with sediment
Foster-5	Foster Street	Flared HDPE end is cracked, partially buried with sediment

Tahattawan-2 Clay Pipe Outfall in need of repair

The outfalls included in the table below were noted as requiring maintenance and should be evaluated by Town staff and cleaned and/or repaired as soon as possible. The photo below the table depicts a clay pipe that has been separated at the outfall. Other outfalls requiring maintenance include those that were partially or completely full of sediment, leaves, or debris. Some outfalls were difficult to see due to thick brush, therefore it is recommended to revisit and check for any maintenance required.
