## Littleton FY18 Outfall Inventory and Dry Weather Screening Field Effort Summary

**To:** Chris Stoddard, PE, Director of Public Works  
**COPY:** Town of Littleton Stormwater Management Program Files  
**DATE:** June 30, 2018

This memorandum presents a summary of Tighe & Bond’s second round of outfall investigation field work and findings in FY18. Tighe & Bond completed 115 outfall investigations and sampled at 1 outfall with dry weather flow during the Fall 2017 field effort.

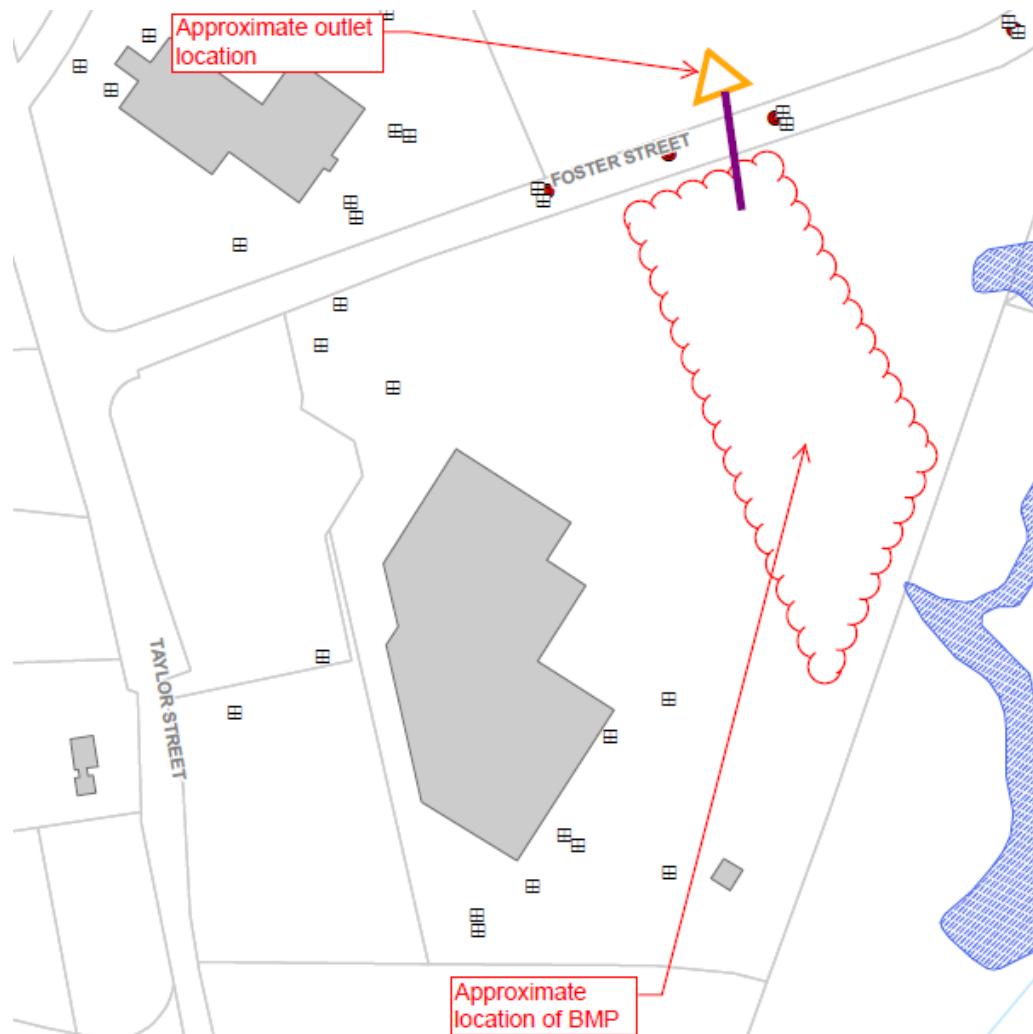
- **Review Foster Street area as-builts.** A BMP was located during this field effort near 300 Foster Street (see sketch below). It appears that drainage from Foster Street discharges into the pond, which then discharges across Foster Street and down a steep slope. The BMP's outlet was not accessible and therefore not investigated as part of this field effort. The Town should review Foster Street as-built plans and update drainage connectivity in GIS. The Town should conduct outfall investigation(s) for new outfall(s) once mapping is updated.
