Littleton Town Hall Building & Space Needs Assessment

Volume II: Shattuck Street Municipal Complex, Existing Conditions Report

Littleton Town Hall Complex
37 Shattuck Street
Littleton, MA 01609

March 2021

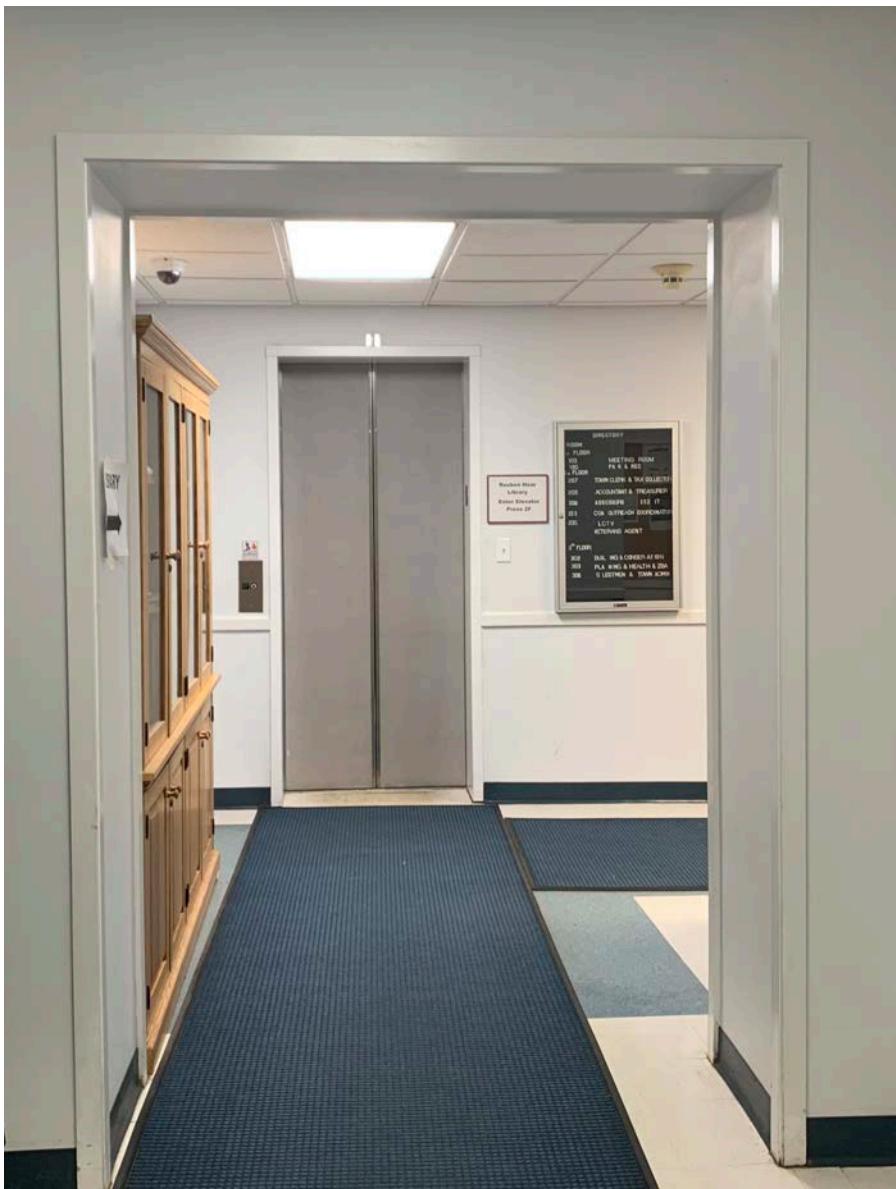
View of existing elevator. Creates a bottle neck in circulation. (Library Wing - First Floor)

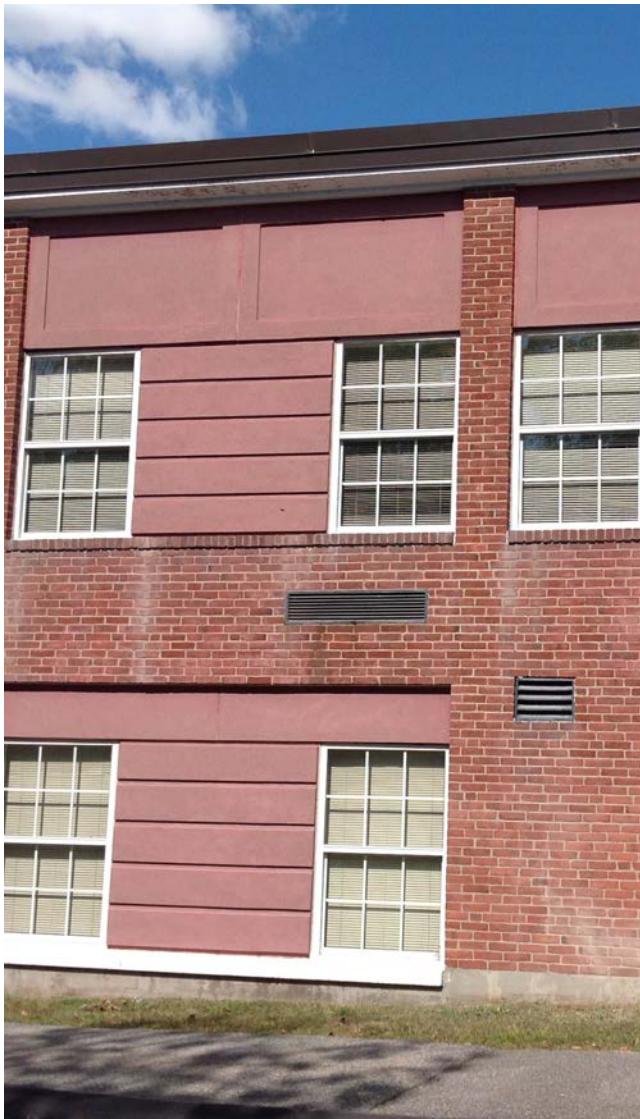
Evidence of staining/soiling at window sills; typical at all window openings on all buildings. (Library Wing - Parking Lot Side)

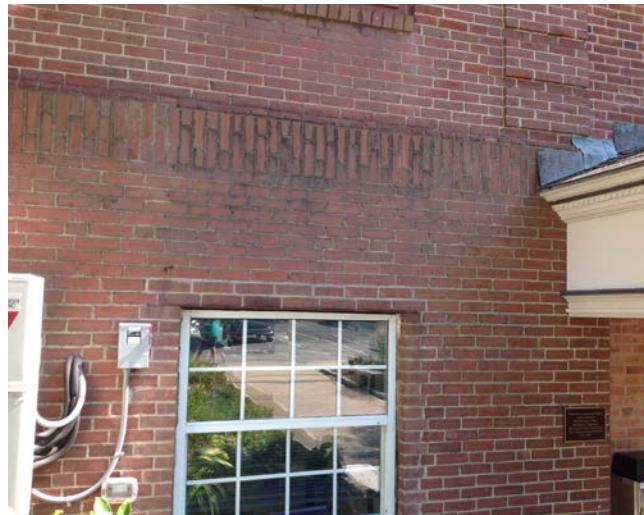
Evidence of staining/soiling near main entrance, most likely from water damage. (Classroom Wing - Parking Lot Side)

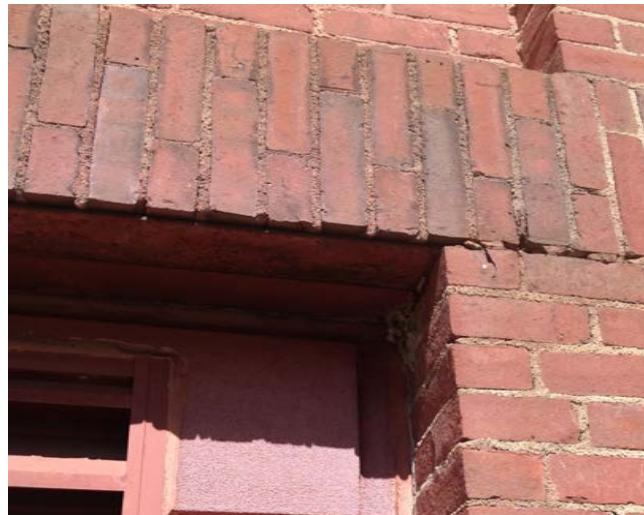
Evidence of staining/soiling and areas of missing mortar. (Multi-Use Wing - Parking Lot Side)

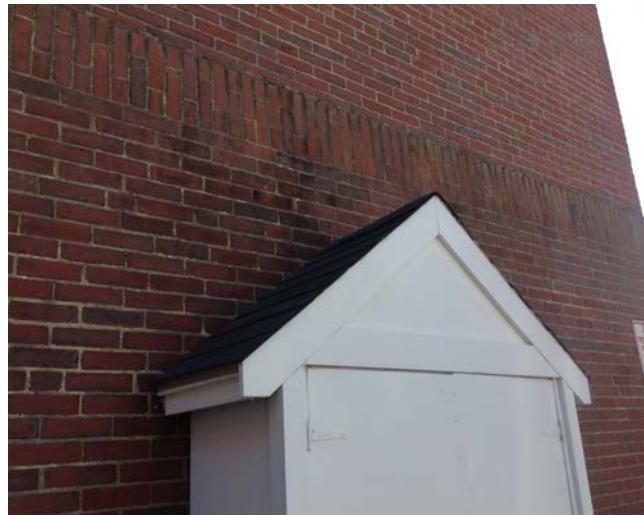
Evidence of staining/soiling, most likely from water damage. (Multi-Use Wing - Parking Lot Side)

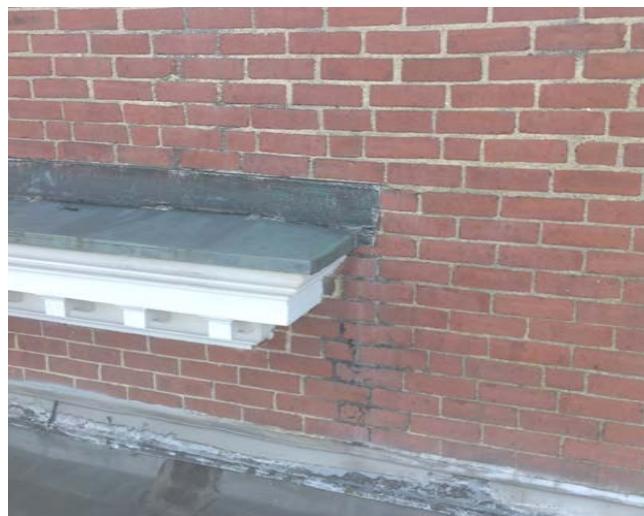
Evidence of staining/soiling and mortar erosion, most likely from water damage. (Multi-Use Wing Roof to Office Wing Roof)

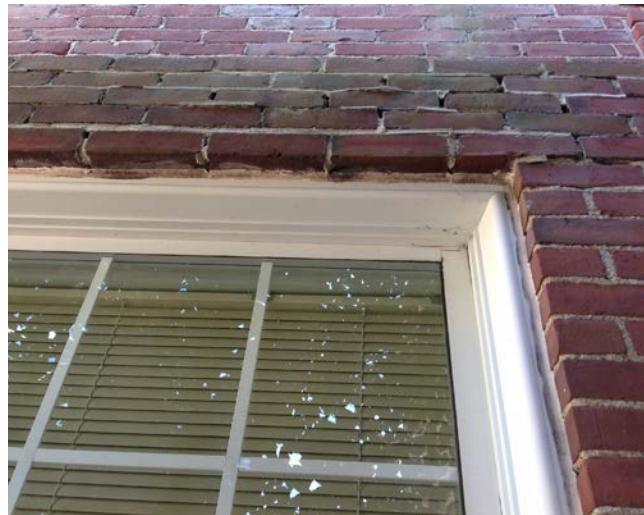
Evidence of staining/soiling at window header, most likely from water damage. (Office Wing - Parking Lot Side)

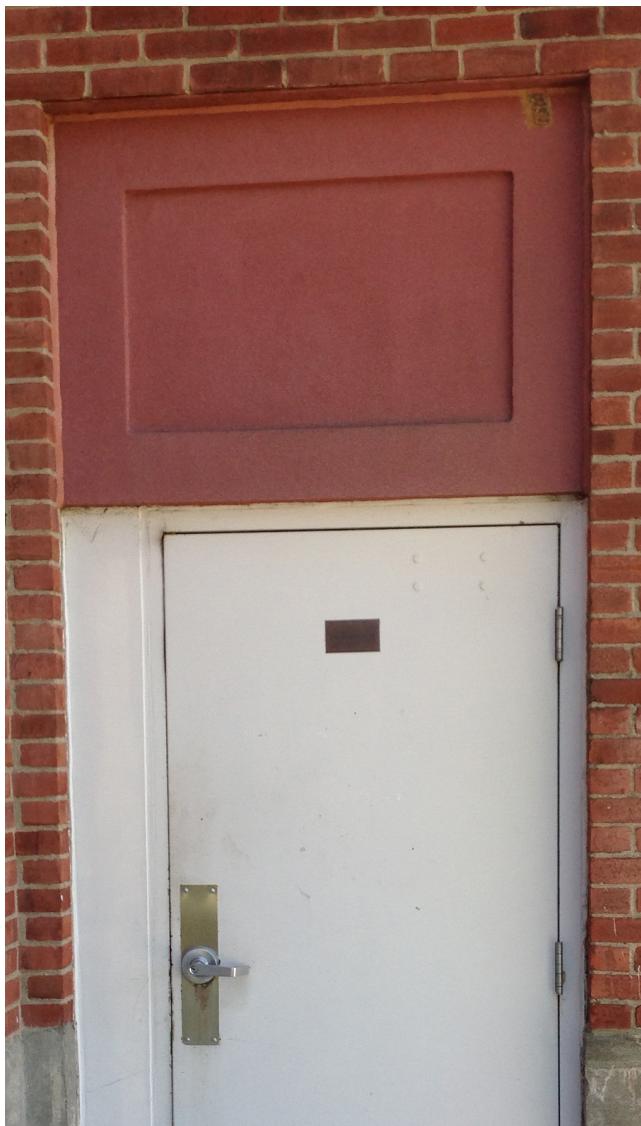
Evidence of damage to EIFS above conference room door. (Library Wing - Parking Lot Side)

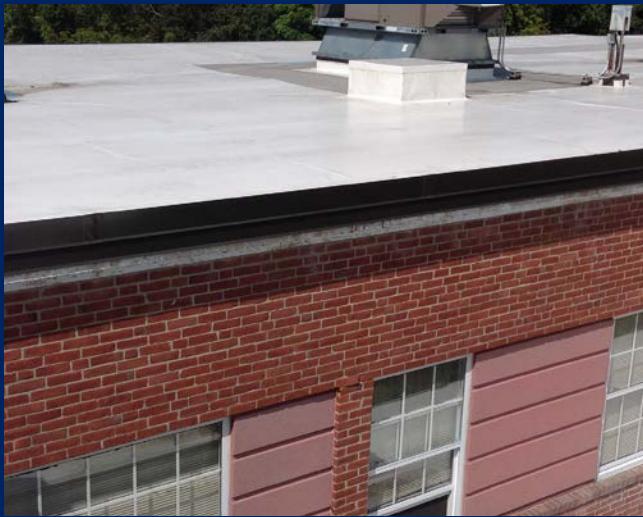
Observed peeled paint on trim board. (Library Wing - Shattuck Street Side)

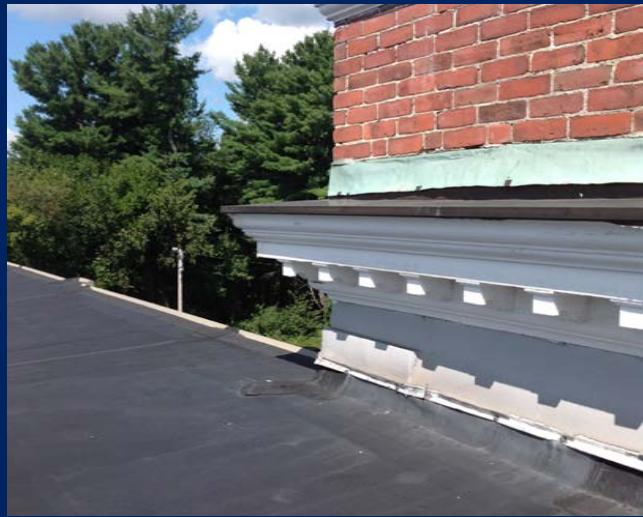
Observed staining/soiling on trim board. (Multi-Use Wing Roof to Office Wing Roof)

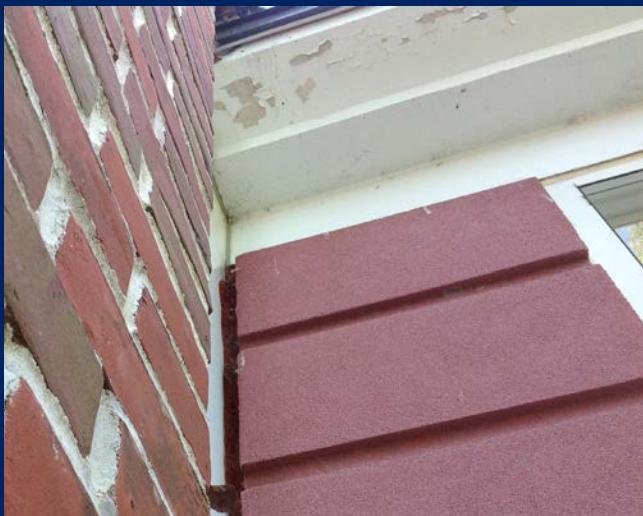
Observed peeled paint on trim board. (Library Wing - Shattuck Street Side)

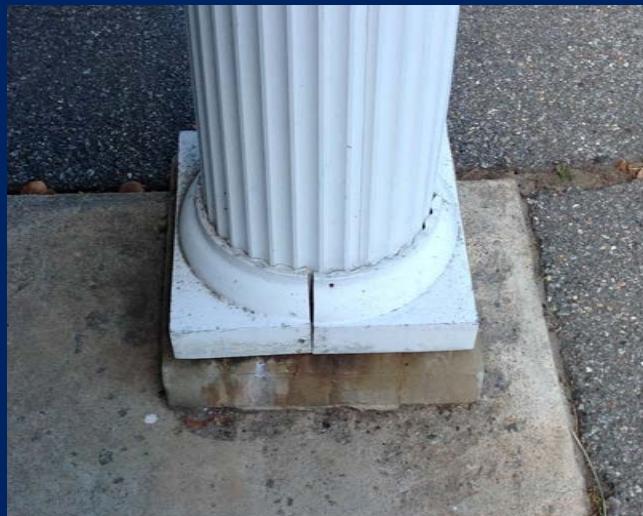
Evidence of cracking/separation of column trim. (Library Wing - Shattuck Street Side)

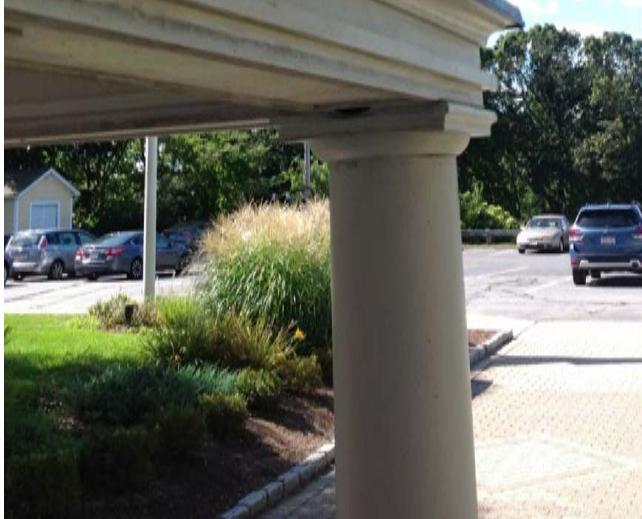
Observed staining/soiling on trim board.
(Library Wing - Parking Lot Side)

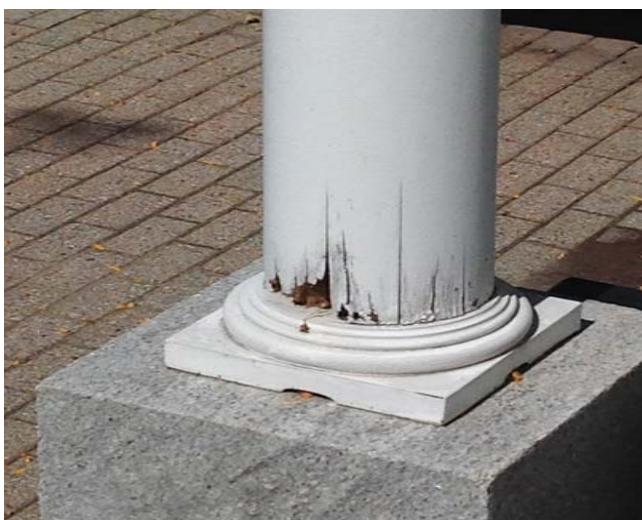
Evidence of cracking/missing wood on column trim.
(Library Wing - Parking Lot Side)

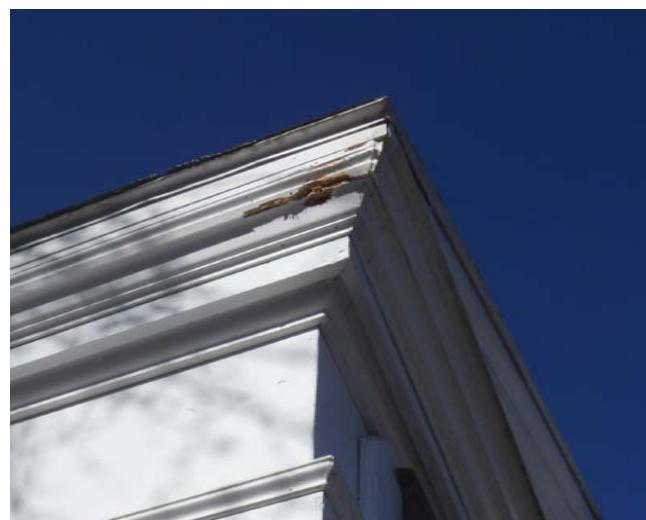
Evidence of damage to trim, most likely from an animal. (Library Wing - Shattuck Street Side)

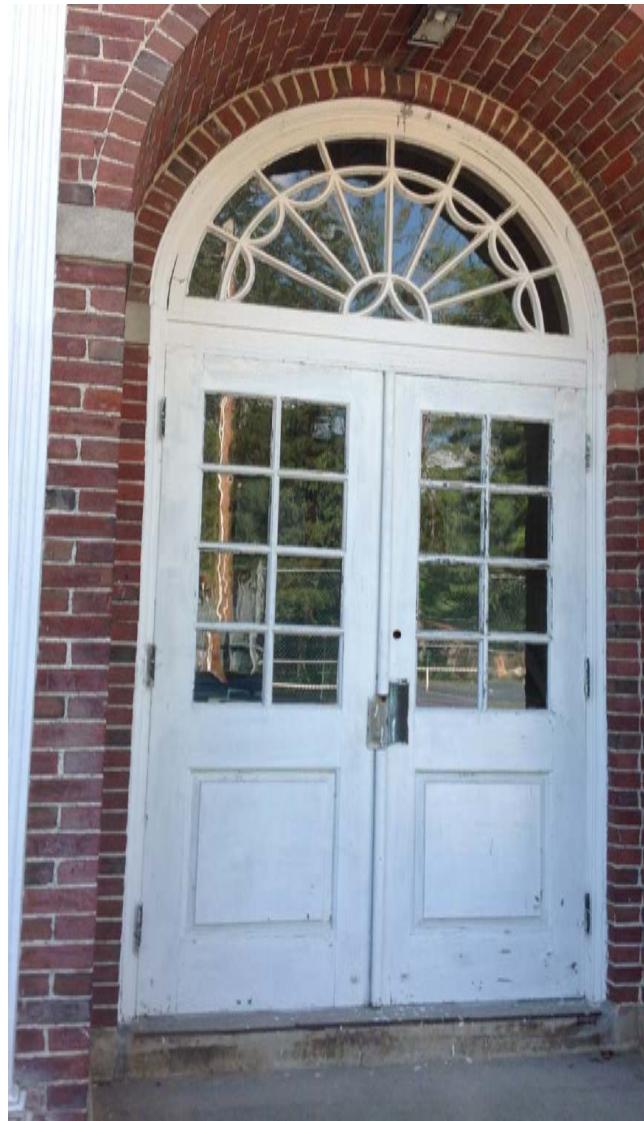
Observed peeled paint on trim board.
(Office Wing - Tennis Court Side)

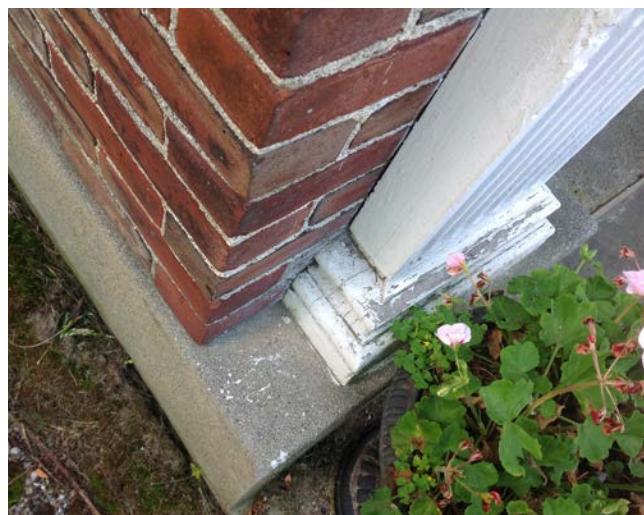
Observed peeled paint on trim board.
(Office Wing - Tennis Court Side)

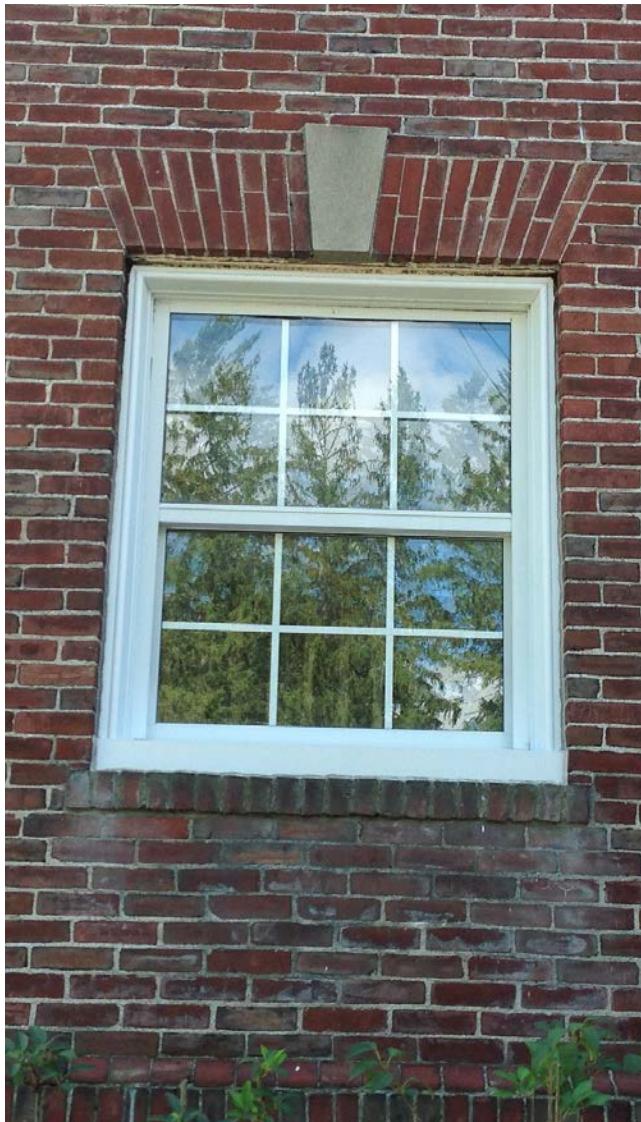
Windows are at the end of their useful life and create difficult and uncomfortable conditions for occupants.

Typical condition of aluminium windows.
(Office Wing - Tennis Court Side)

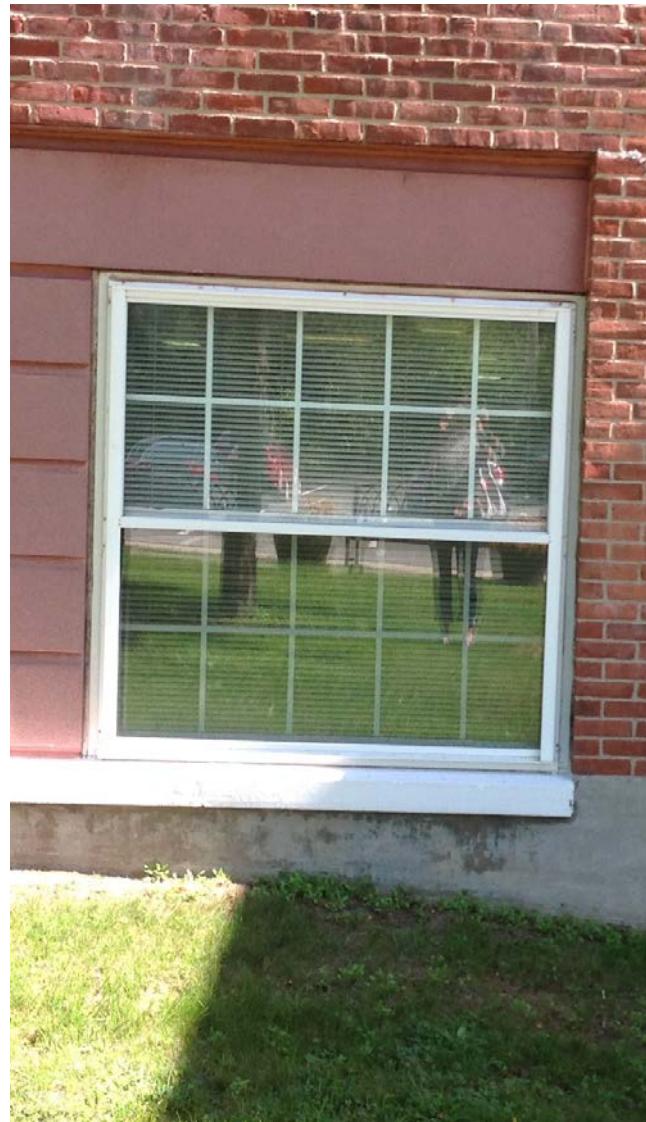
Windows units are typically difficult and dangerous to operate. There is also evidence of cracked caulking, rust, and other discoloration at the window openings. It is recommended to remove existing windows and replace with a more efficient option, reflash, and reseal.

Typical condition of aluminium windows.
(Classroom Wing - Parking Lot Side)

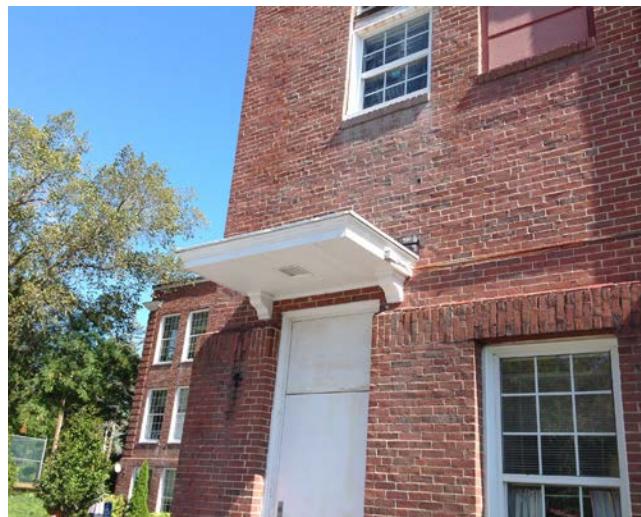
Exterior doors on the west facade showing signs of rust. (Multi-Use Wing - Parking Lot Side)

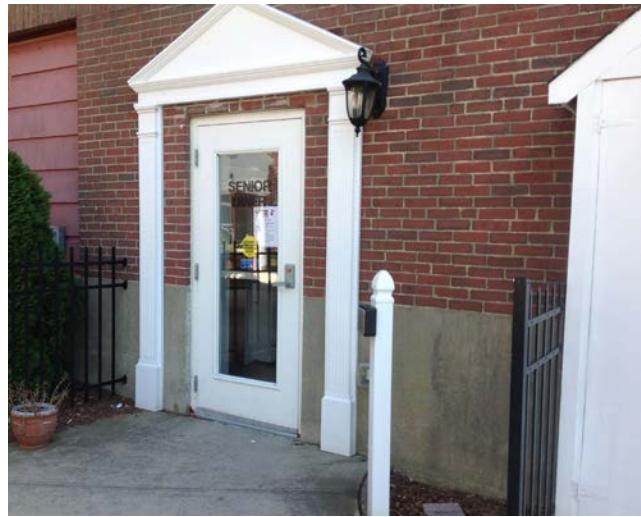
Evidence of rusting exterior door. (Multi-Use Wing - Parking Lot Side)

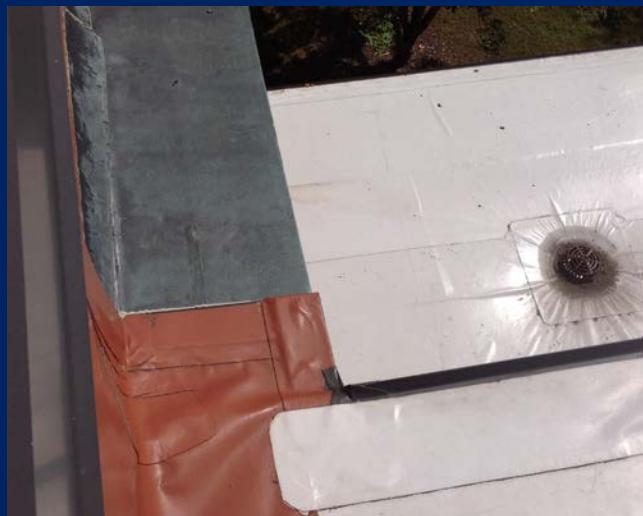
Gap in base flashing. (Library Wing - Roof 2)

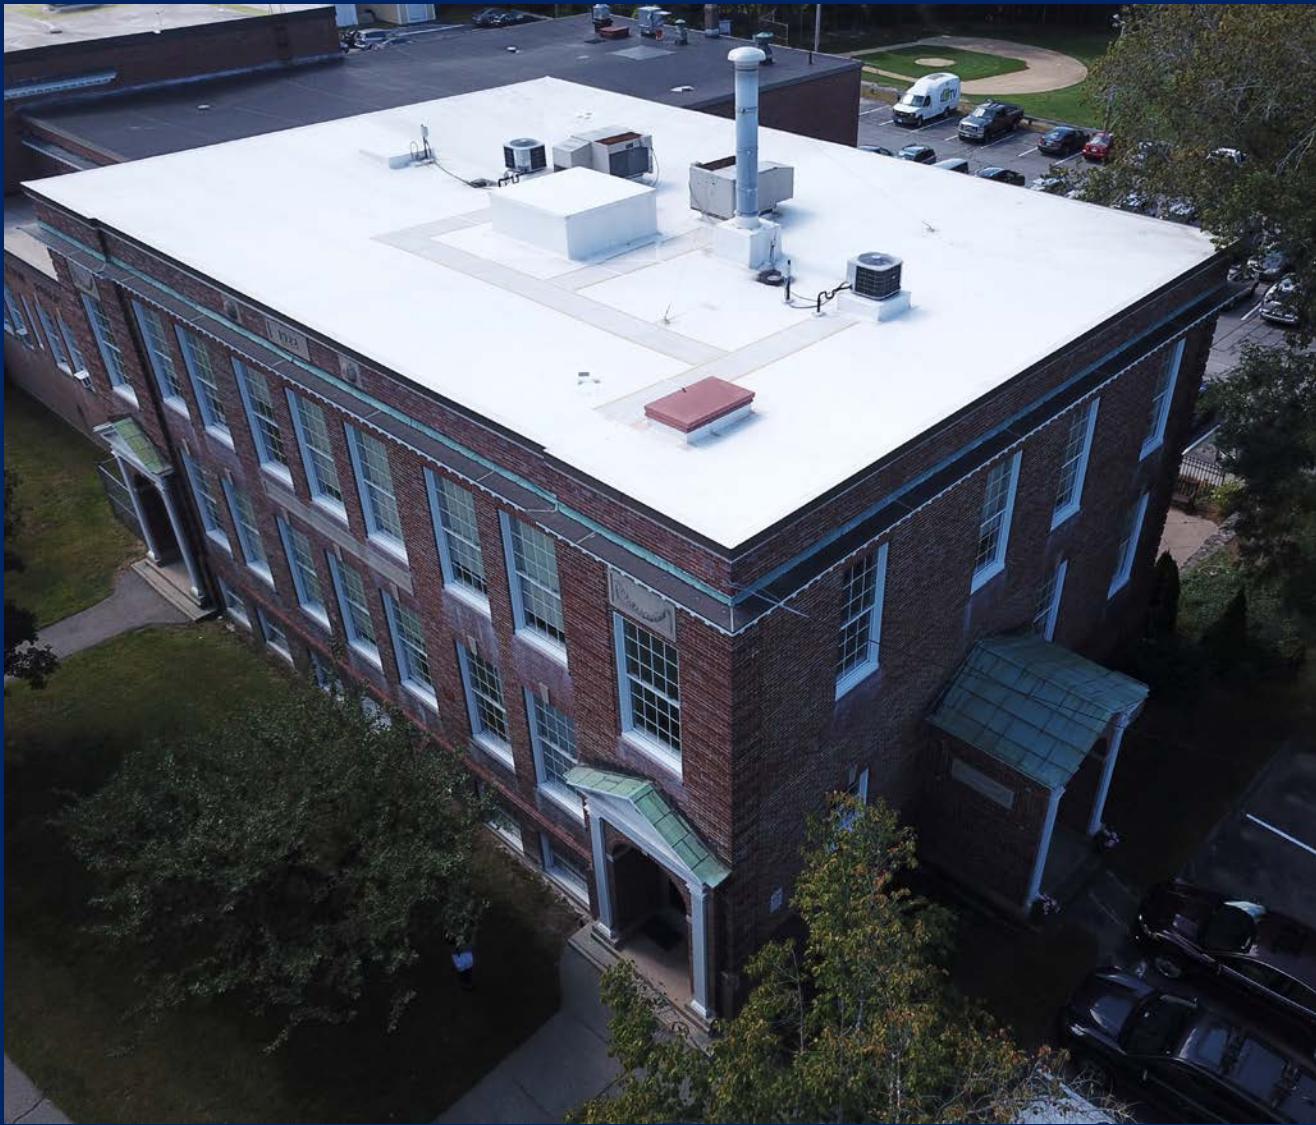
Example copper roof, note abandoned rusted steel frame from removed sign, west facade. (Office Wing)

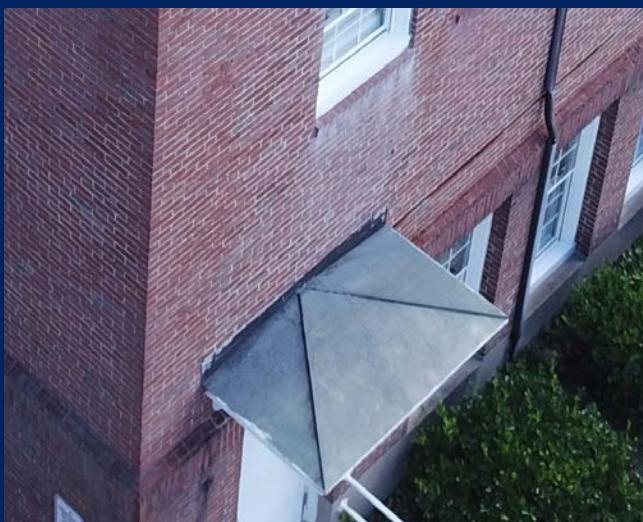
Solder joint at copper gutter showing signs of repair and age. (Multi-Use Wing)

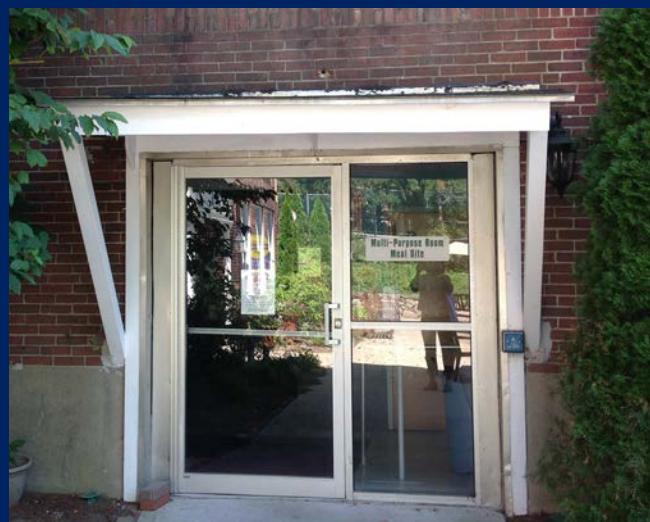
Roof flashing showing signs of age and damage. (Multi-Use Wing)

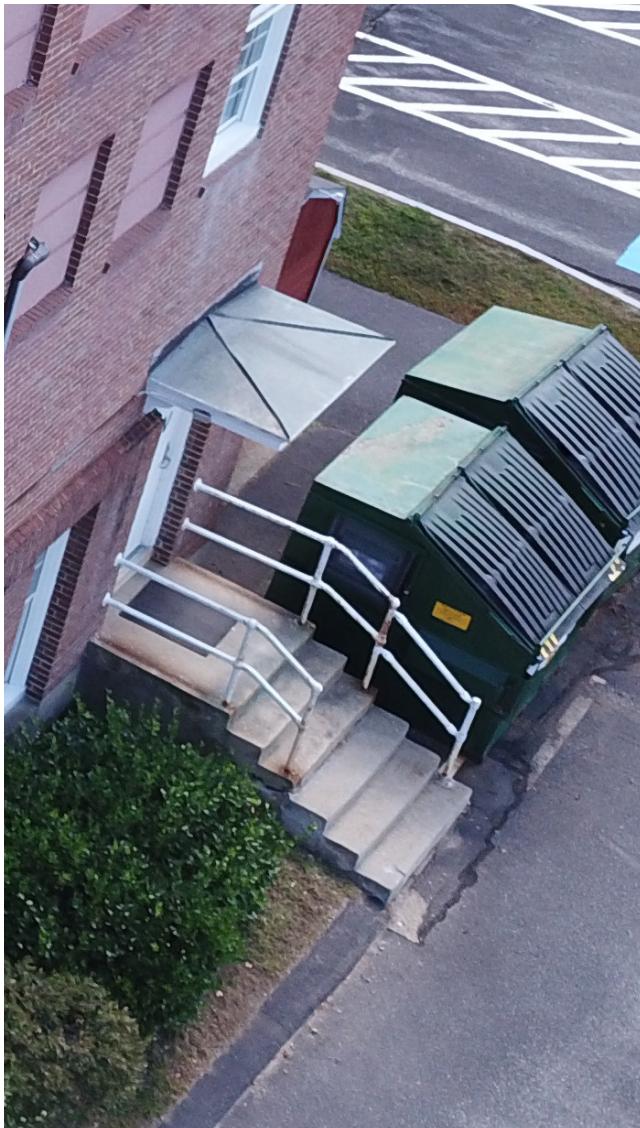
Failed copper cleats, observed from second floor window. (Multi-Use Wing)

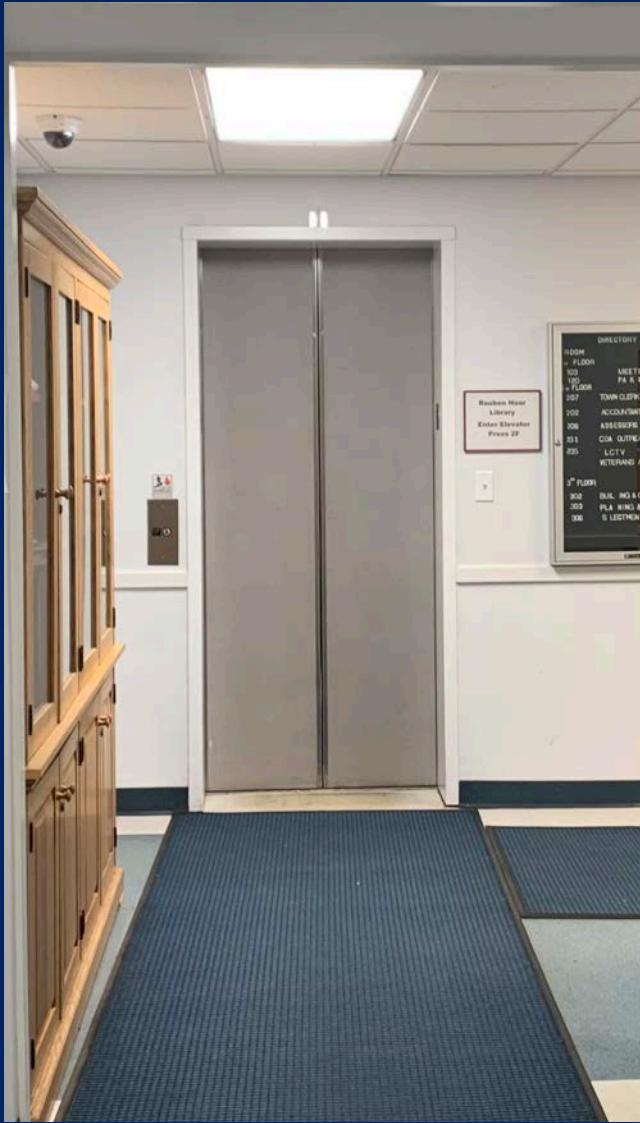
View of existing elevator. Creates a bottle neck in circulation. (Library Wing - First Floor)

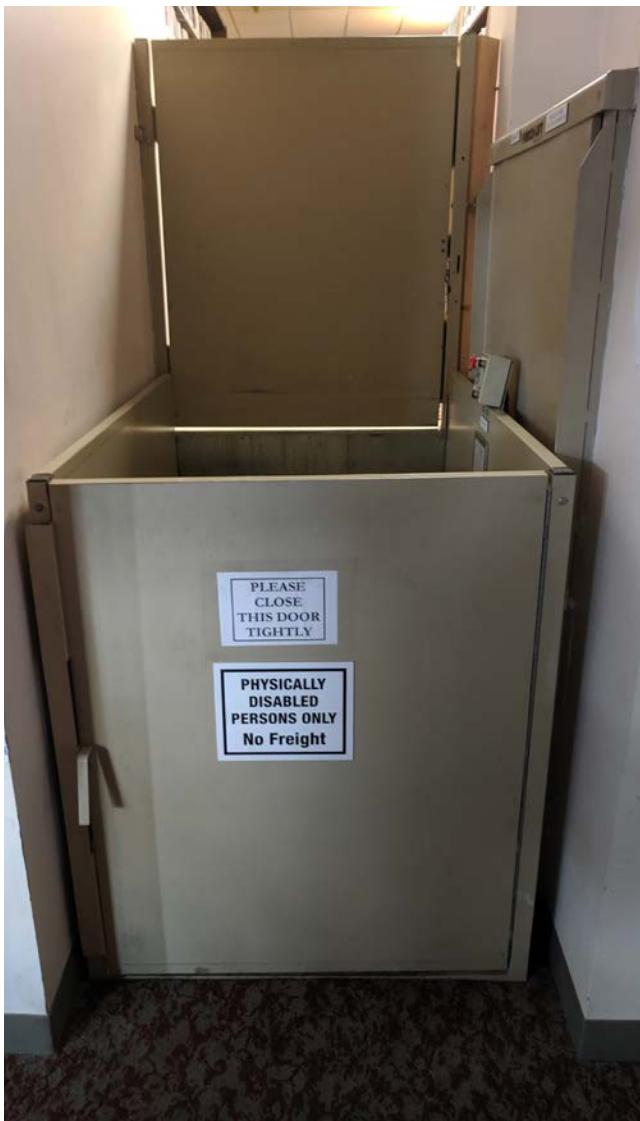
View of existing lift near library main entrance. Too small and people have gotten stuck in it. (Library Wing - First Floor)

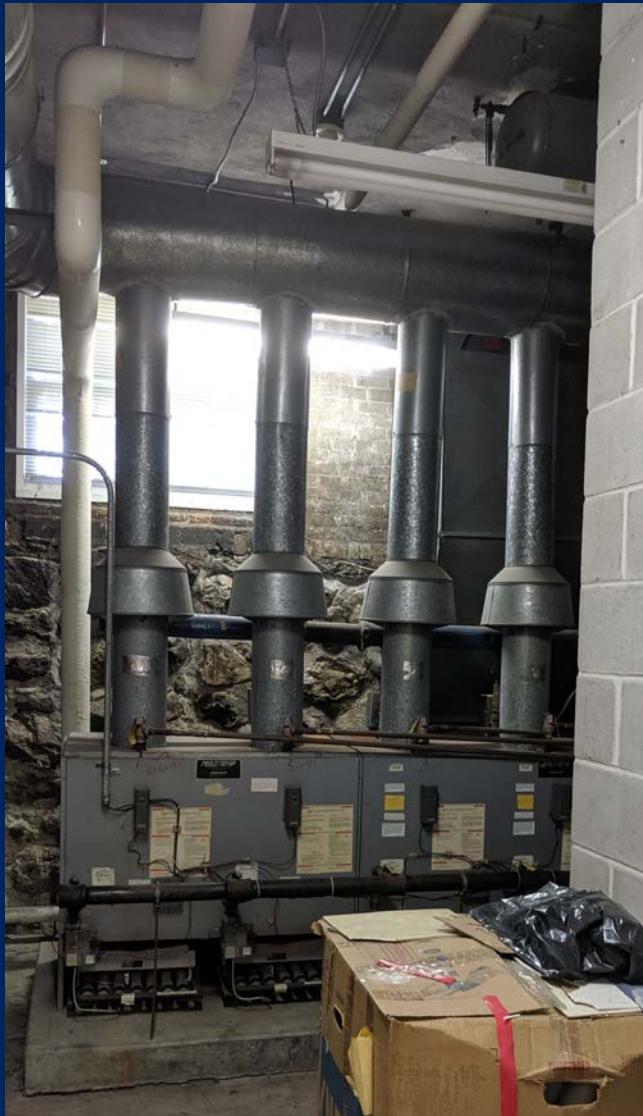
One of two boiler plants, both in need of replacement. (Office Wing - First Floor)

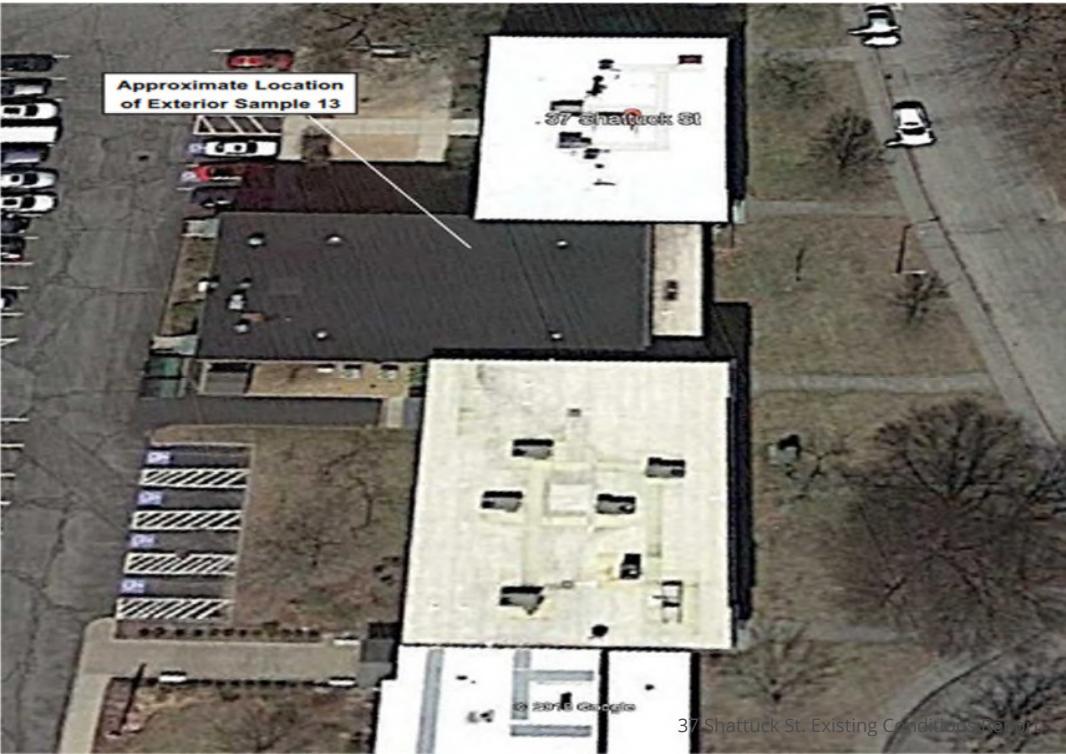
<p>Approximate Location of Exterior Sample 13</p> <p>37 Shattuck St</p> <p>© 2018 Google</p> <p>37 Shattuck St. Existing Conditions Report</p>
Photo Location: Exterior Roof		
Description: Approximate Location of Exterior Sample 13 Confirmed ACM
