Littleton Town Hall Building & Space Needs Assessment

Volume IV: King Street, Existing Conditions Report

Indian Hill Music Center
36 King Street
Littleton, MA 01460

January 2021

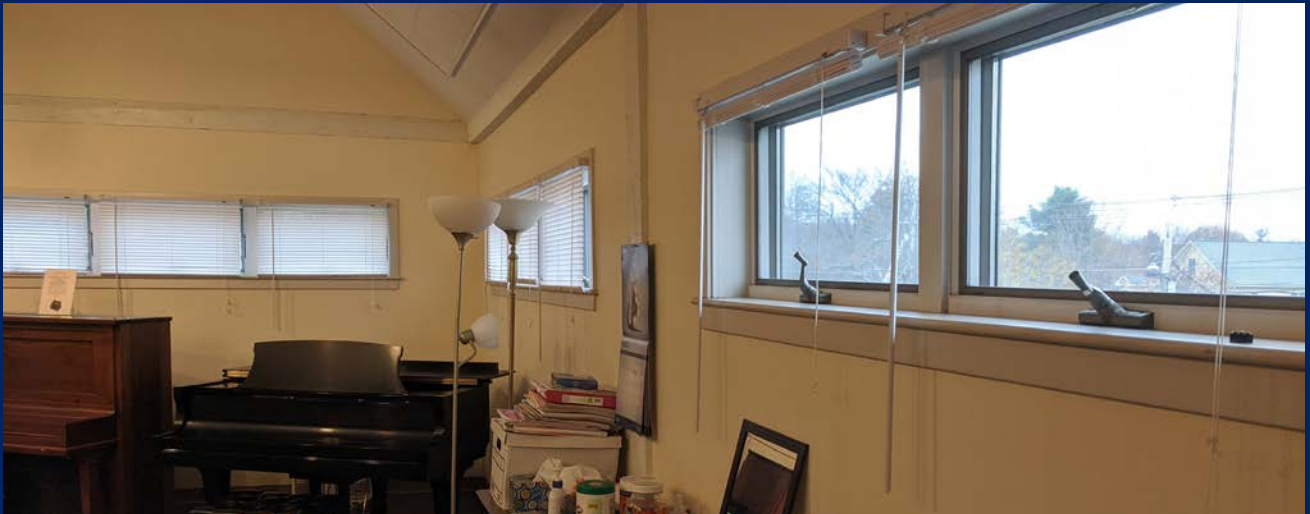
Typical interior view of an upper story room. The window hardware is in generally good operating condition.

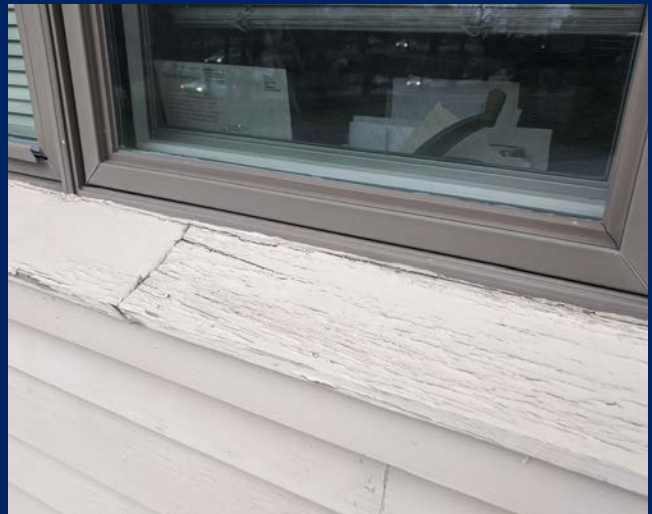
View of a typical window sill, generally the window is in good condition, the wood trim however needs to be addressed.

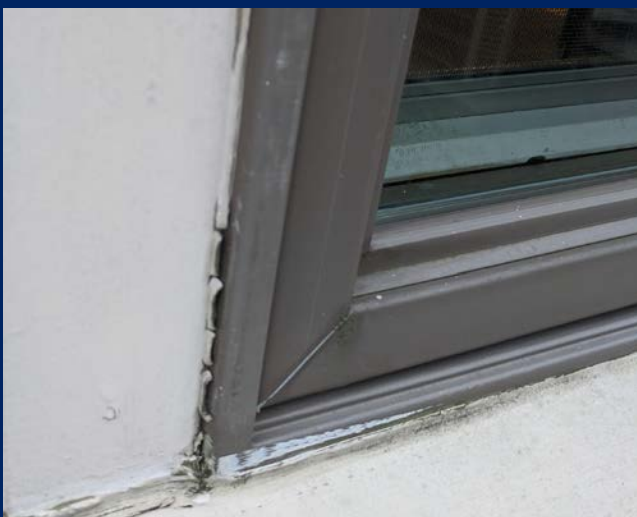
This photograph shows loss of the sealant at the window perimeter as well as some dirt which can be cleaned.

Windows are showing signs of age but can remain in-use; consider replacement during building renovations.

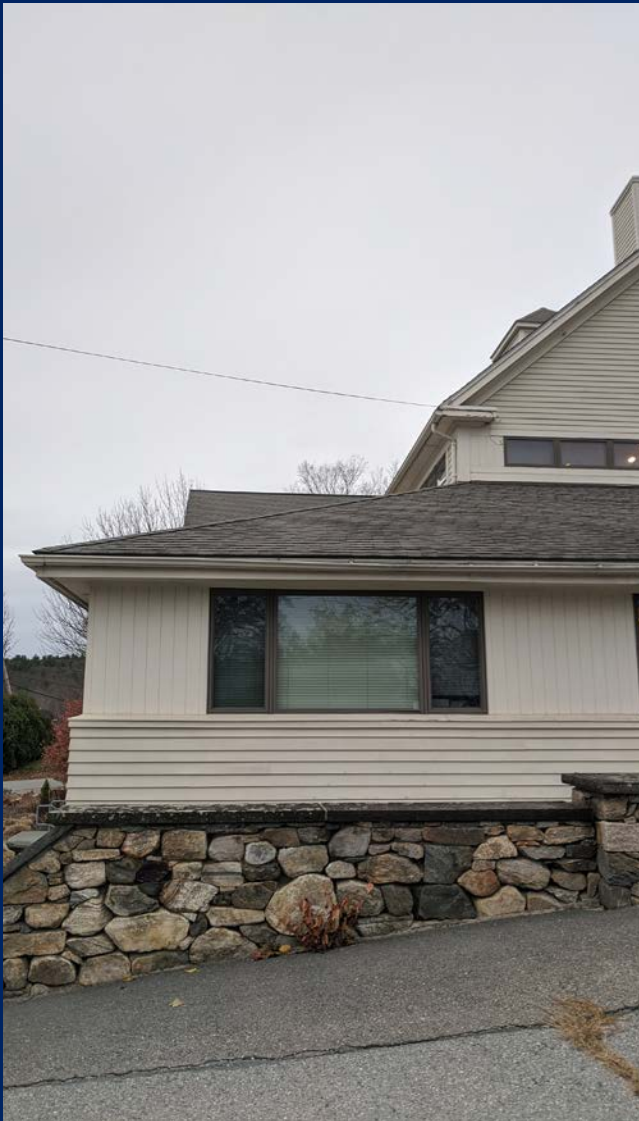
View of exterior wall, plant growth at base and on wall should be removed.

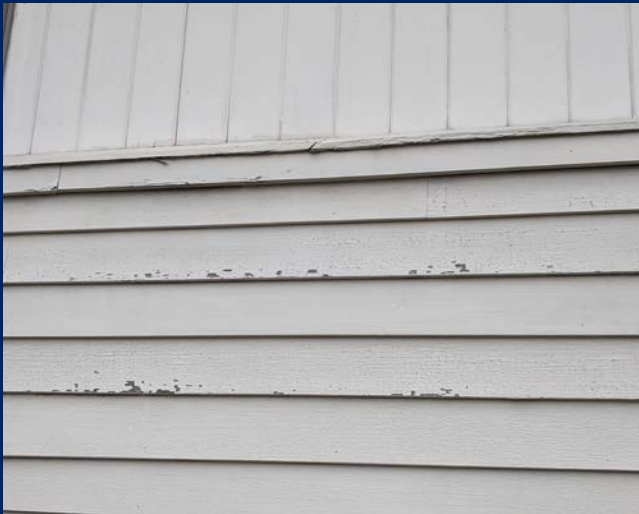
Close up photograph at typical clapboard siding shows signs of paint loss.

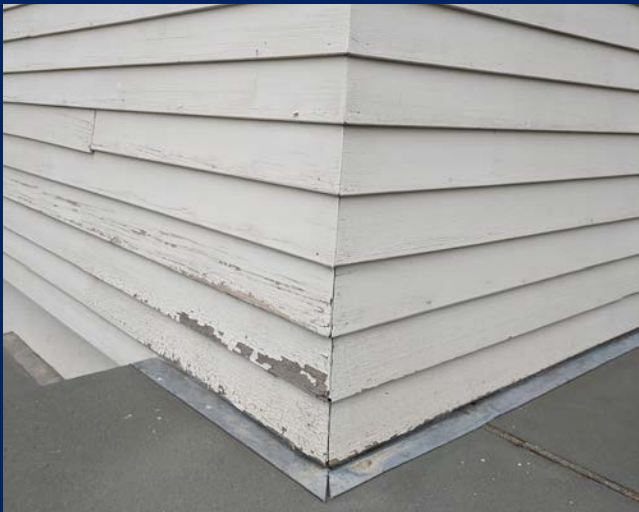
Exterior corner shows paint deterioration and mitred joints that have begun to separate.

At a minimum, we suggest repairing the open joints to ensure a weather tight building envelope in the interim.

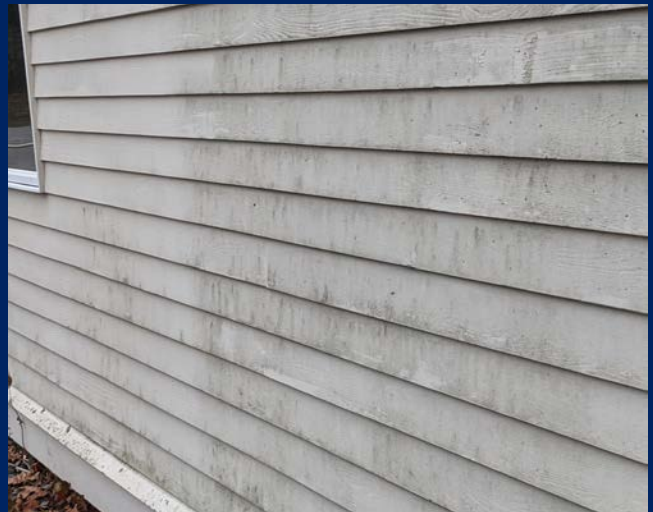
Generally the exterior siding should be cleaned to remove organic growth.

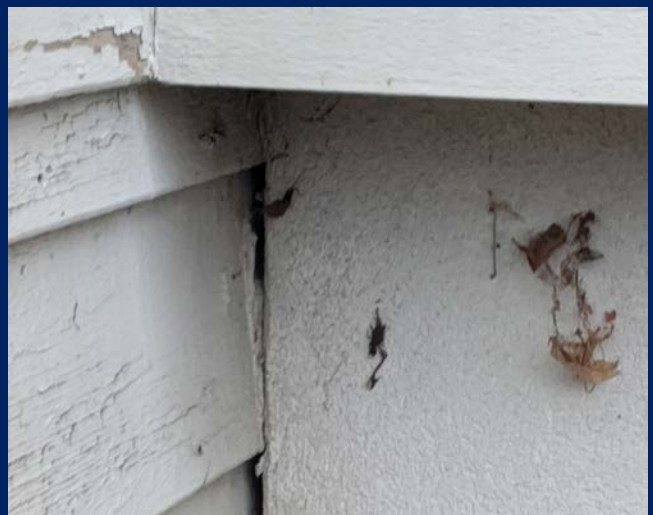
Close up detail where siding meets foundation wall, this joint should be cleaned and sealant applied.

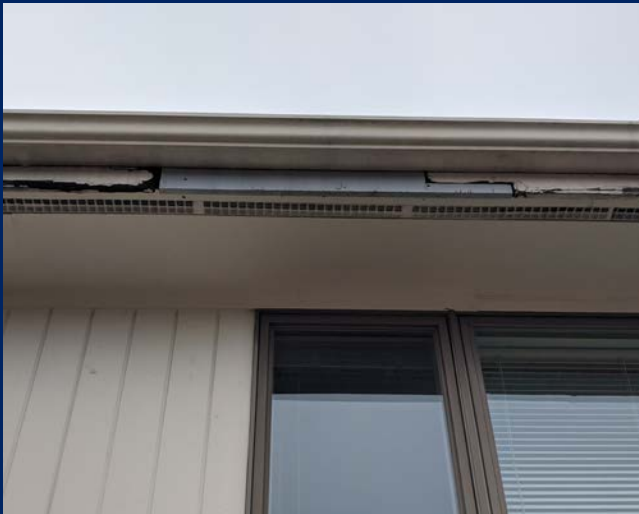
View from the ground at roof soffit where small repair was attempted to enclose lost wood trim. Condition to be monitored.

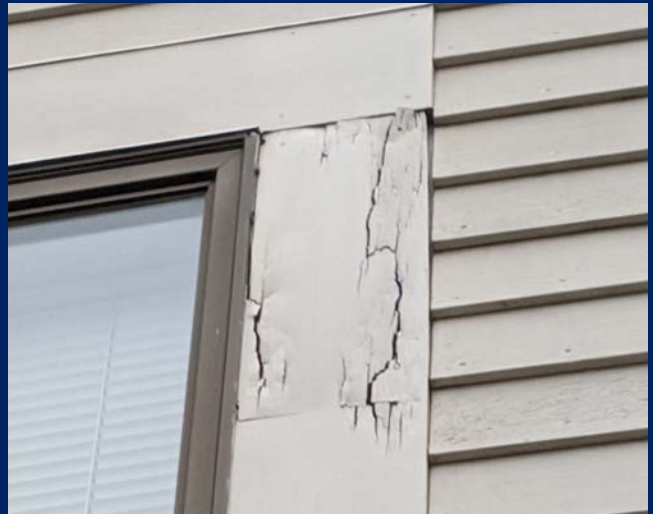
Close up view of failing paint finish and potentially damaged wood substrate.

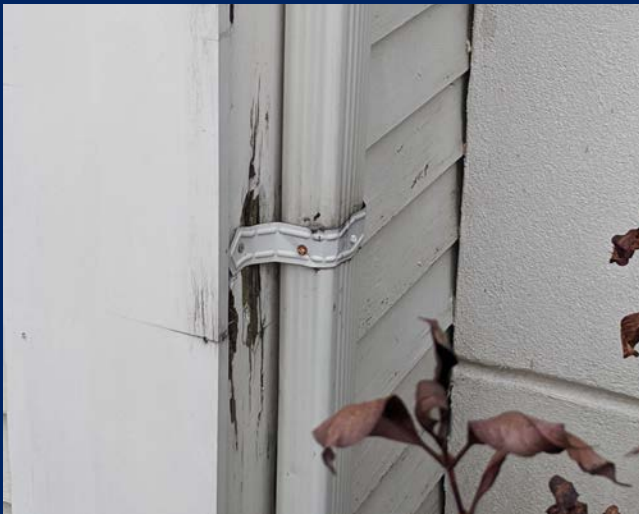
Water damaged trim board at gutter bracket, paint loss and trim should be repaired to prevent further damage.

Most significantly, there are some trim boards that are failing and will need to be repaired to prevent further water infiltration and damage. These sections present significant potential for water infiltration and subsequent damage to the building and interior walls and insulation.

Some trim is damaged and should be replaced.

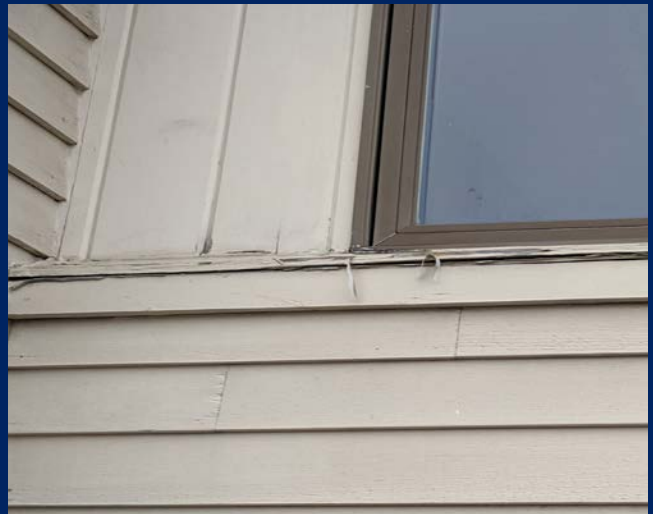
Close up view of trim transition condition where paint finish is beginning to fail.

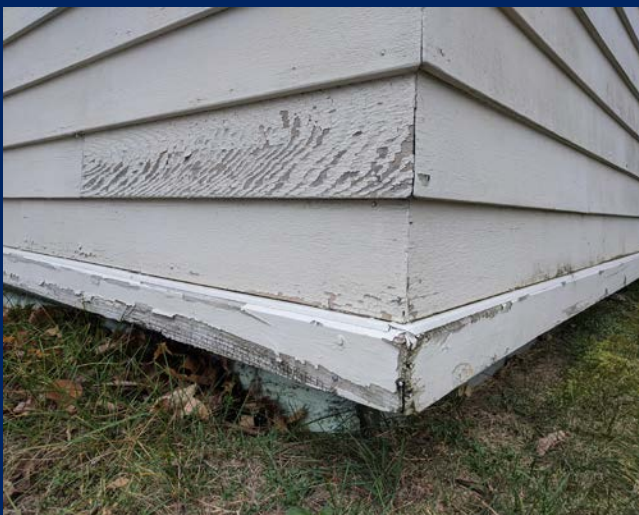
A typical corner condition showing paint loss and amage to trim boards.

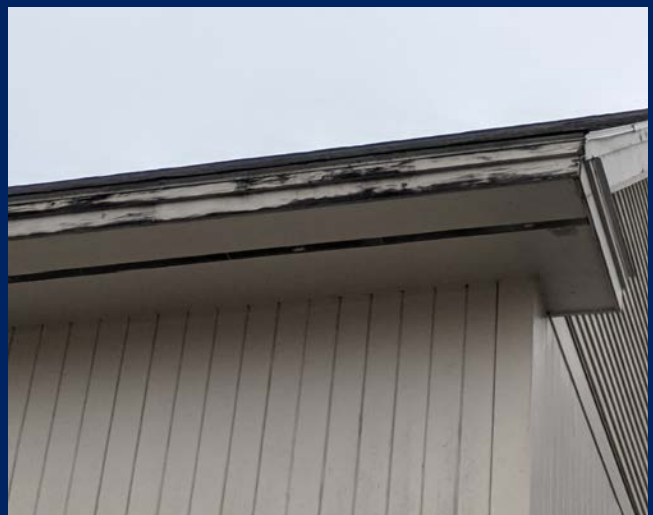
This photograph shows the condition of the roof trim and loss of finish paint exposing the wood substrate.

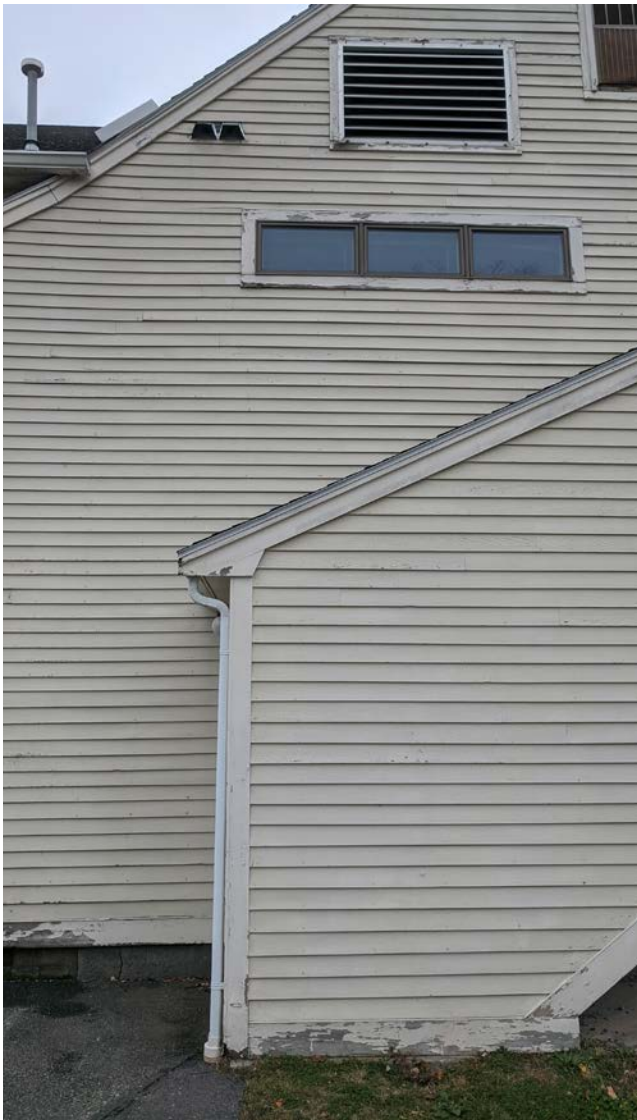
Wider exterior view shows general aged trim and paint and loss.

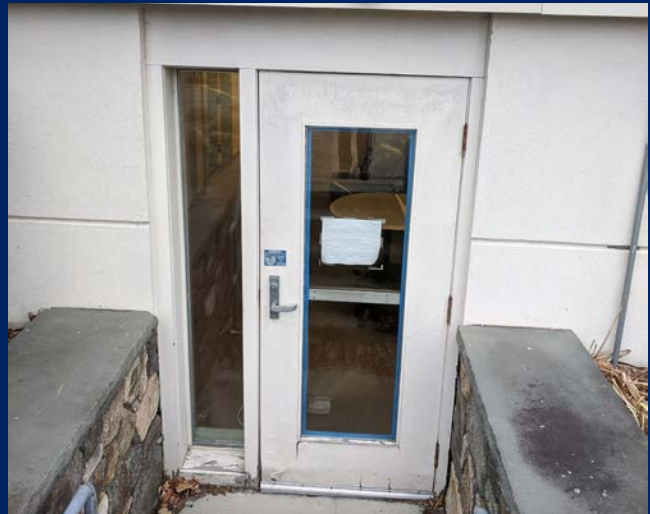
This door and frame from the basement are reaching the end of useful life and should be replaced with an FRP door and frame.

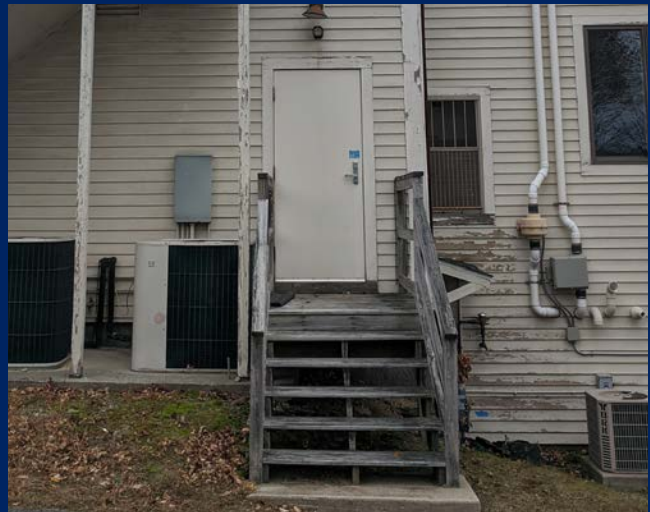
The hinges on this door appear to be rusting, and should be monitored and replaced if not serviceable.

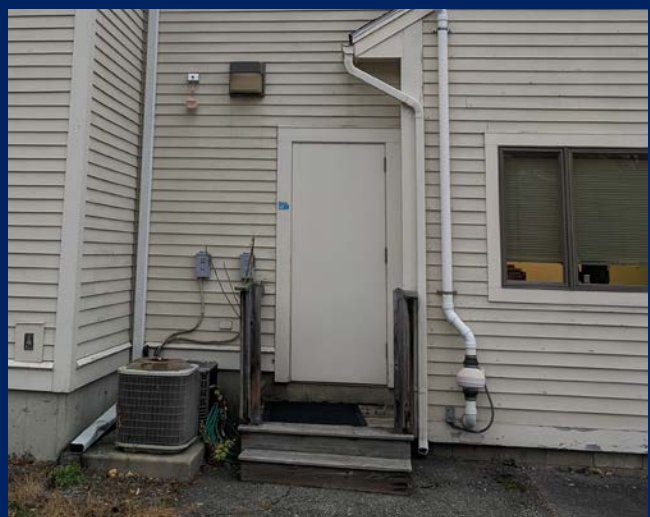
The hinges on this door appear to be rusting, and should be monitored and replaced if not serviceable.

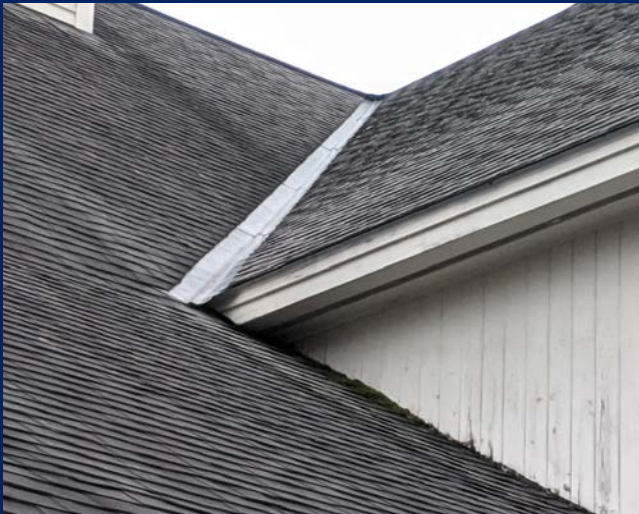
Detail view at valley intersection, vertical wall shows organic growth. Streaking and staining can be observed.

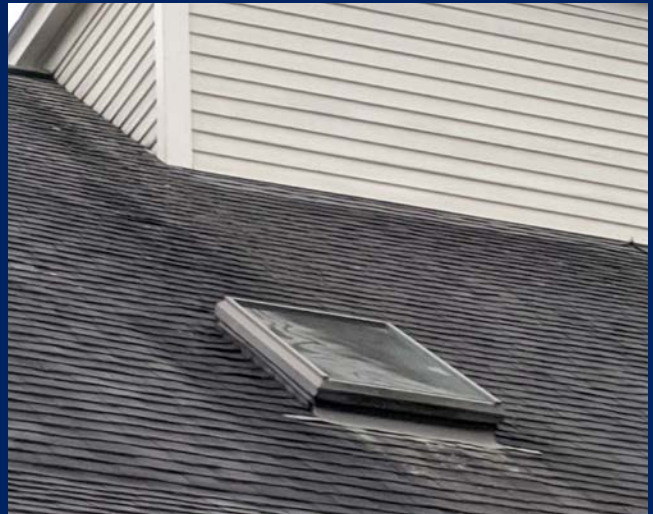
Streaking and staining can be observed at one of the skylights on the north roof.

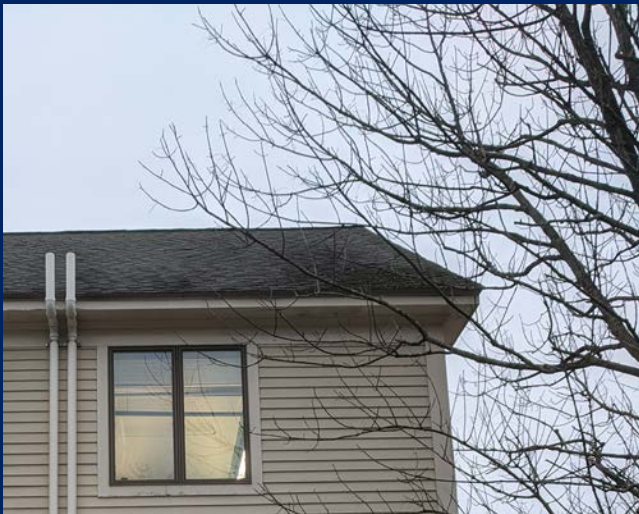
Abrasive wearing can be observed at the SW corner under the tree canopy.

The shingles for the most part appear to be in generally good shape, with little observed granular loss. The southwest corner of the roof appears to be wearing at a greater rate than the rest of the roof areas, as an adjacent tree canopy is most likely abrading the shingle surface with wind movement of the branches.

The southwest corner of the roof appears to be wearing at a greater rate than the rest of the roof areas, as an adjacent tree canopy is most likely abrading the shingle surface with wind movement of the branches. Suggest an arborist review and provide professional corrective measures of the tree.

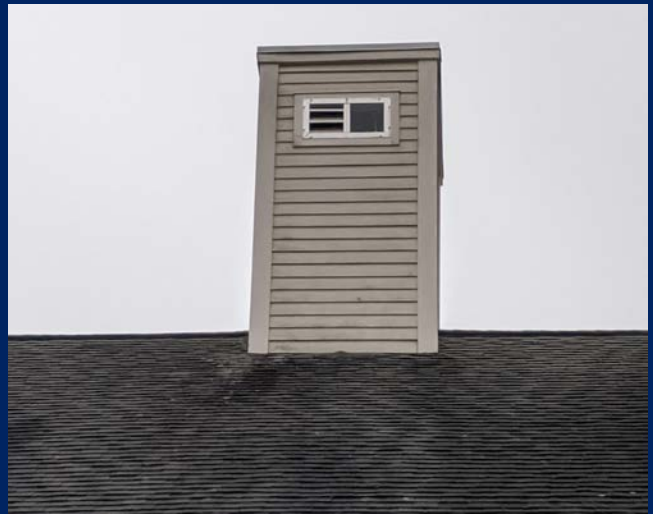
Detail view at chimney. Streaking and staining can be observed.

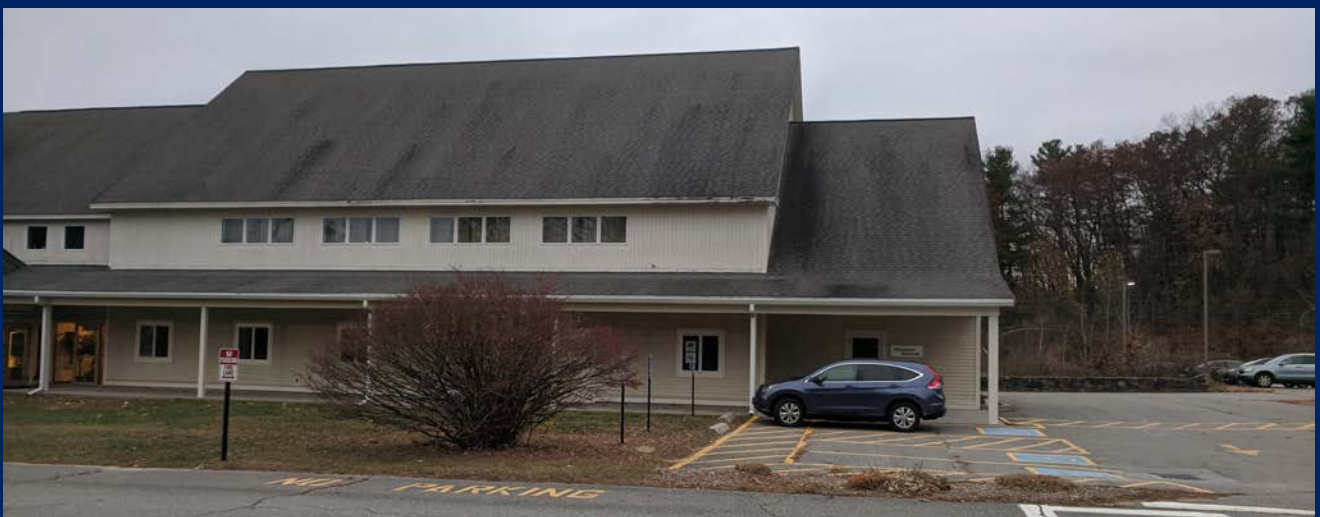
Overall view from the north east side looking at the Performance Hall. Streaking and staining can be observed.

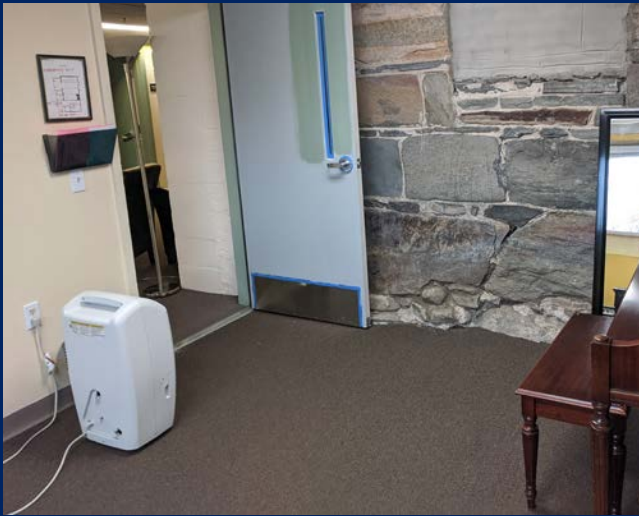
Portable dehumidifiers (Classroom - Basement)
