# Littleton Town Hall Building & Space Needs Assessment

## Volume III: DCU Office, Existing Conditions Report

DCU Office & Retail Branch Building  
255 Great Road  
Littleton, MA 01609

October 2019

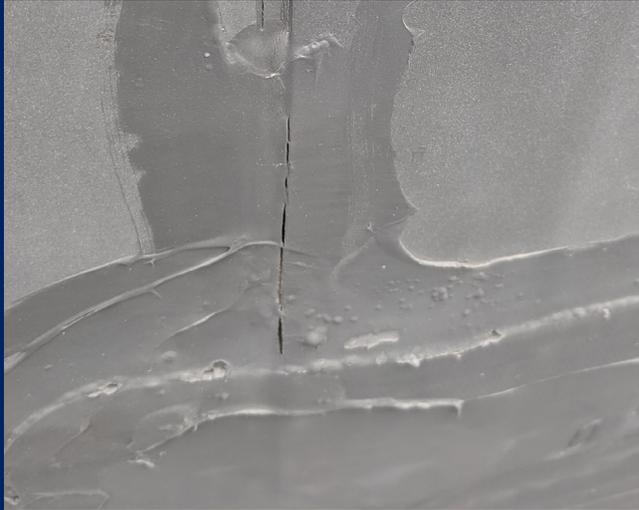
Separation of what appears to be an already repaired joint (via applied darker coating) occurring in mansard wall.

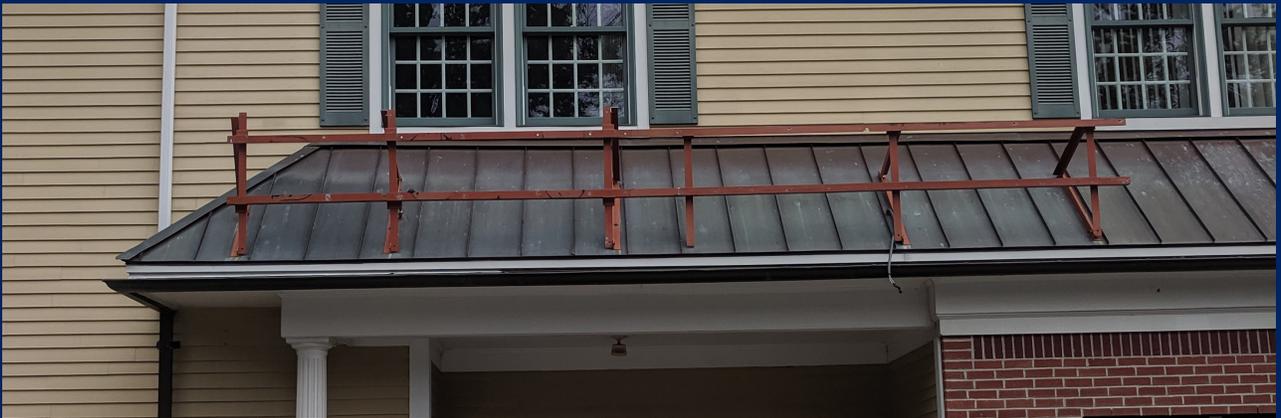
Example standing seam copper roof, note abandoned rusted steel frame from removed signage, west facade.

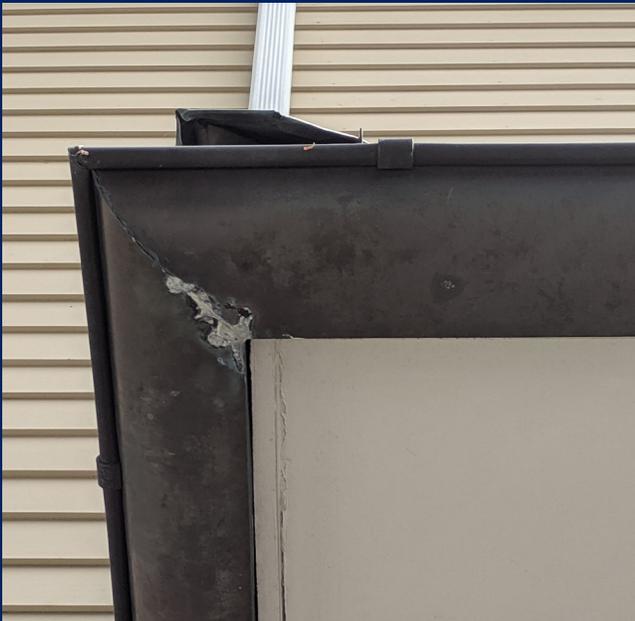
Solder joint at copper gutter showing signs of repair and age.

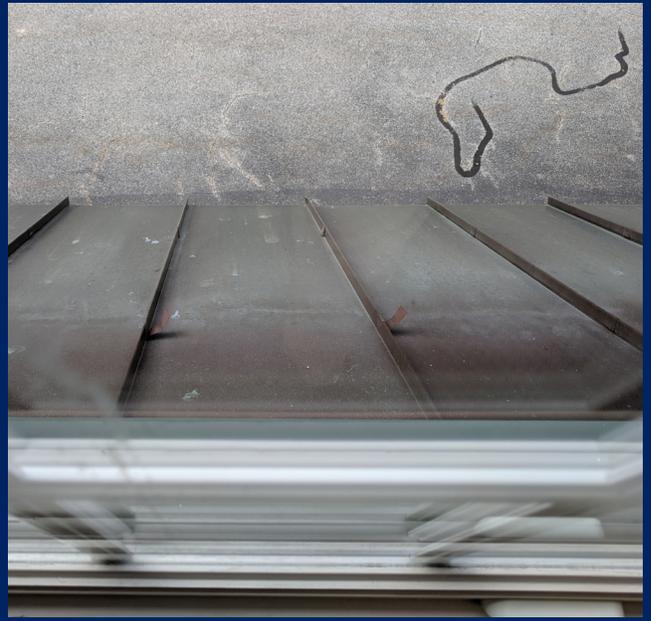
Failed copper cleats, observed from second floor window.

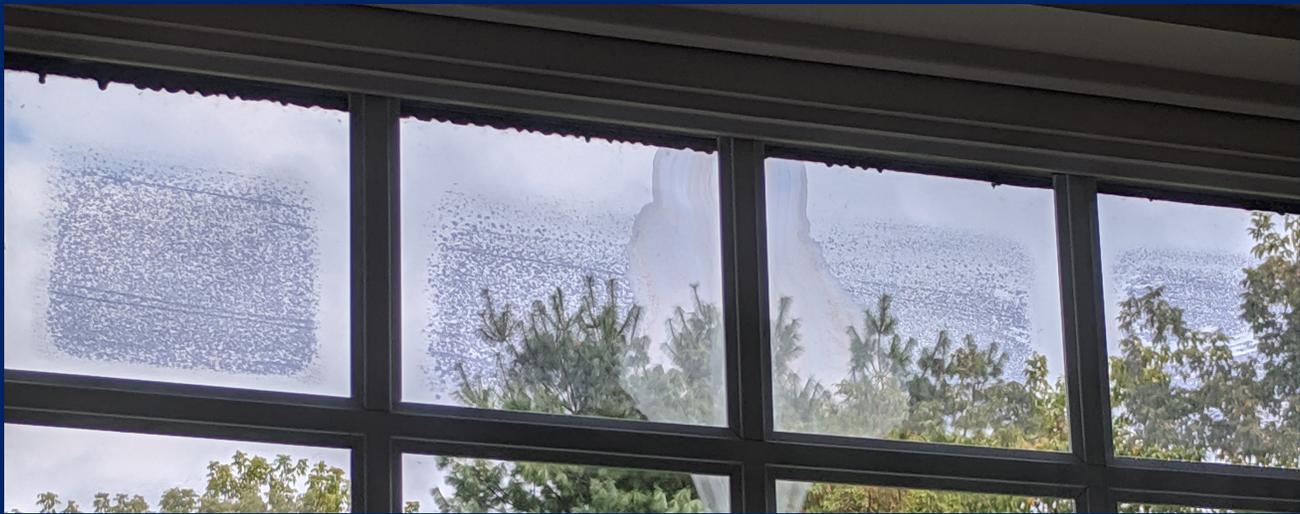
Evidence of "frosting" in failed insulated glass unit most likely due to de-hermetization of the IGU and excess moisture condensating.

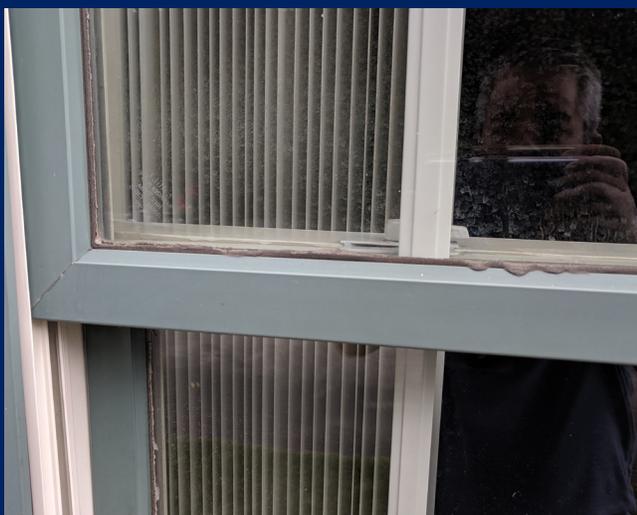
Window sash sealant failure .

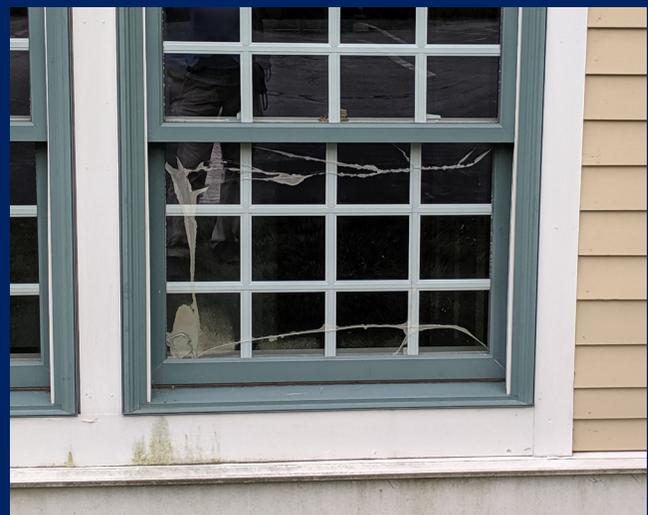
IGU at lower sash broken, should be replaced.

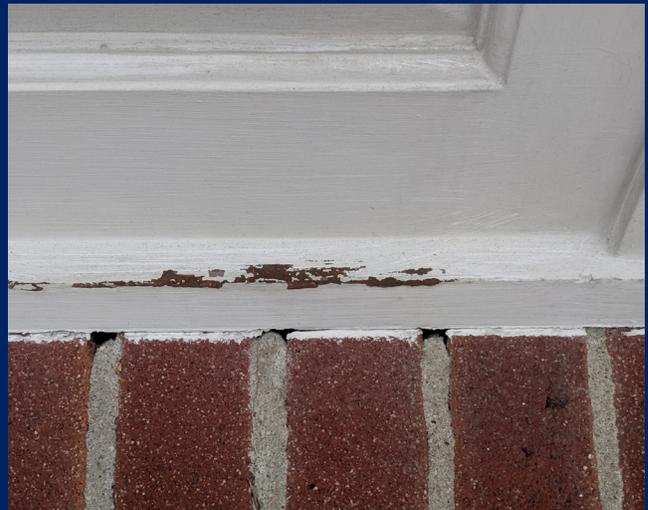
Evidence of missing mortar and lack of sealant.

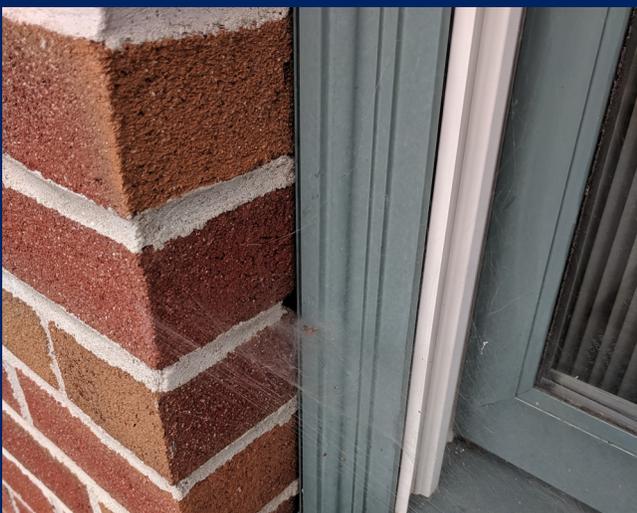
Evidence of missing mortar at window jamb. Also note lack of sealant at window frame to brick.

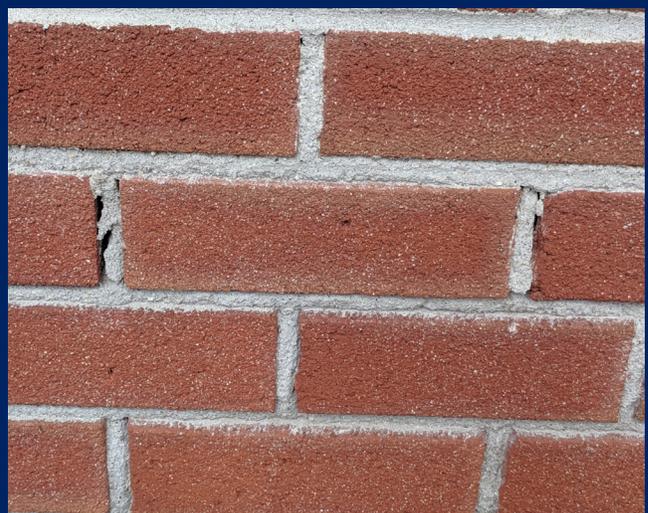
Poorly toothed mortar, separation can be seen at head joint.

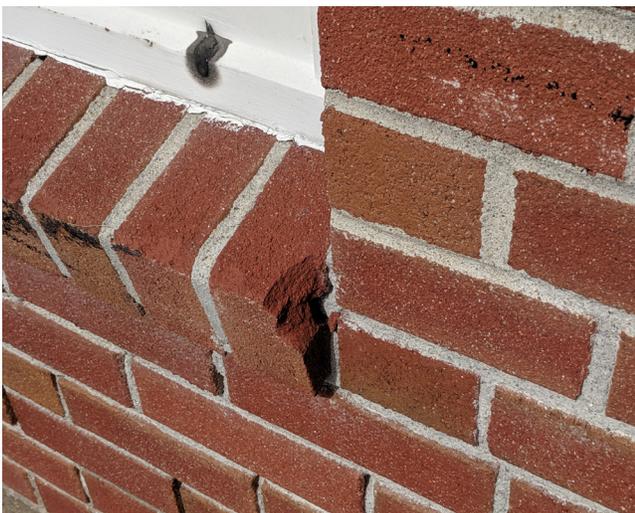
It appears as though the building sustained vehicular impact, you can see crack lines in the mortar.

Closeup at damaged brick at southeast corner.

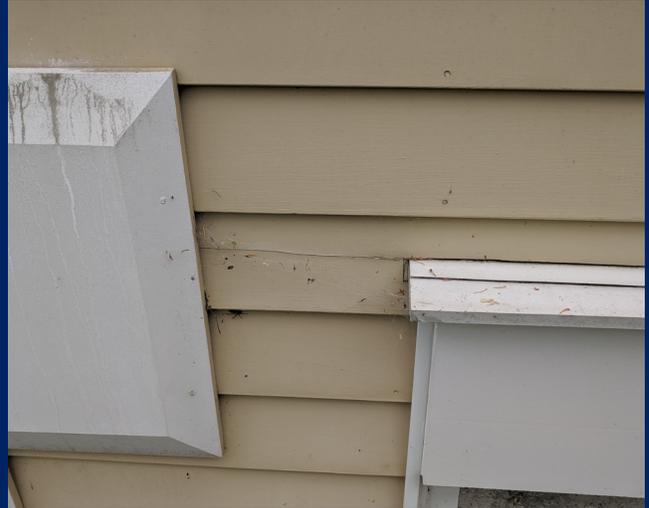
Visible horizontal crack in clapboard siding.

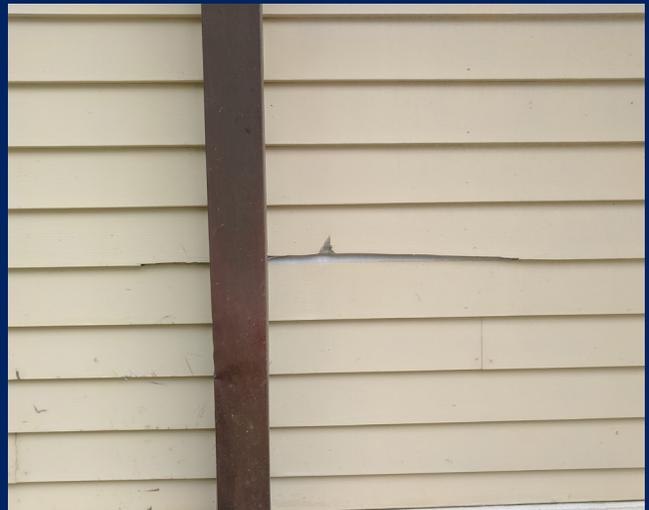
Evidence of missing clapboard section.

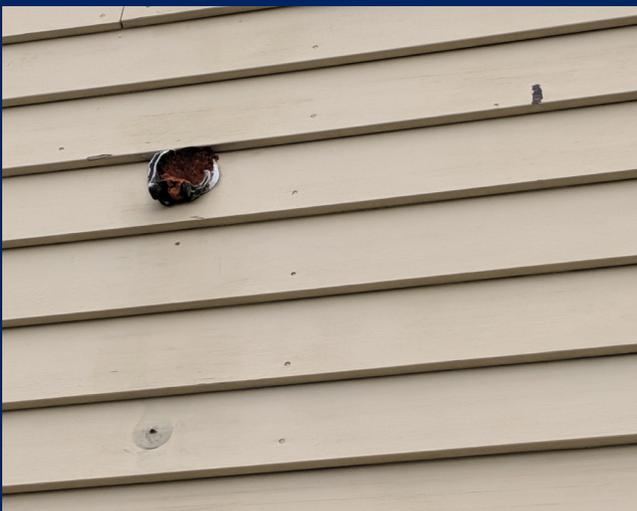
Evidence of damaged paint finish and abandoned throughwall penetrations.

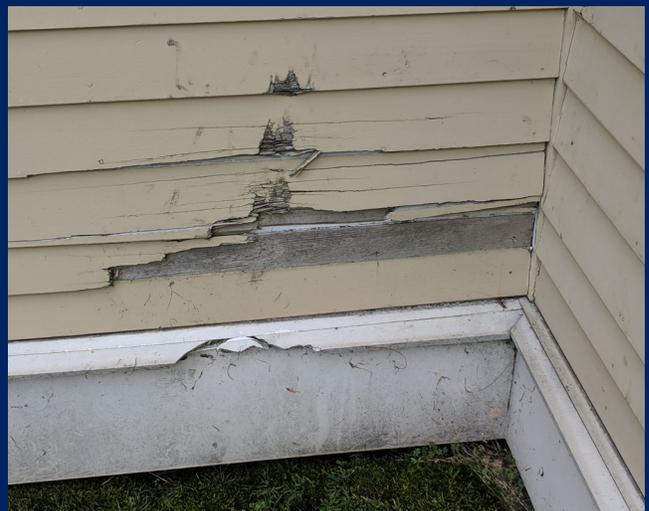
Evidence of missing and damaged clapboard sections, and wood trim.

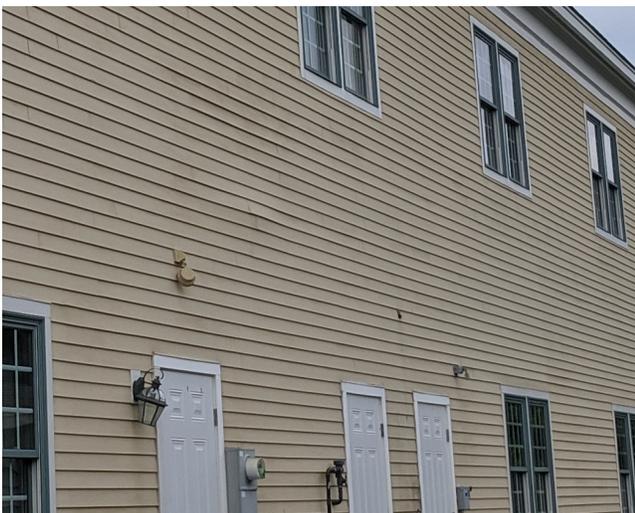
Closeup at east facade, note the bulging section of clapboards between the first 2 doors, rows 4 and 5 above the broken light.

At a minimum, we suggest repairing the open joints to ensure a weather tight building envelope in the interim.

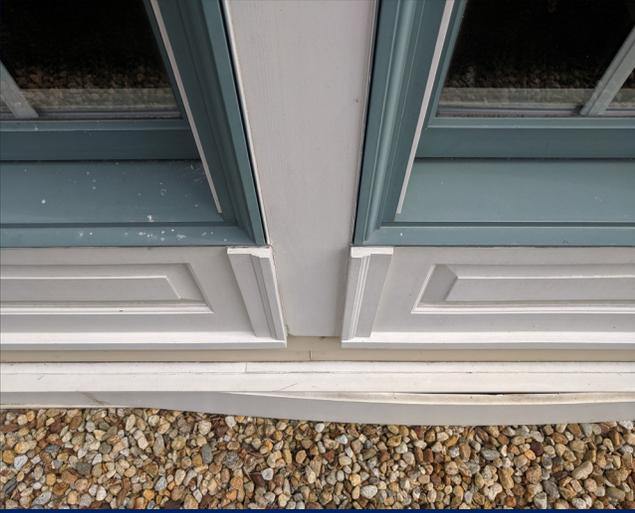
Observed horizontal wall trim board separated from blocking.

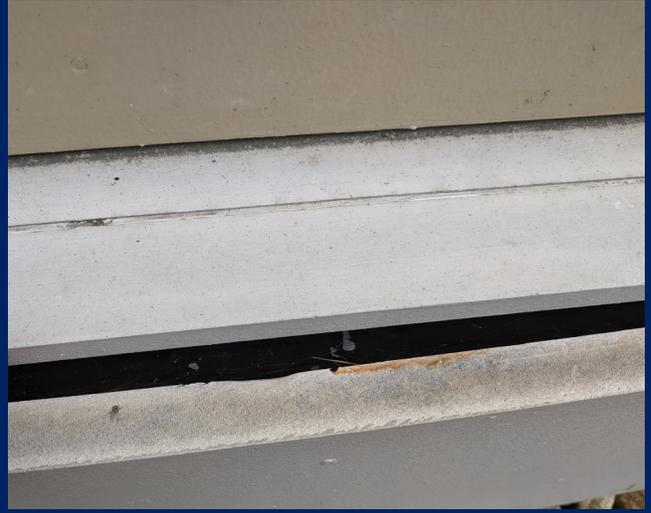
Closeup at horizontal trim board separation, exposing wall back up.

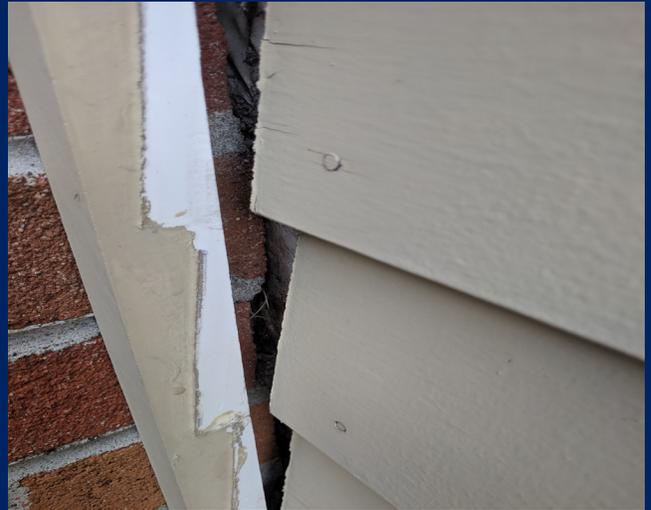
Closeup at vertical trim board separation, exposing wall back up. We can note that there is no evidence of a sealant joint.

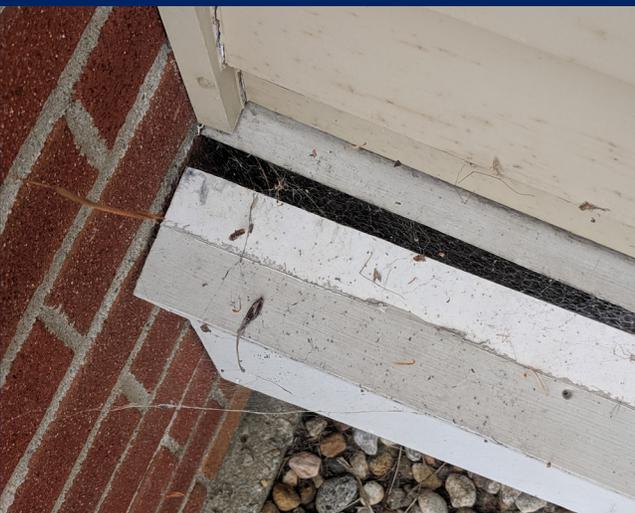
Observed horizontal wall trim board separated from blocking.

**Some trim is failing and exposing the backup wall system to water infiltration. Other trim is damaged and should be replaced.**

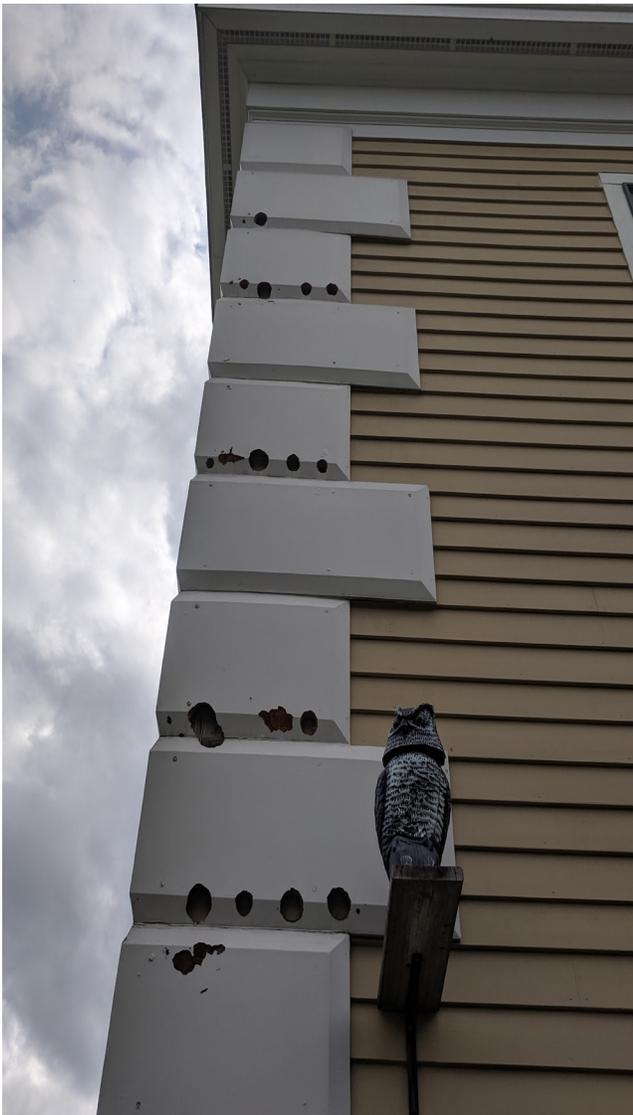
Closeup at damaged painted foam quions from woodpeckers at northeast corner.

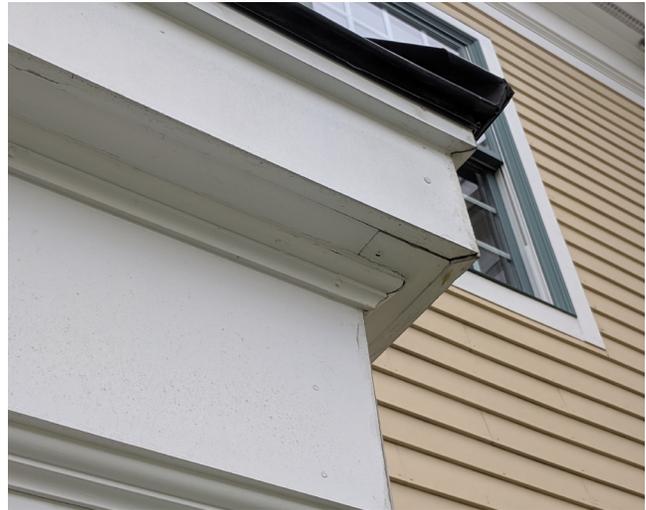
Closeup at opposite corner, stresses appear to have pushed out the corner causing separation.

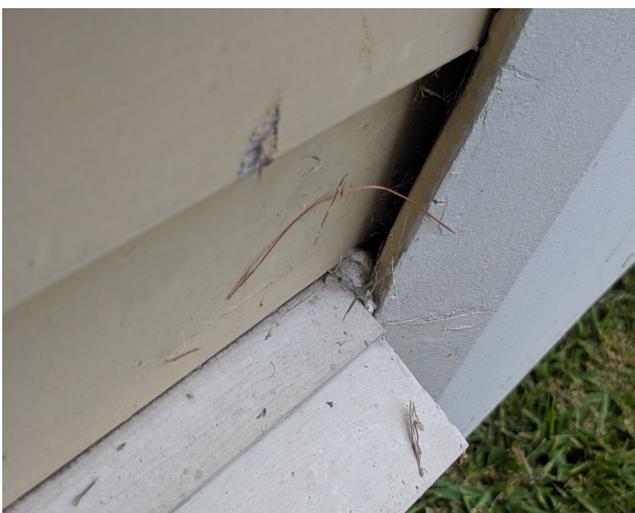
Observed horizontal wall trim board abutting quon. Note gap size (+/-3/8"), lack of sealant and debris and cobwebs.

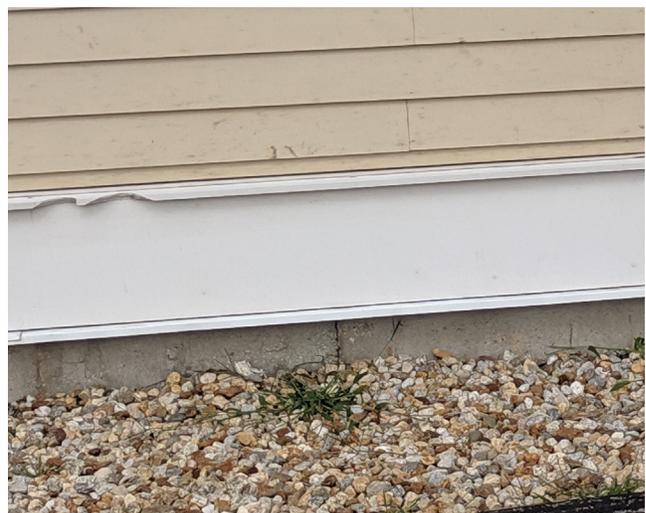
Closeup at horizontal trim board, damaged and missing segments.

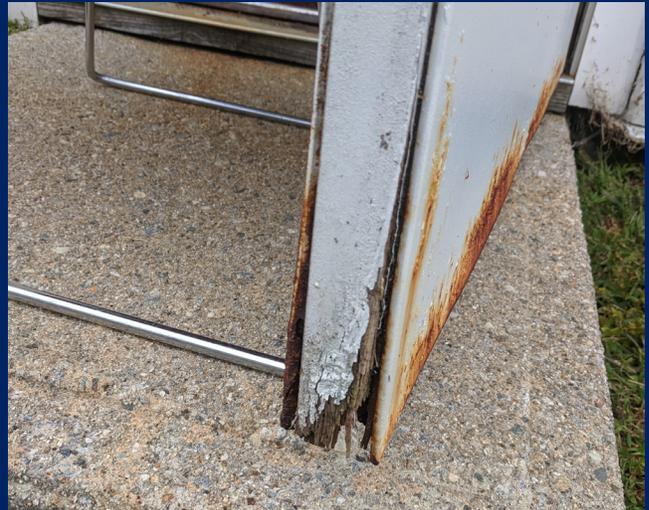
Evidence of damaged & deteriorated paint finish, and rotting (loss) of core material.

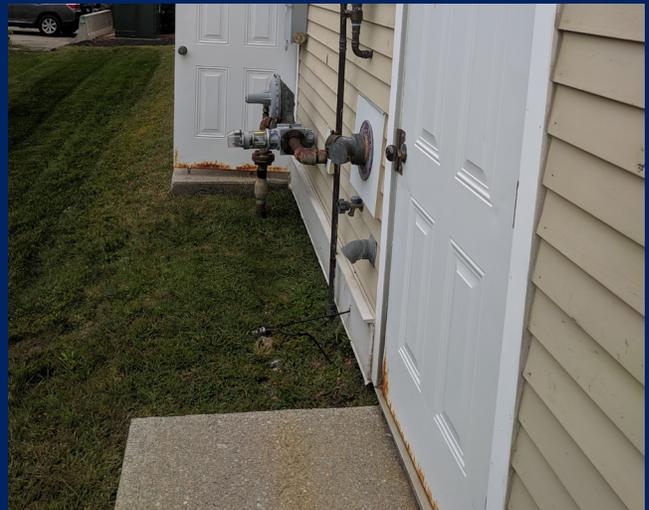
Exterior doors on the east facade showing signs of rust on the sills.

**Exterior Doors on the east facade are in poor condition and should be replaced.**

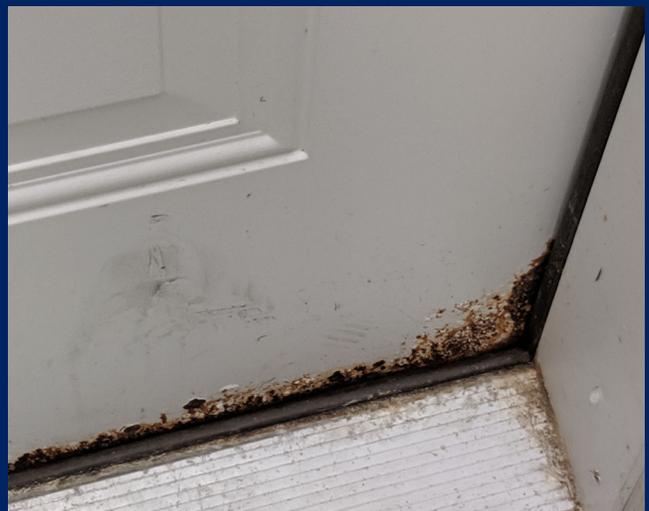
Evidence of rusting exterior hollow metal door.

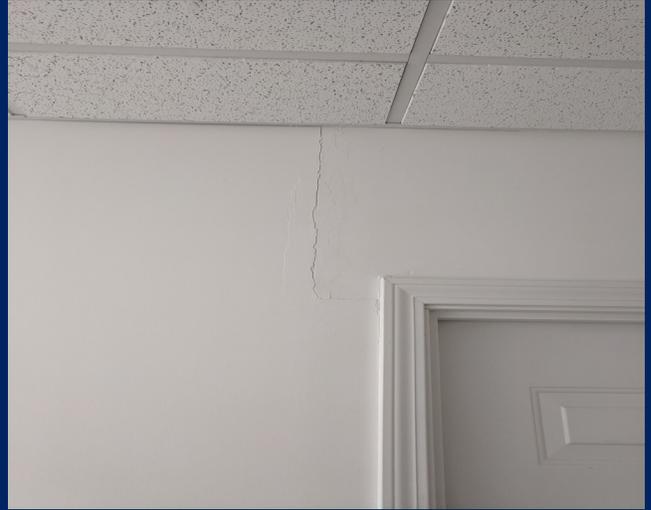
Observed crack above interior door head second floor.

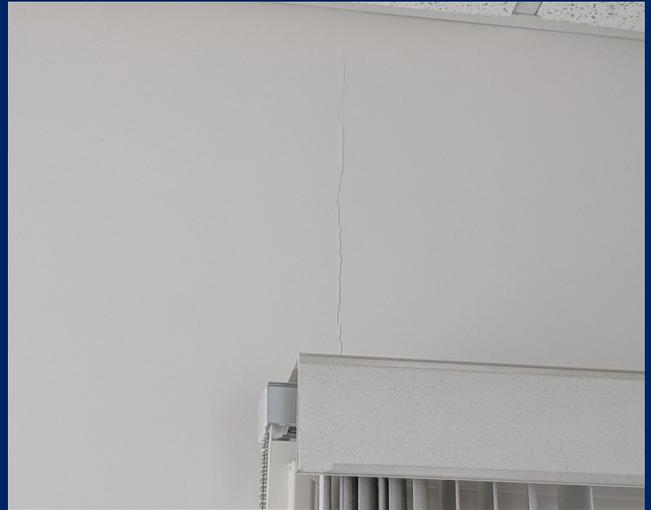
Observed crack at exterior wall below window, second floor east.

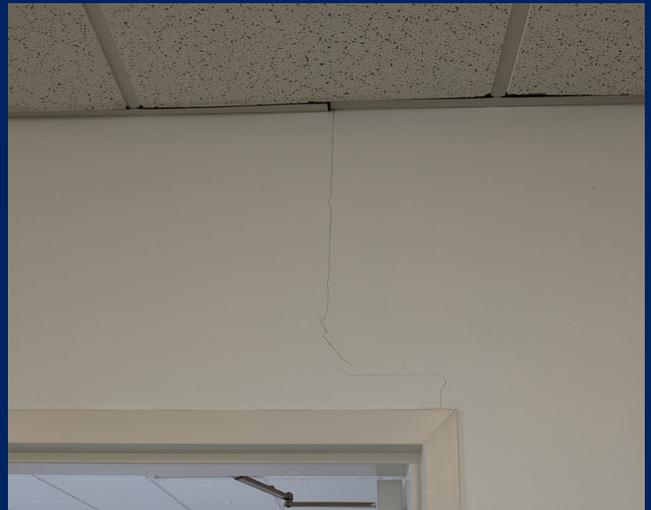
Observed crack at interior wall above door, first floor north.

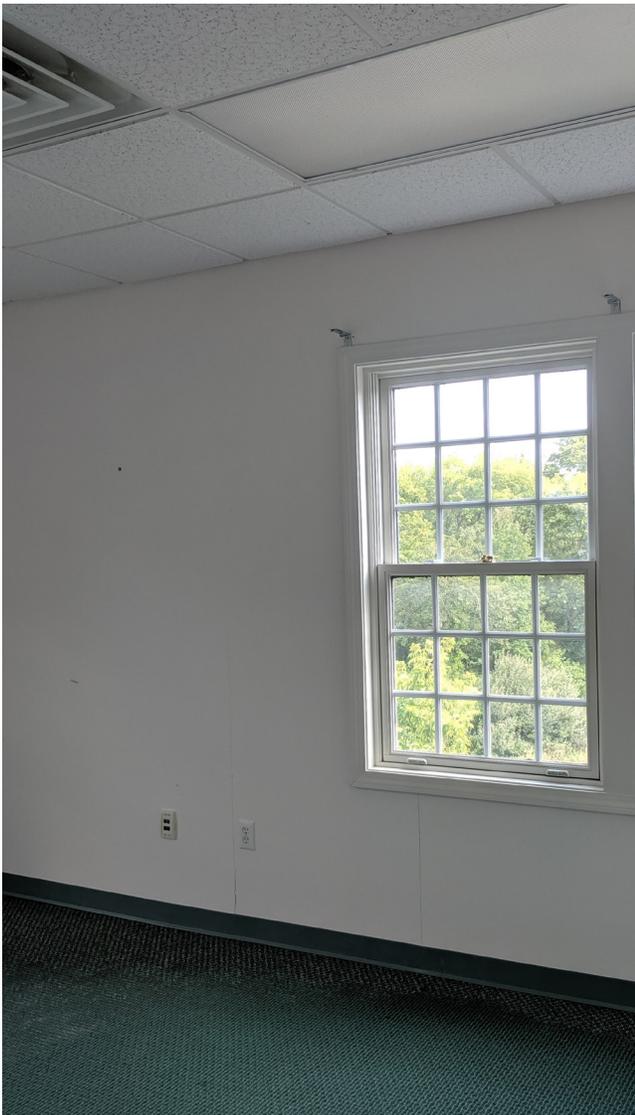
Observed vertical crack in drywall at exterior wall, second floor northeast.

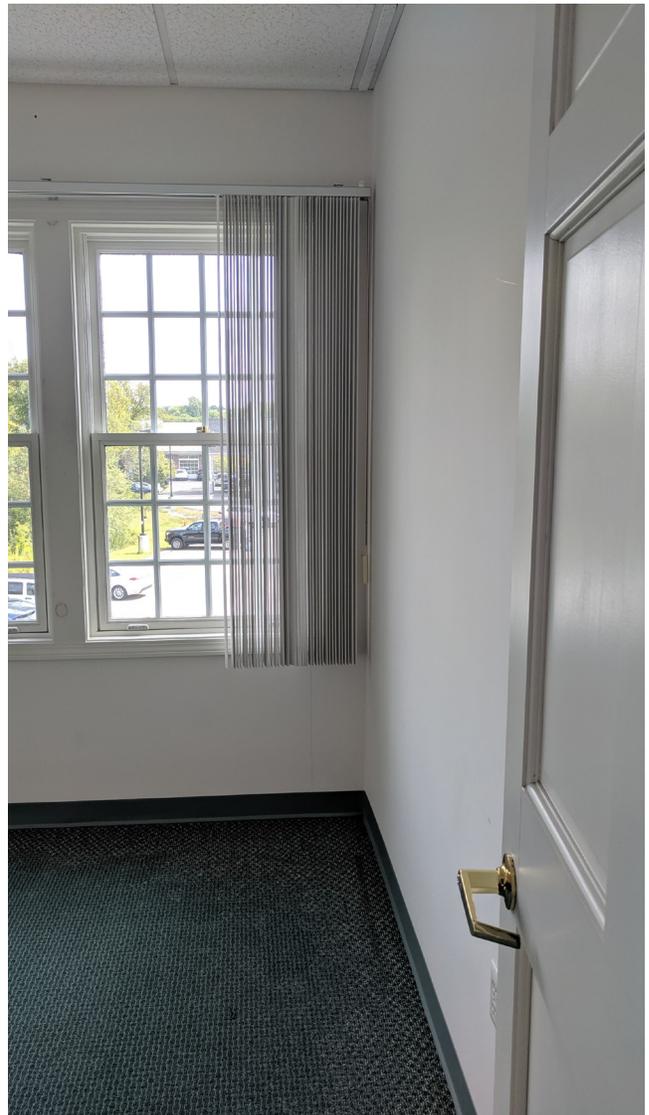
Observed vertical crack in drywall at exterior wall, second floor northeast, above and below window.

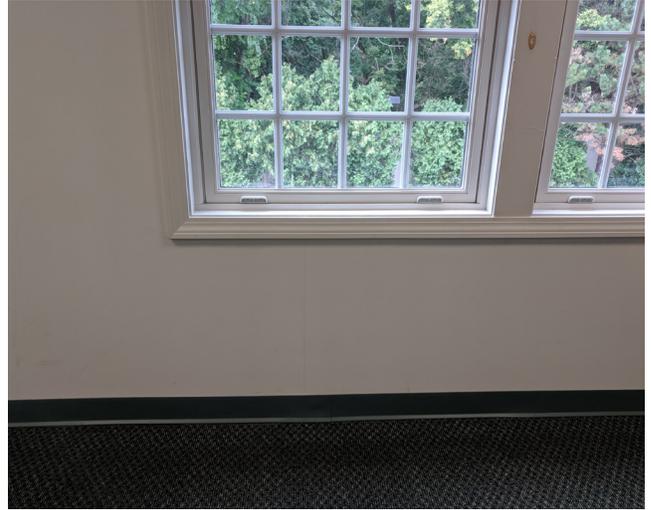
Closeup at bottom of window showing crack, second floor, west exterior wall.

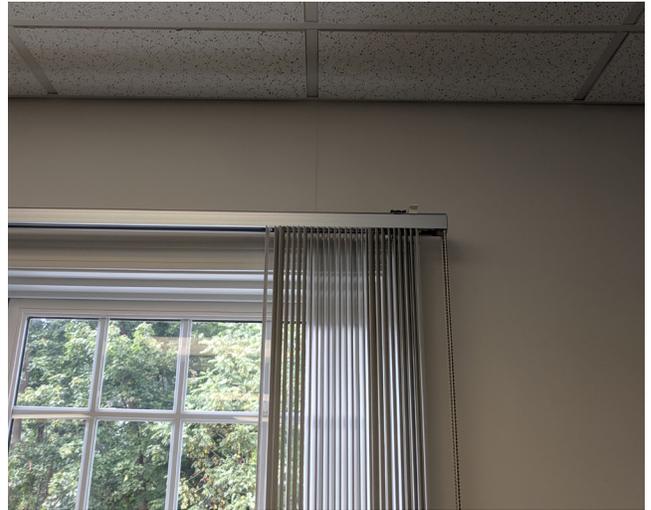
Closeup at top of window showing crack, second floor, west exterior wall.

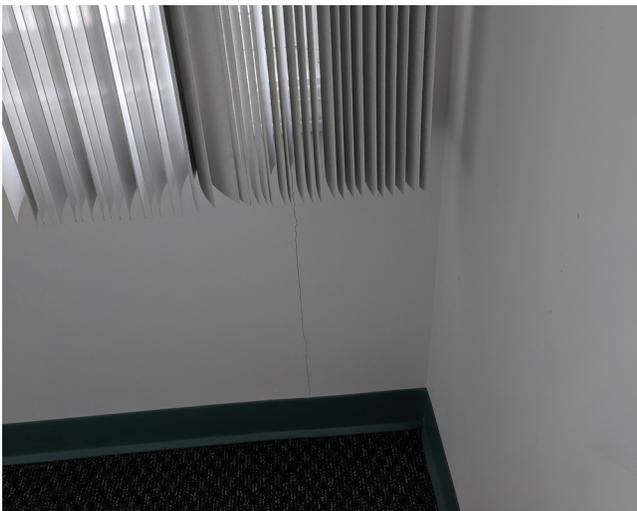
Closeup of crack below window.

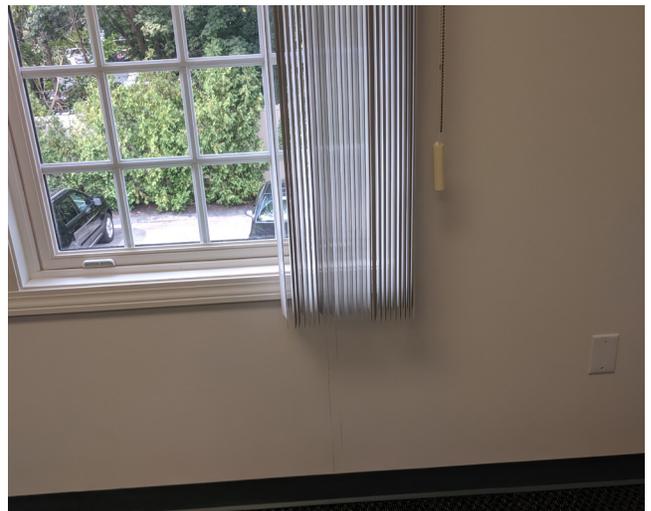
Closeup at bottom of window showing crack, second floor, west exterior wall.

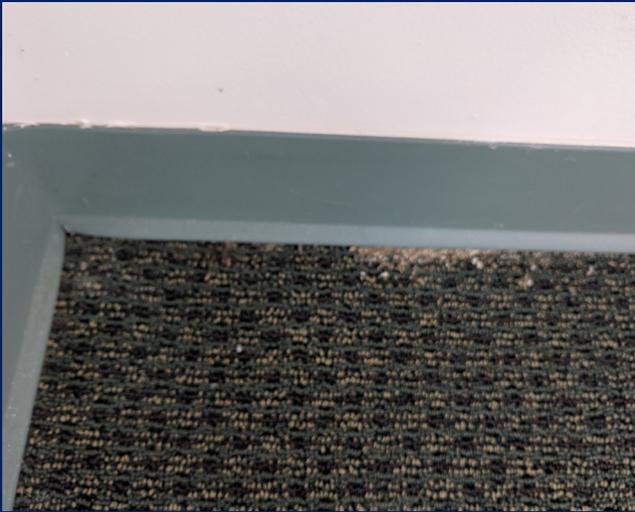
Evidence of what appears to be frass, first floor Northeast corner.
