SITE VISIT MEMORANDUM

Project Name: Couper Farm Construction Observations
Green Project No. 15002.030

Subject: Site Visit 1

Date / Time: 5/19/2017 (11:00 AM- 11:30 AM)

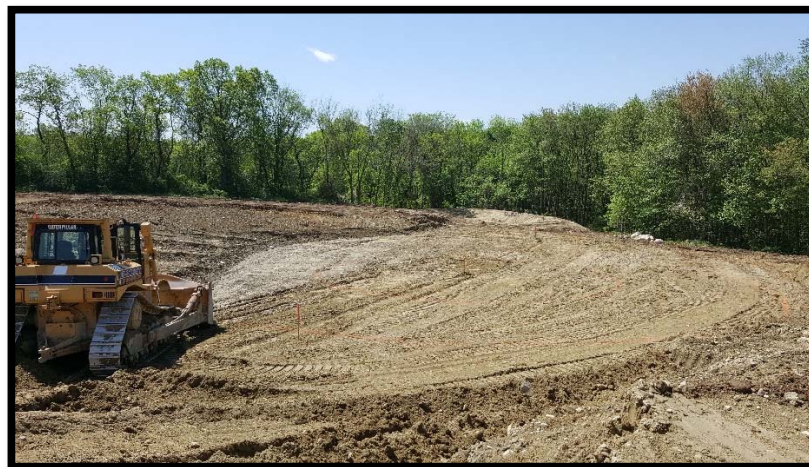
(Layout of the cul-de-sac on Vint Lane)

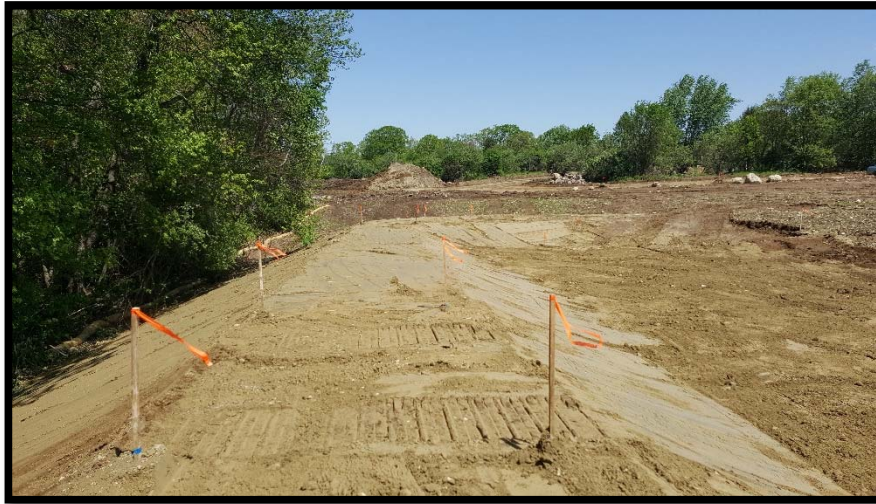
- The Contractor was in the process of laying out the cul-de-sac for Vint Lane.
- Infiltration Basin No 1 has been rough graded and the Contractor was forming Infiltration Basin No 2. TB noted that the Contractor should be careful to not overcompact the soils on the bottom of the basins.

(Standing on the berm for Infiltration Basin No. 2, looking north)

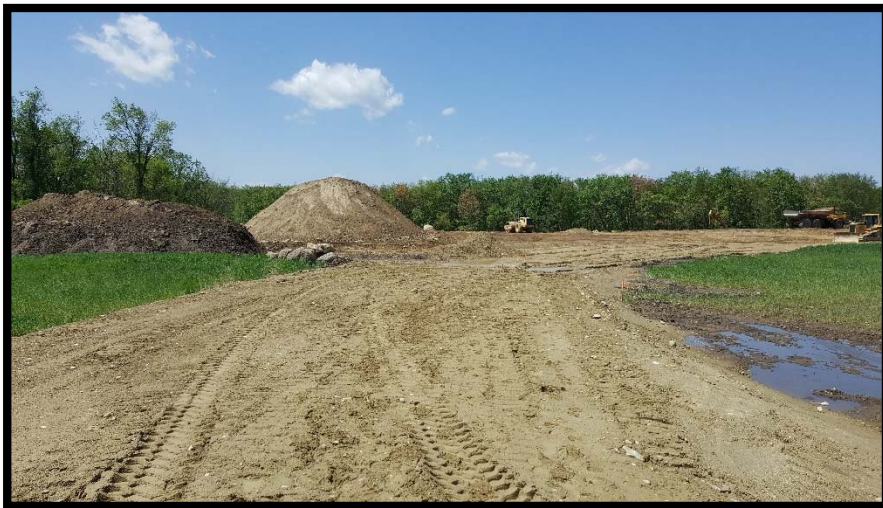
(Standing on Couper Farm Lane at Sta. 10+00, looking west)

- AP stated that some material was brought in for Couper Farm Lane near Sta 10+00 and Sta 12+00.
- A temporary HDPE cross culvert was installed near Sta. 11+00. The HDPE pipe will be replaced with a permeant culvert, as shown on the plans at a later date.
