Request to Littleton Conservation Commission

Request to remove two hazardous trees

DEP File No. 204-901

49 Matawanakee Trail
David and Patricia Barr
978-201-9524
barrdt@gmail.com

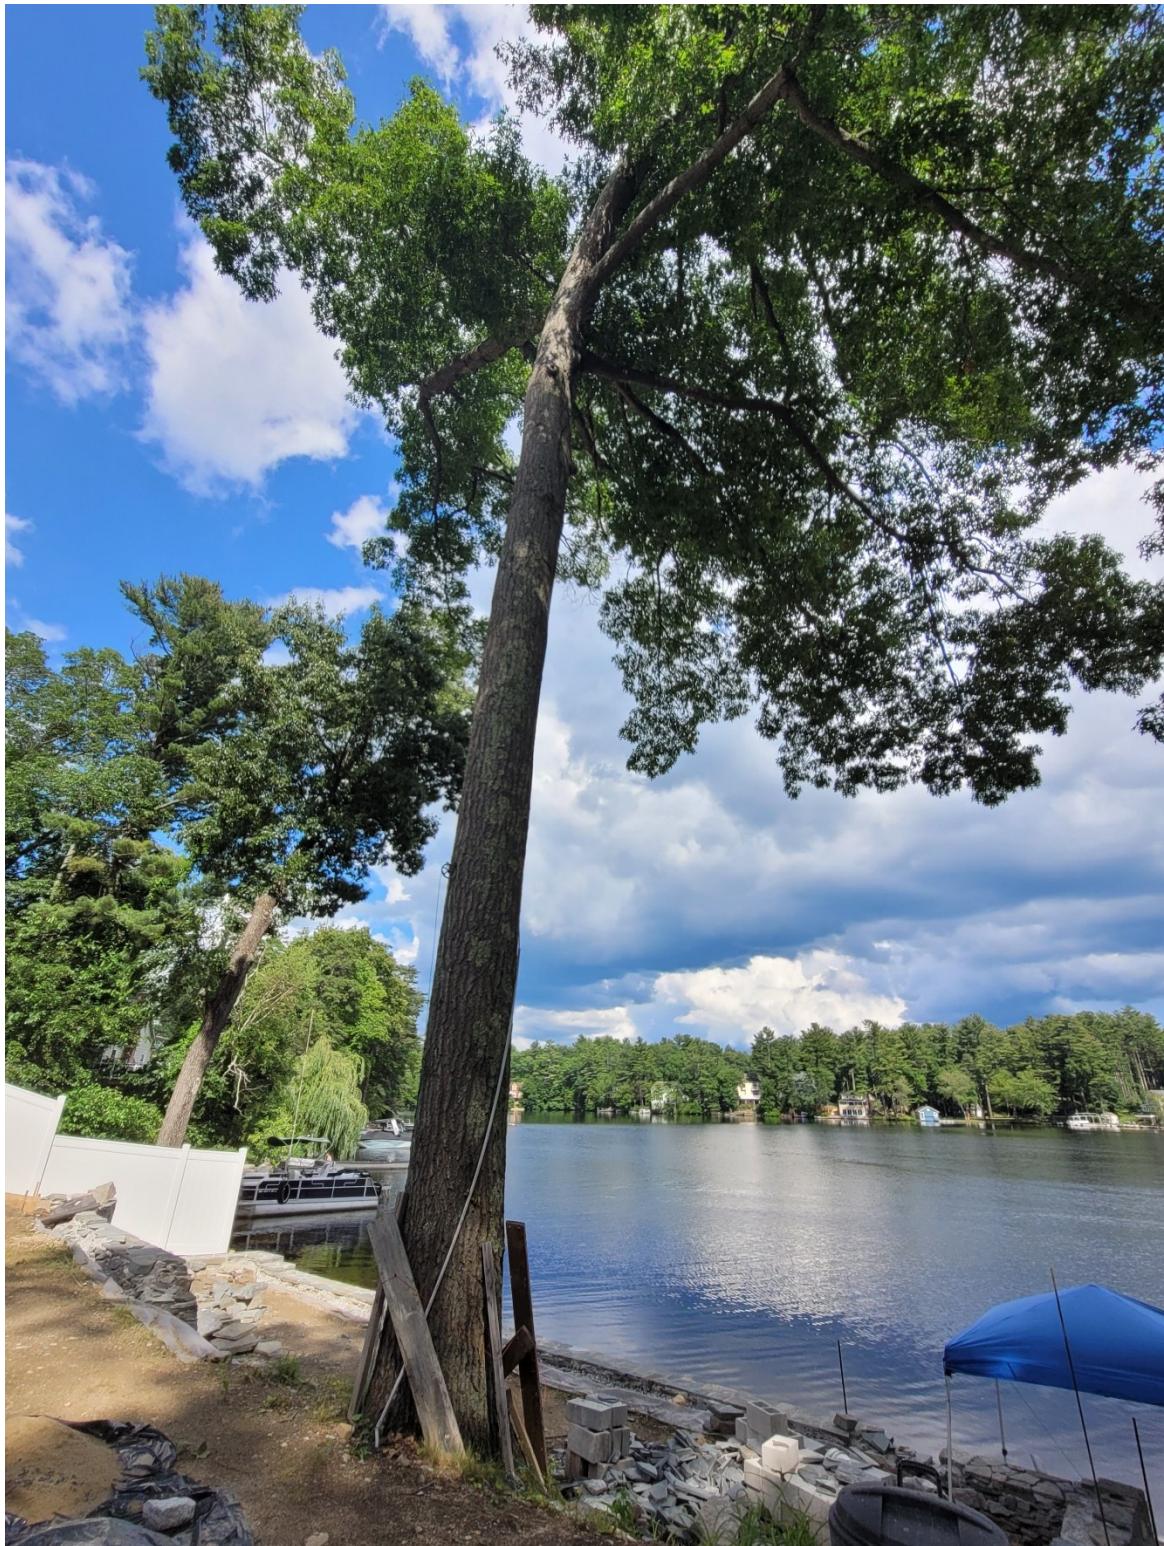
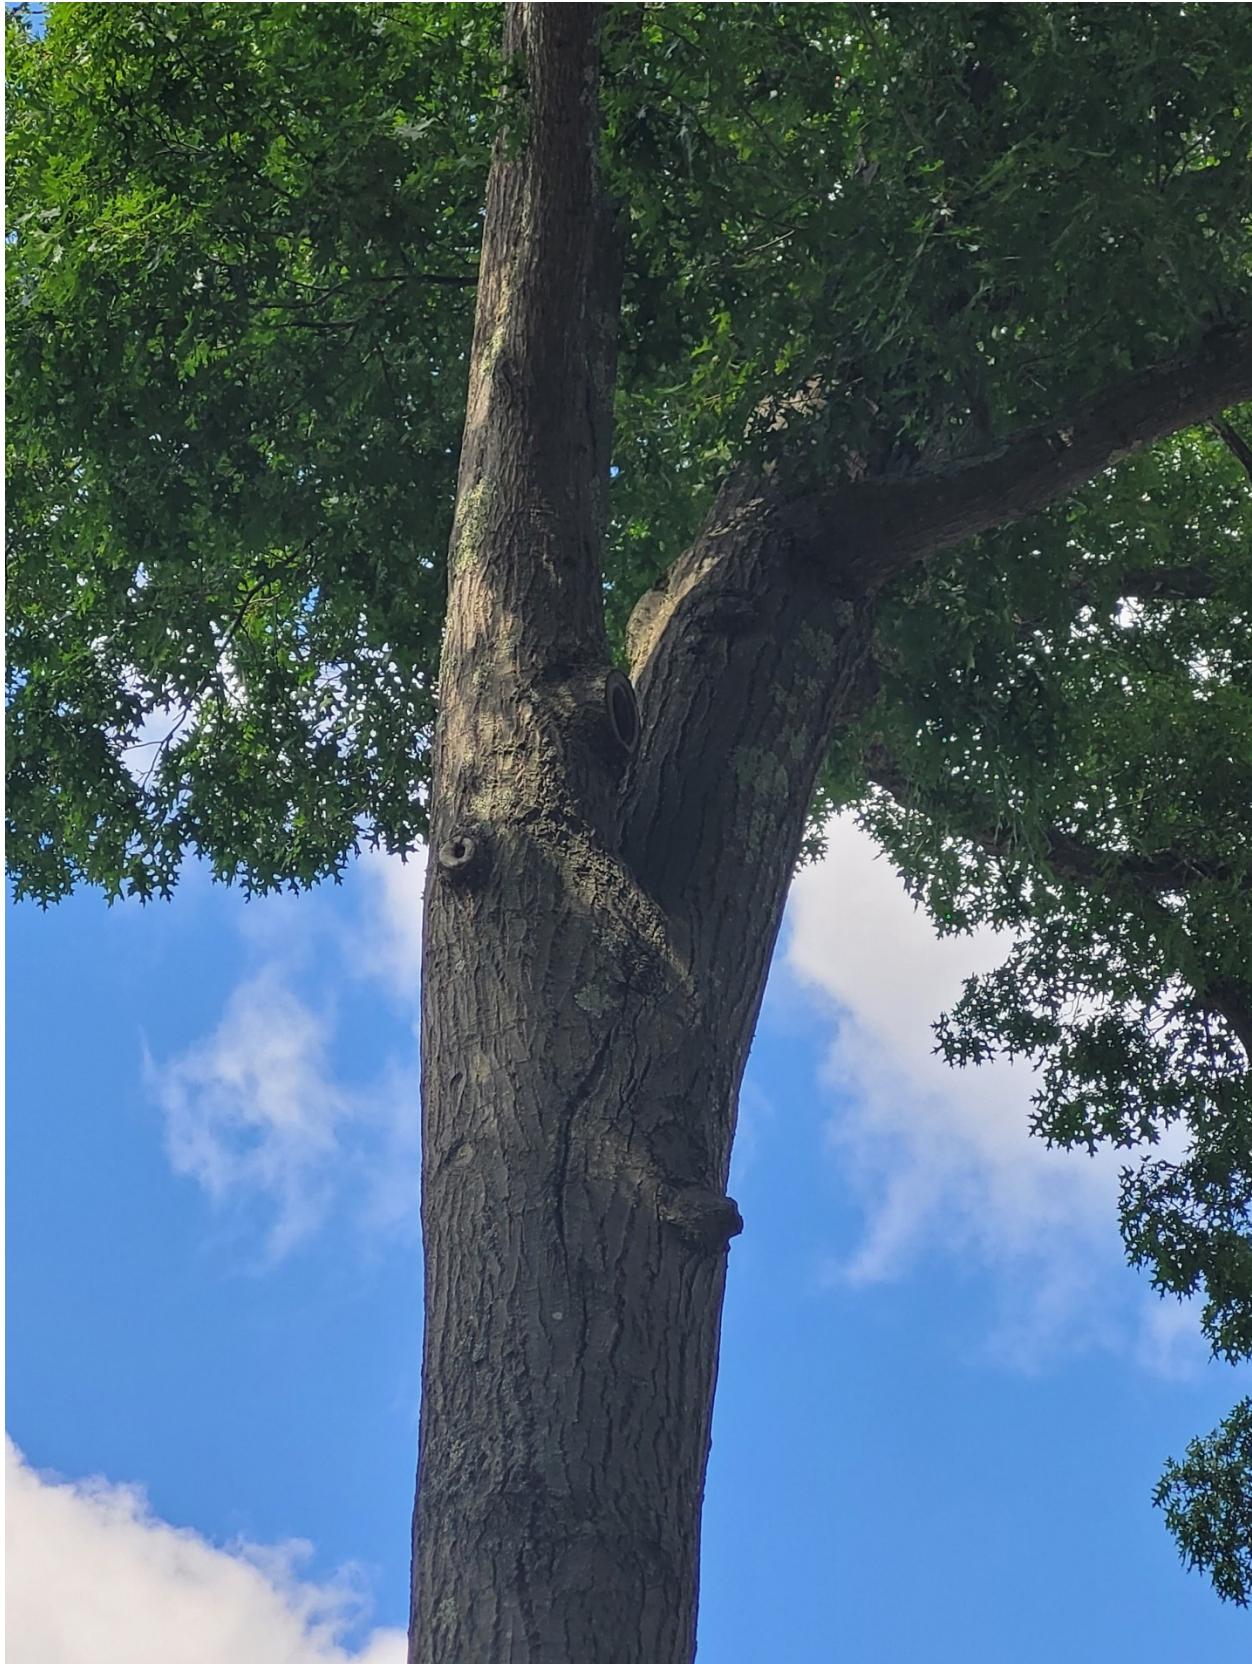
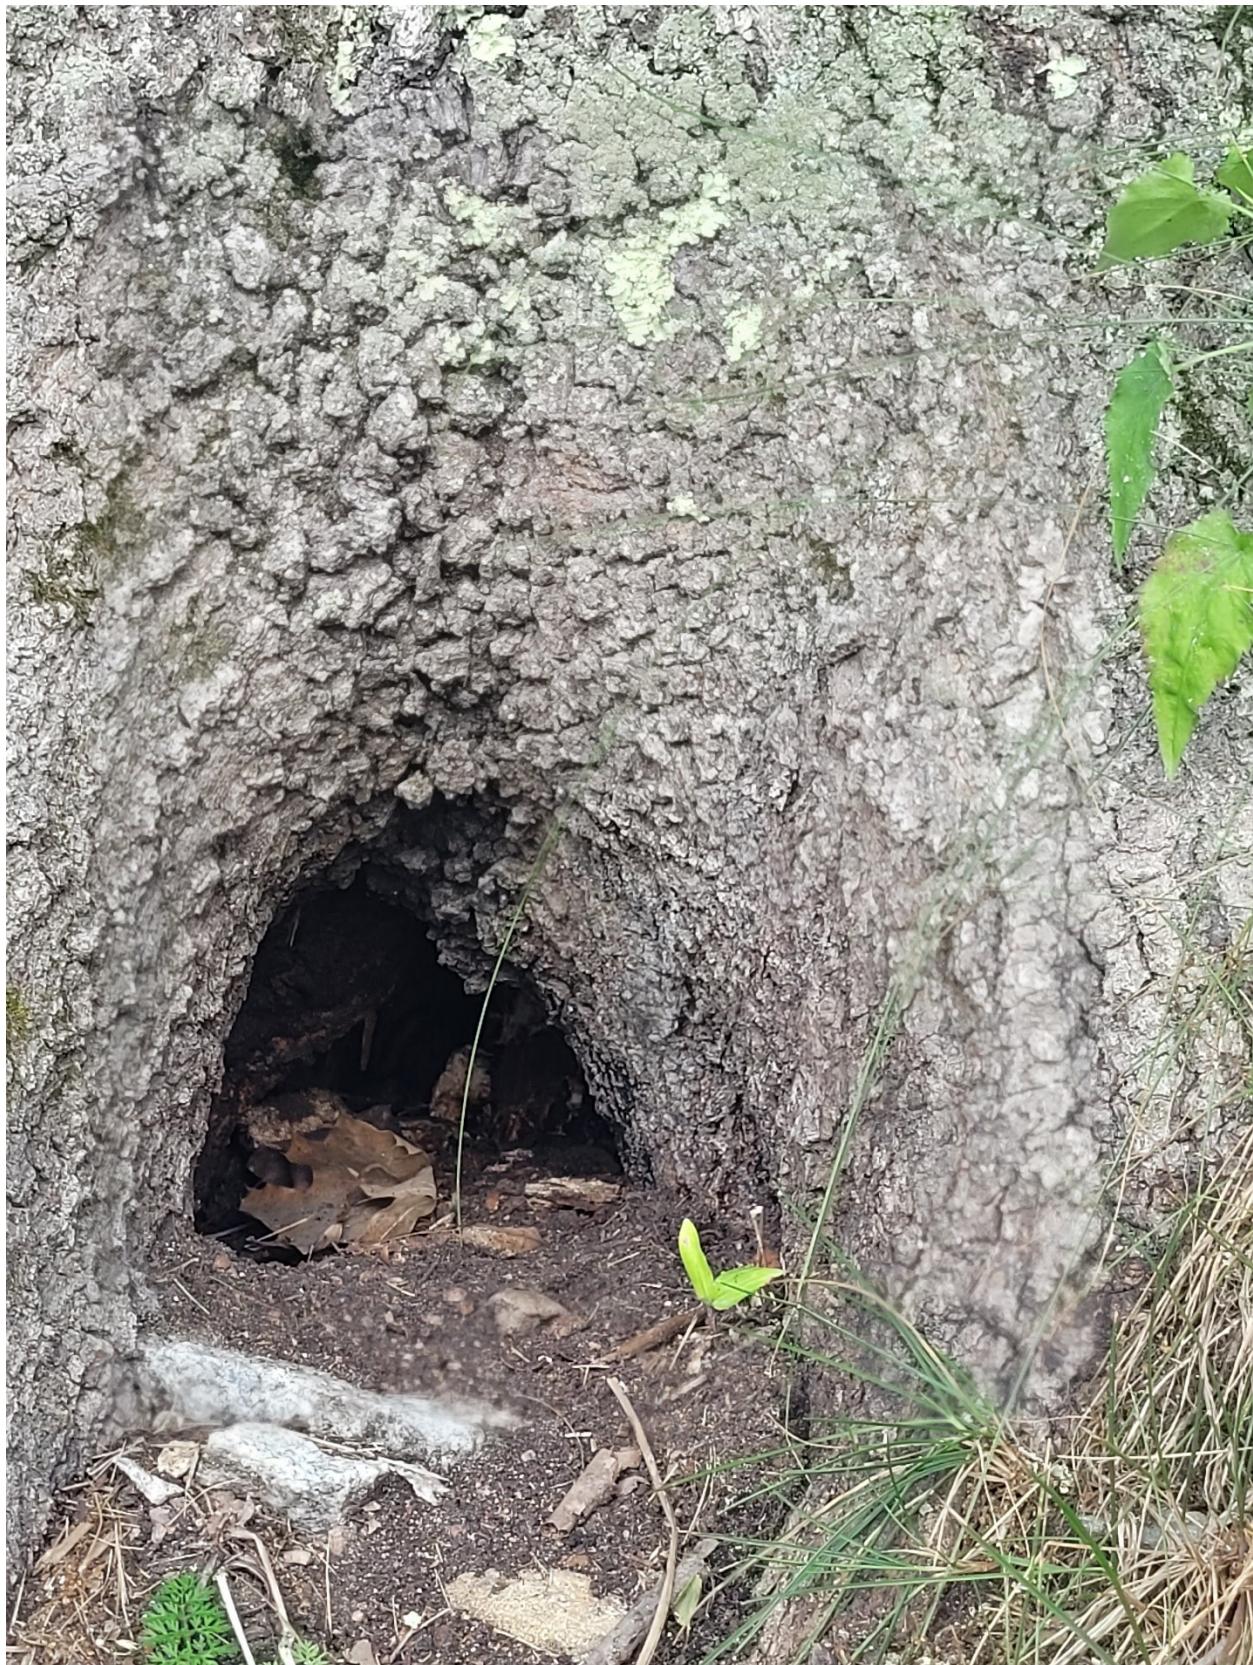
Photos of the large oak

The tree was on a steep slope between the house and lake, and the grade had been disturbed in the past and presently. The ground was compacted, and a number of retaining walls were either present or under construction. I noted that the tree had a crack in the main crotch about 30 feet up, and that there was a large cavity in the buttress roots.

The critical root zone of a tree is commonly defined as a radius in feet around the tree equivalent to the diameter of the tree in inches. All excavation and disturbance in the Critical Root Zone should be avoided or mitigated. The Critical Root Zone of this tree is about 27 feet in radius or 54 feet in diameter. Virtually the entire critical rootzone of the tree has been compromised. This fact, plus the obvious flaws noted above (crack in crotch and cavity in root buttress), leads me to the recommendation that the only safe course of action would be to remove the tree. This is a standing hazard tree.

To our surprise, he said the tree was a hazard with the two main branches splitting apart and an open area between two of the main tree roots. He recommended that the tree be removed for safety reasons. We asked about reinforcing the branches with a cable to relieve the stress where the main branches meet and allow the tree to remain standing. He said our best option with cabling was not going to be very satisfactory. And the open area between the roots had soft wood that extended upward and also halfway through the tree diameter. We brought in a tree company to give us a quote on doing the cabling to support the branches and their representative also said that cabling would not be effective and the soft wood at the base of the tree was a particular concern.

If the decision is made to retain the tree, further excavation should be avoided, and a Certified Arborist hired to install a cable secured with through bolted eye bolts installed to attempt to hold the two leaders together. That said, my original recommendation stands.

As such, we reluctantly decided that the large oak needed to be removed. The yard area around the tree is actively used as the waterfront and a play area. And the height of the tree would mean that it could pose a real risk at quite a distance from the tree, including to those of us in the house.

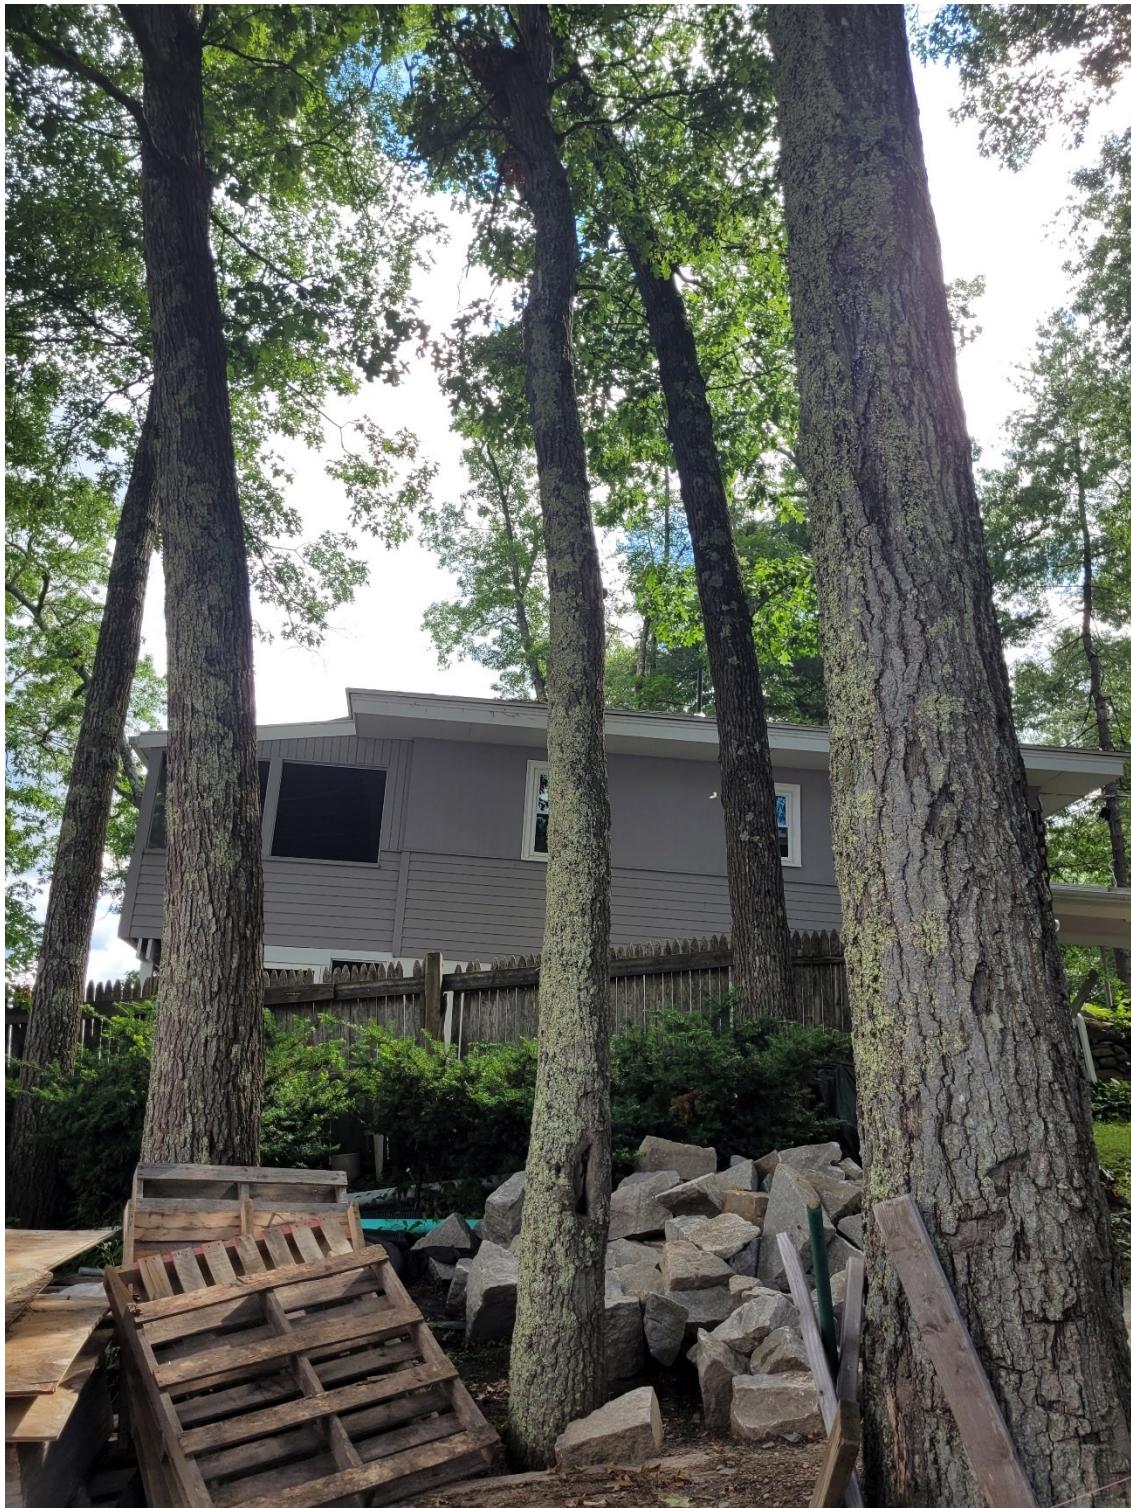
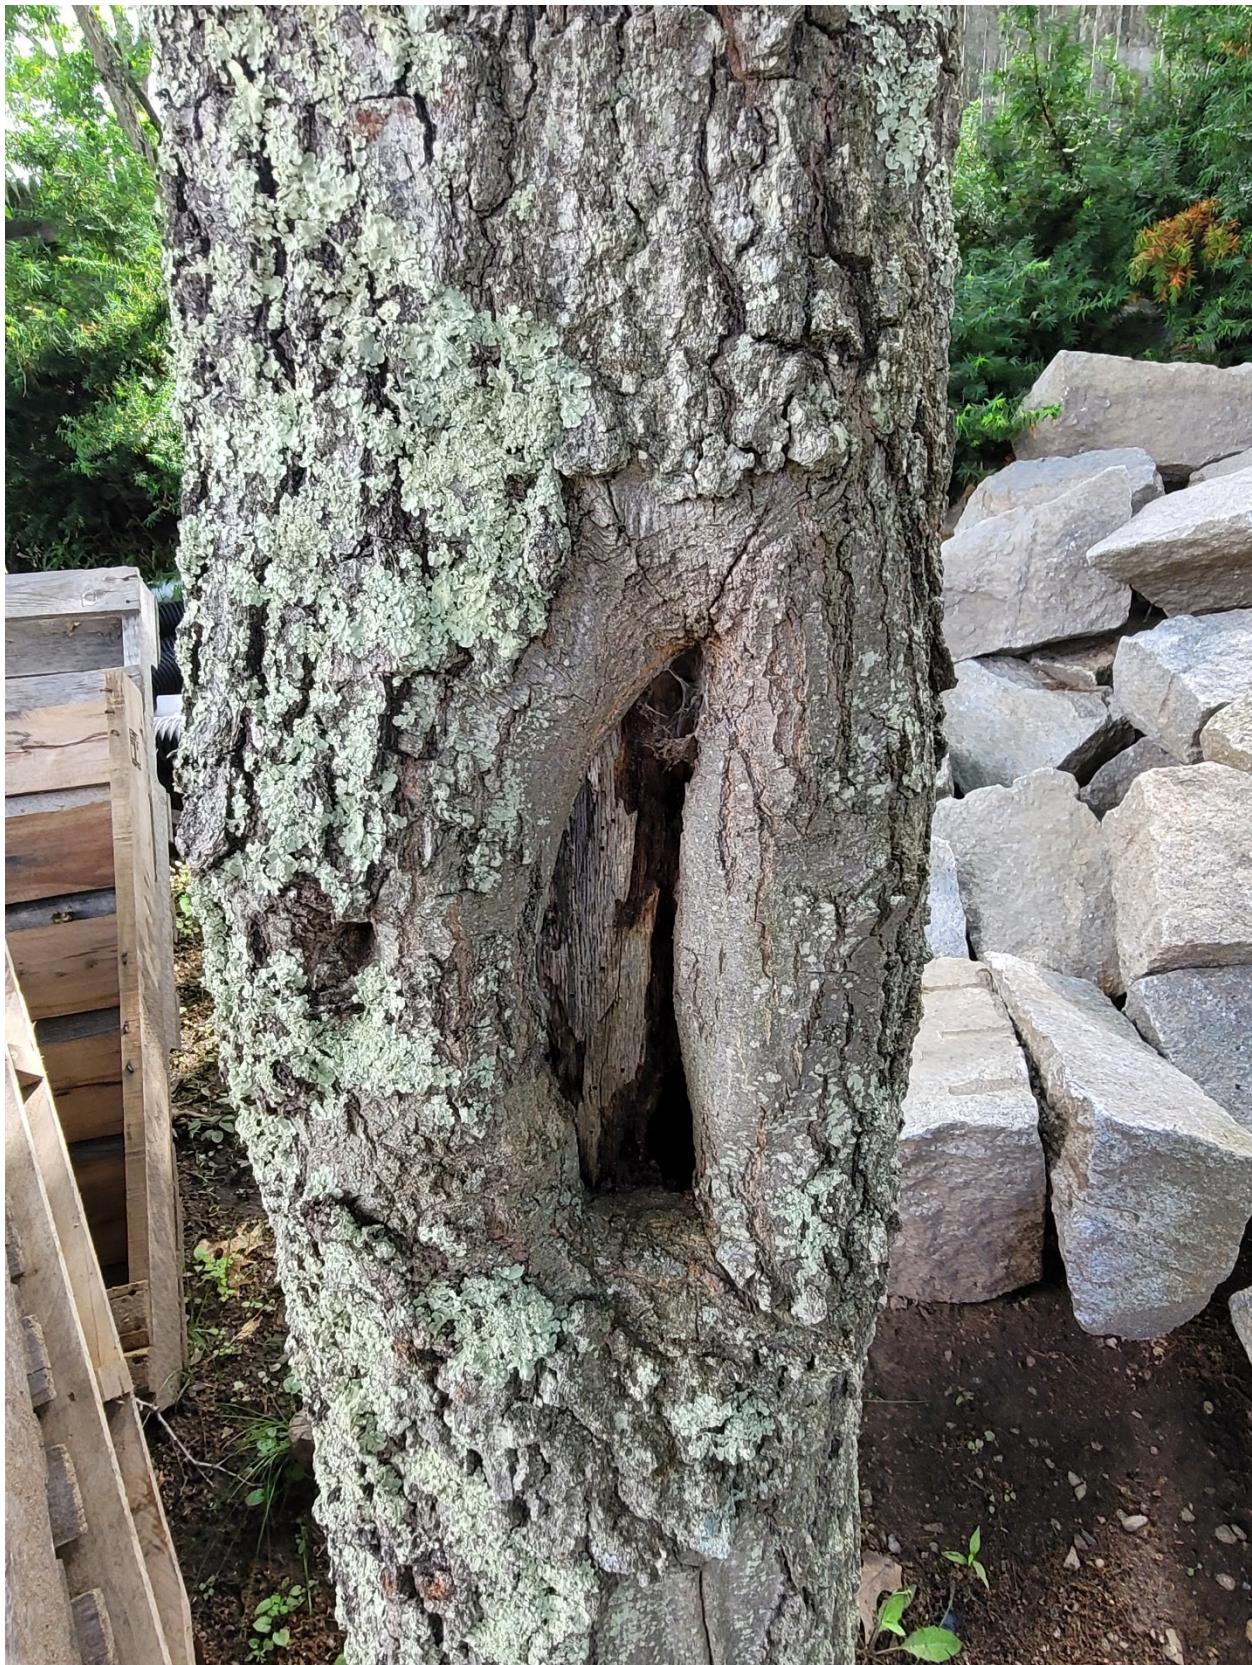
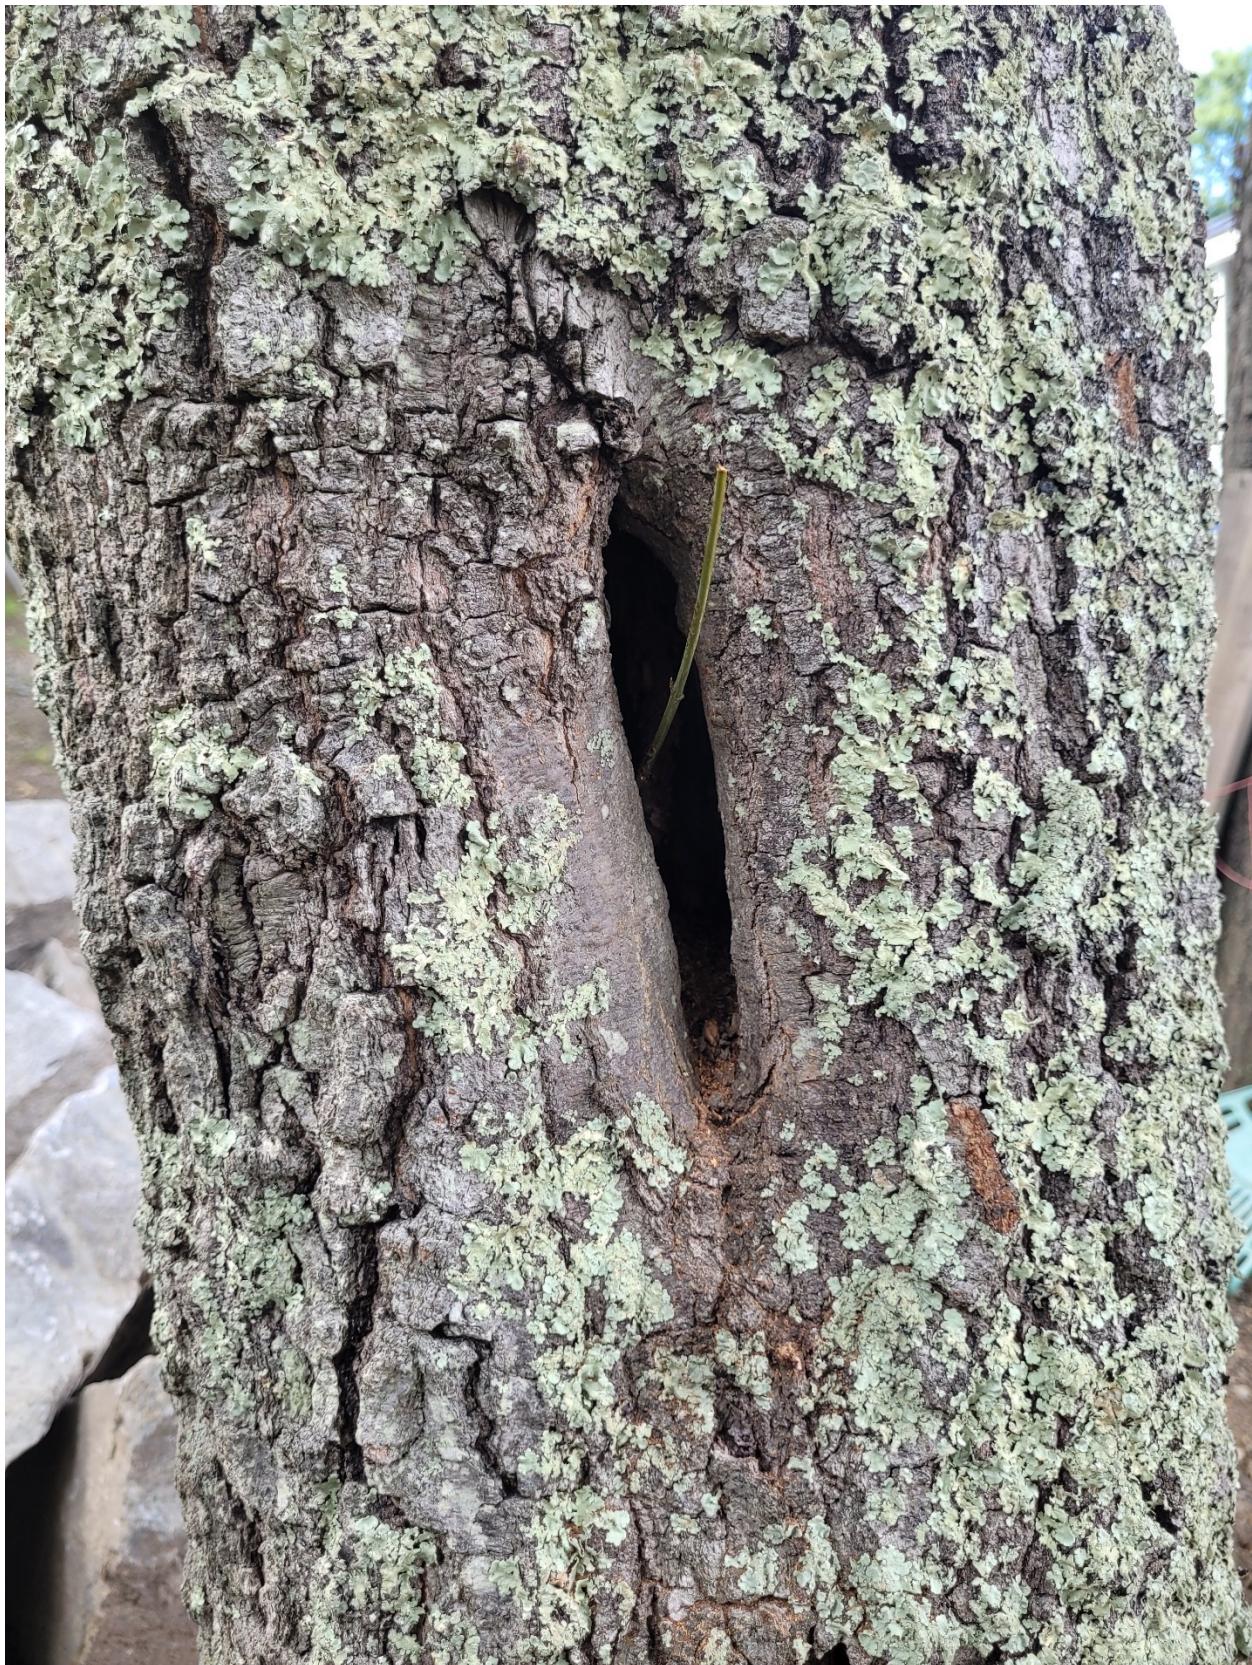
Photos of the small oak:

The tree was leaning towards the residence at #45 Matawanakee, and I noted cavities in the tree at around four feet above grade. I probed the cavities and noted that the entire center of the tree is hollow and the two cavities, on opposite sides of the tree, almost connect. The tree trunk is like a soda straw with two holes in it, and it is at risk of failure, falling onto the adjacent home. The only safe course of action would be to remove the tree. This is a standing hazard tree.

The smaller oak, on the side of our lot next to the Hoffmans' house (45 Matawanakee Trl) was also recognized by Dean Charter as a hazard when he was here, with two holes on opposite sides of the tree and rotten wood completely between the two holes. He recommended that we remove it, especially since it leans over the Hoffmans' house. We agreed and included it in our request.
