1 SANDAS POINT  
GAETZ

1 SANDAS PT  
GAETZ

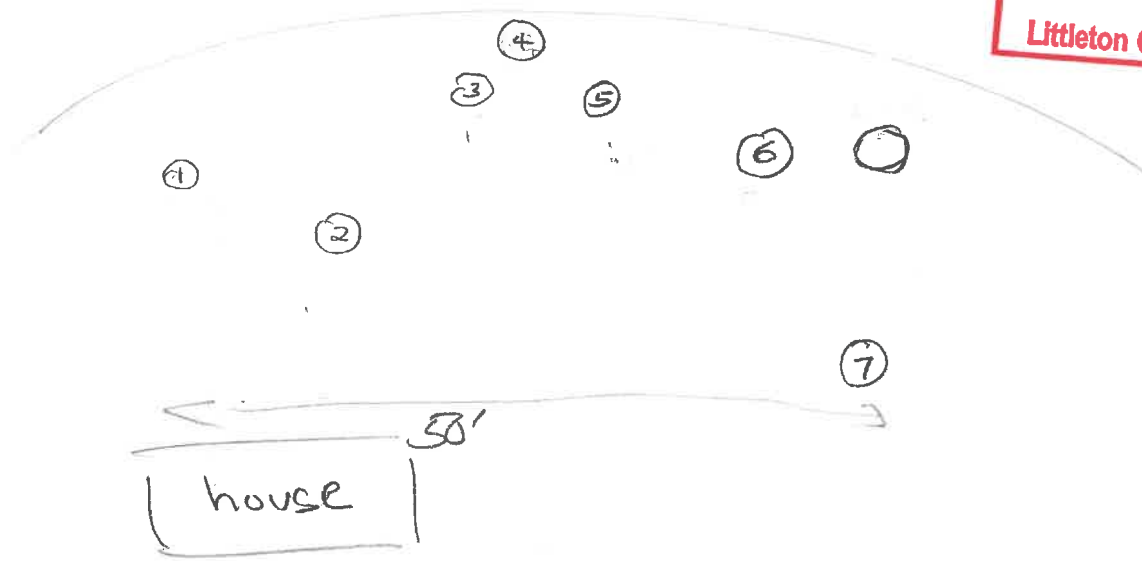
① 43' from deck  
13' from water  $\approx$  90-100 yo

② rotted / split @ base  
have 3 pictures

③ dying hole @ base

④ near water line - similar to what came down

⑤ scraggly but no visible rot

⑥ possible rot problem - look lifted.  
leaning  $\rightarrow$  house/driveway

⑦ looks OK no visible rot  
leaning  $\rightarrow$  house/driveway
