PHYSICAL NEEDS ASSESSMENT

of
SHAKER LANE SCHOOL

35 Shaker Lane
Littleton, Massachusetts 01460

EMG Project #: 104477.13R-004.017
Date of Report: July 15, 2013
On site Date: June 19 and 20, 2013

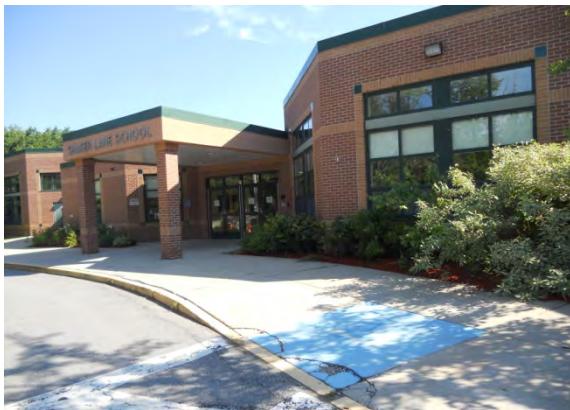
Photo #1: Front entrance and deteriorated curb cut

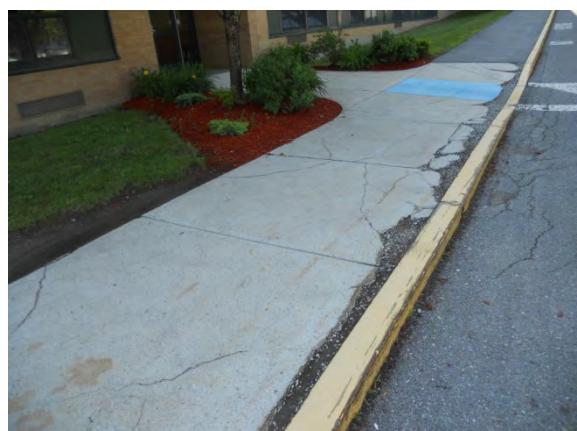
Photo #12: Cracked and deteriorated sidewalk along west side of building

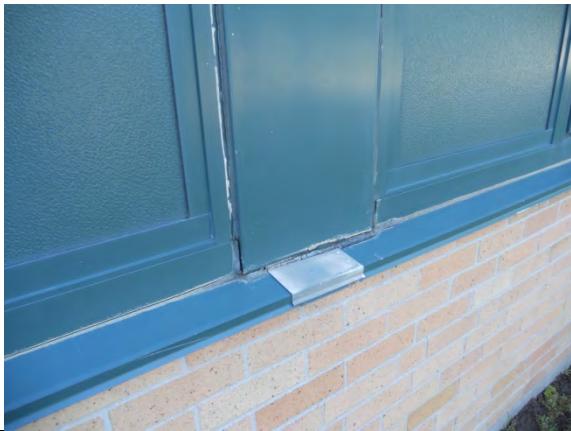
Photo #13: Deteriorated sealant at spandrel panels

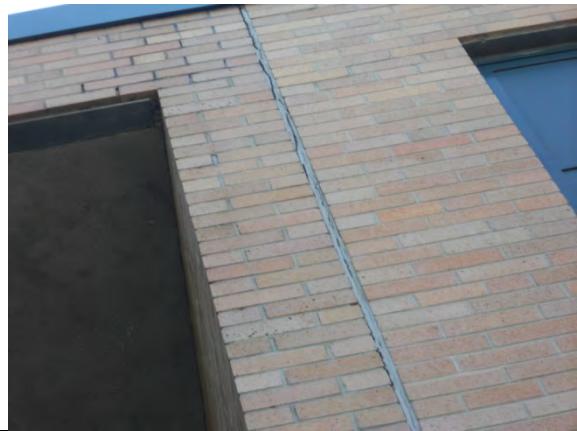
Photo #14: Deteriorated expansion joint

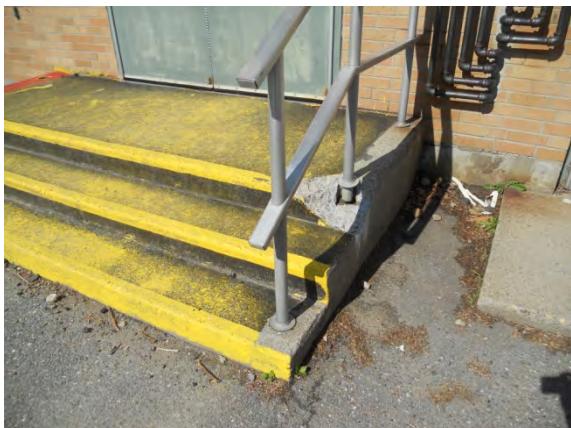
Photo #15: Deteriorated concrete at rear steps

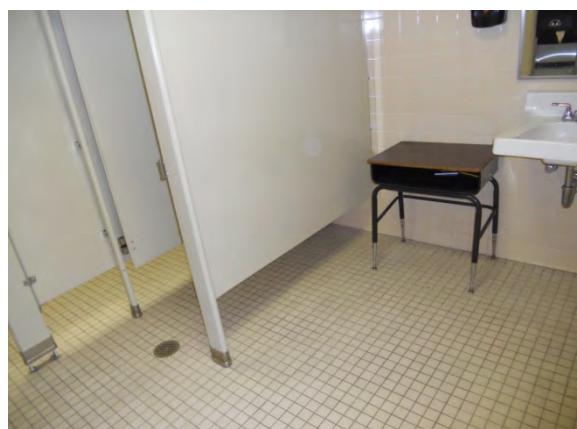
Photo #18: Common area restroom with no drain pipe insulation

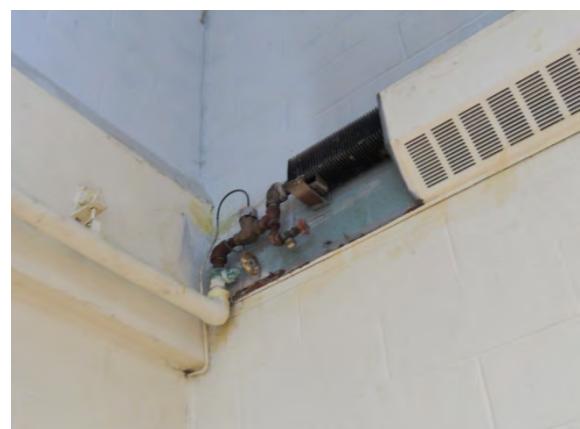
Photo
#24: Wall mounted radiant heater with missing cover

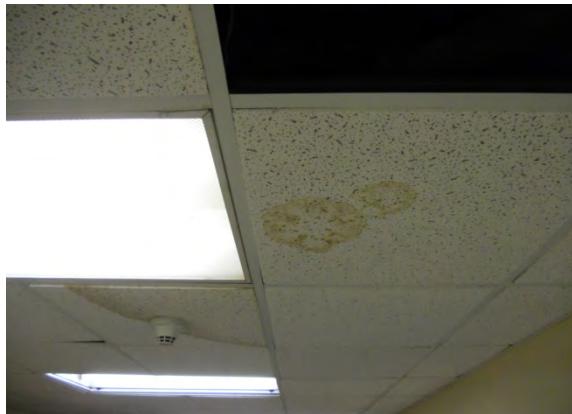
- A full ceiling tile in the women's common area restroom across from the gymnasium was water stained.
- Storage/office area off gymnasium exhibited four square feet of moisture damaged ceiling tile. The damage appears to be under a roof drain.
- Room 116 has seven square feet of moisture damaged ceiling tiles. It is believed to be from the method of floor cleaning involving saturating the floor above.
- Roof 113 has five square feet of moisture damaged ceiling tiles. It is believed to be from a past leak at the univentilator above. The univentilator above has been repaired but not replaced.

Photo #25: Water staining

EMG recommends replacing the affected ceiling tiles and routinely clean and clear roof drains. Monitoring is also recommended for any active leaks as none were observed.

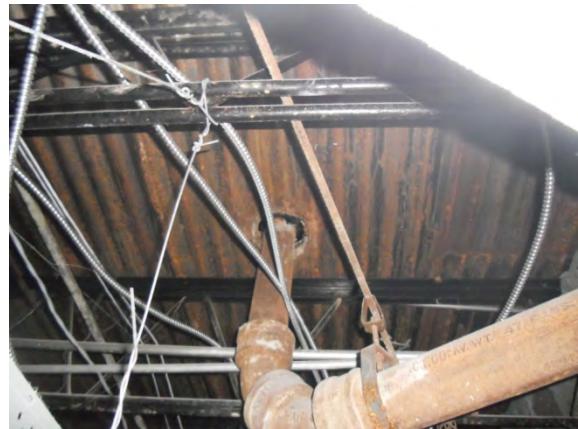
Photo #26: Drain line above stained ceiling tiles

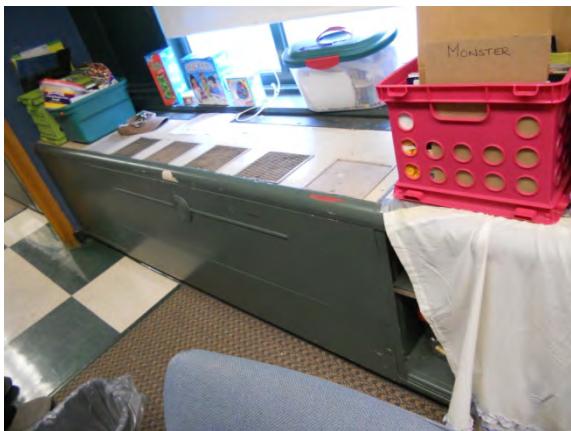
Photo #33: Older univentilator

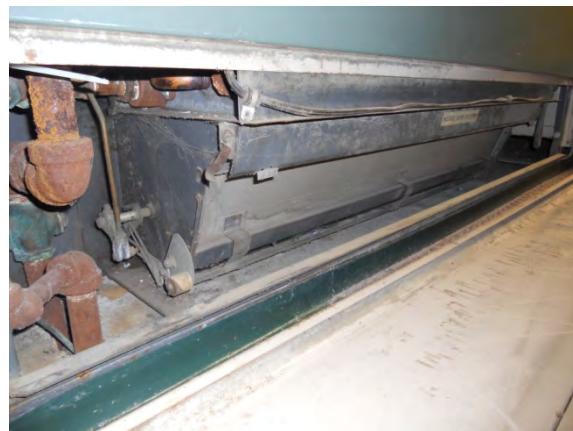
Photo #34: Older univentilator piping and grill

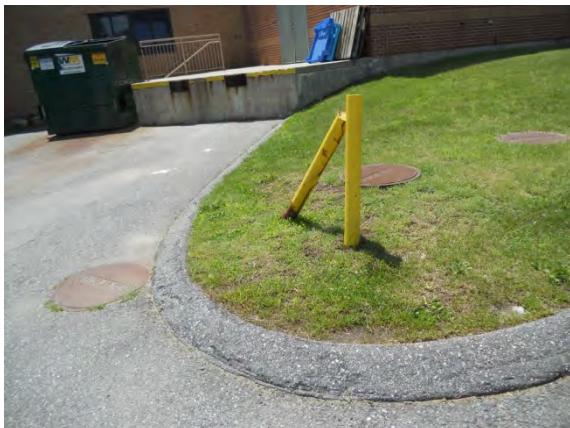
Photo #41: Loading dock with damaged bollards

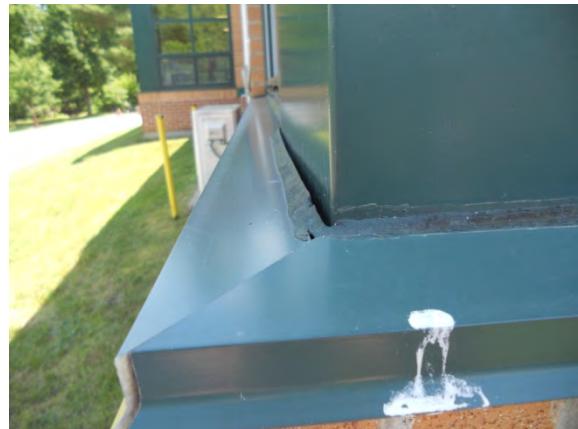
Photo #40: Deteriorated sealant at rear of building at kindergarten classroom addition

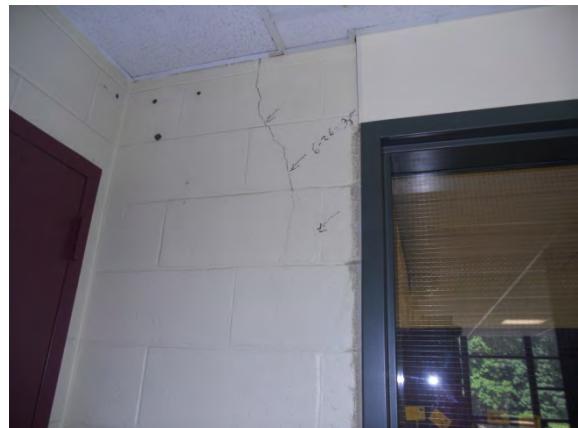
Photo #42: Settlement cracking at second floor of stairwell adjacent to generator room

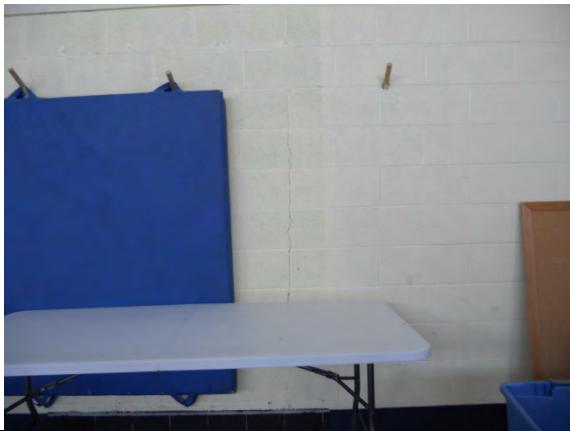
Photo #43: Cracking in gymnasium

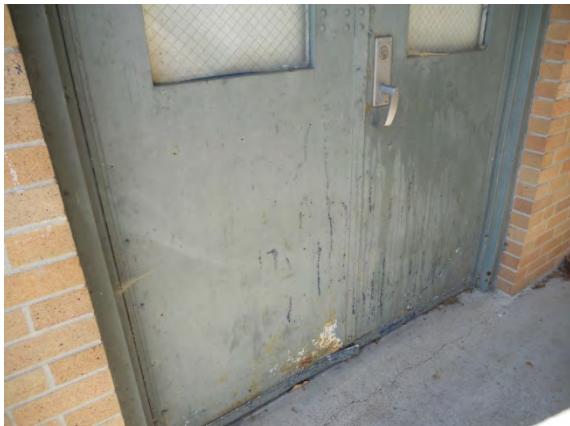
Photo #51: Rusted and deteriorated service door
