## Complete Streets Tier 2 Prioritization Plan: Town of Littleton

June 2016

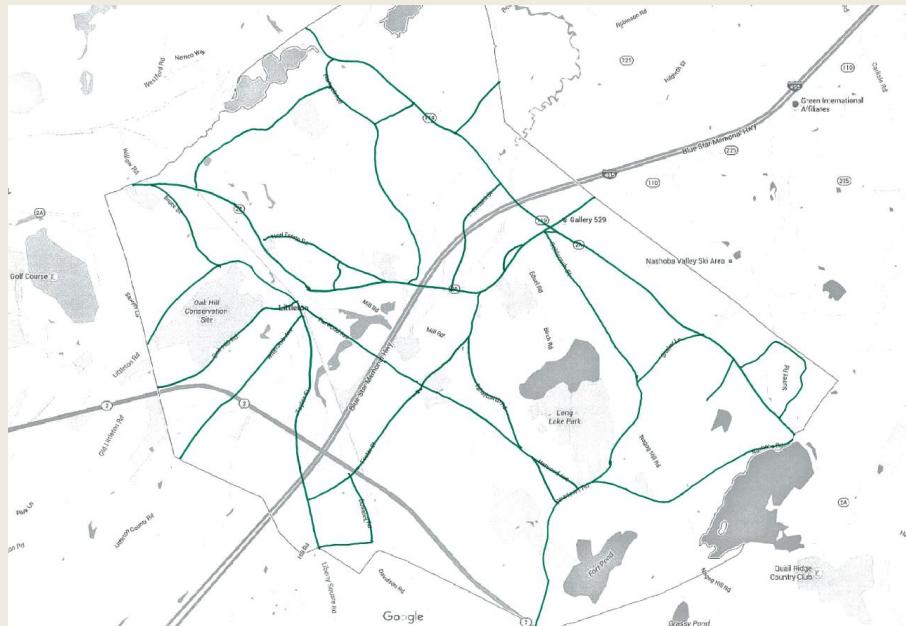
# Windshield Survey Routes

- Drive through each study corridor, passenger takes notes on roadway segment form.
- Separate form developed for roadway segments and intersections.
  - Midblock crosswalks used a roadway segment form.
- Measured roadway cross-sections.
- All intersections and midblock crosswalks were analyzed by walking.

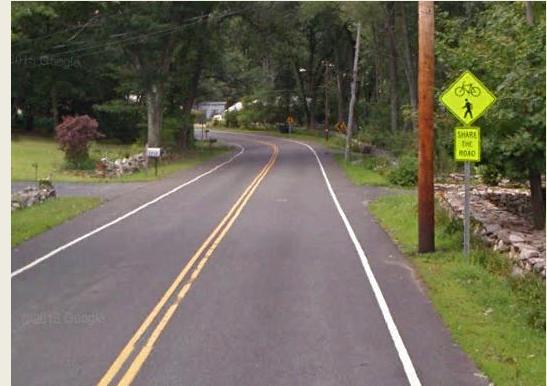
- **Reconstruction of Harvard Rd. – Green International Affiliates, Inc. (Green)**
  - Incorporation of “Complete Streets” design aspects.
    - Narrowed travel lanes to provide 3 ft. striped shoulders.
    - Installed “Share the Road” signs for pedestrian & bike accommodation.

**Harvard Road after reconstruction.**

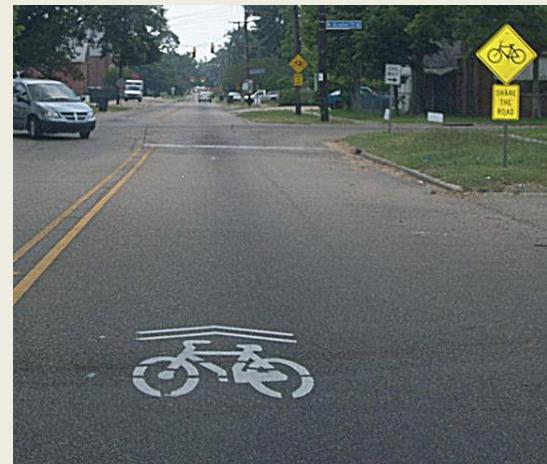
- Improvements to roadway geometry.
- Incorporation of “Complete Streets” design aspects.
  - Installing “Share the Road” signs for pedestrian & bike accommodation.
  - Installing “Sharrows” along the roadway surface.

**Example of roadway with “Share the Road” signs & “Sharrows”.**

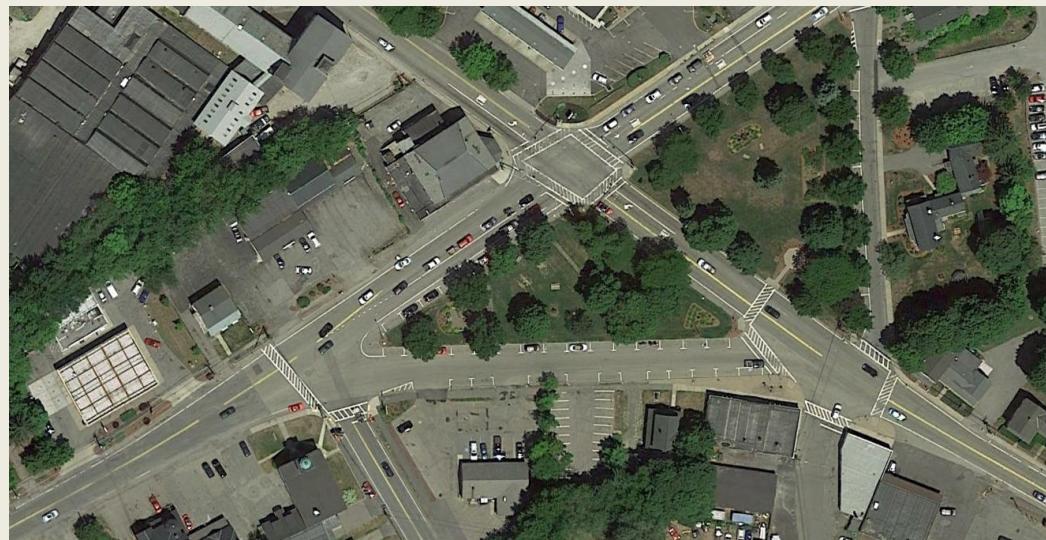
- Approximately 75 ft. crossing across King St (Rt 2A/110) at Goldsmith St.
  - One pedestrian crossing warning sign (W11-2) present at the north end of the crossing facing WB traffic.
  - No advanced warning signage provided.
- No bicycle accommodation throughout the Common, particularly from King St (Rt 2A/110) to Stevens St to Great Rd (Rt 2A/119), no bike racks present.
- No detectable warning panels installed on curb ramps at intersection of Meeting House Rd/Adams St/Stevens St/Great Rd.

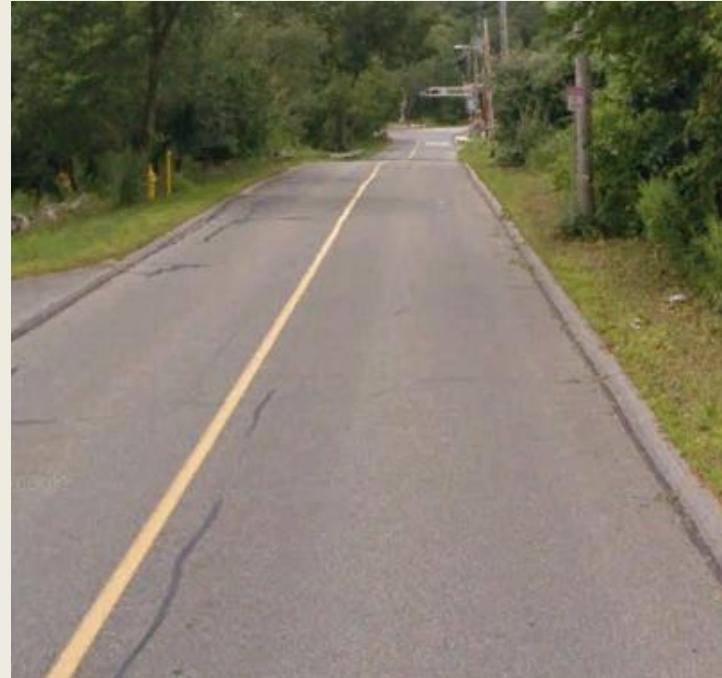
- High pedestrian & bicycle interest due to Littleton / I-495 Commuter Rail Station.
- Identified by January 2016 StreetScan study as the #1 highest priority road in Littleton for roadway improvements.
- No pedestrian or bicycle accommodations south of Tahattawan Rd, including no sidewalk or crossing at the commuter rail station entrance.
- Roadway pavement is in poor condition, further hindering safe pedestrian & bicycle travel.

Typical section of Foster St, south of Tahattawan Rd.

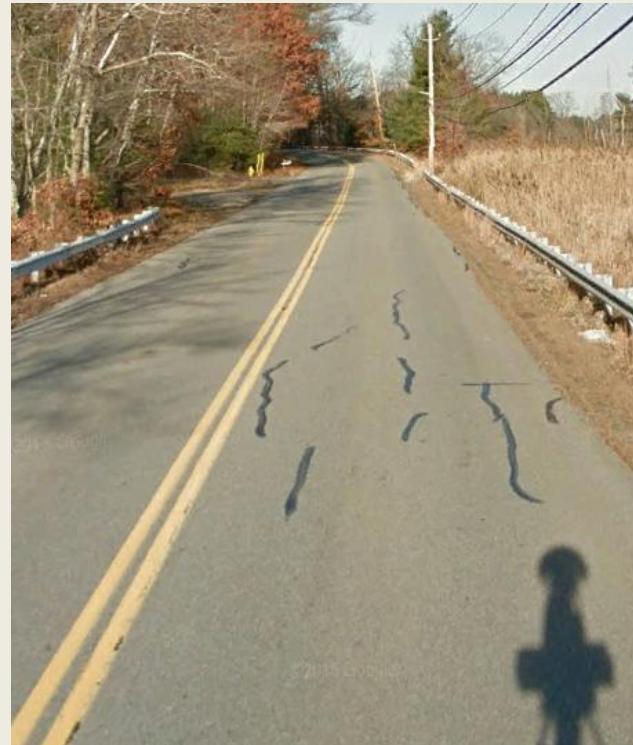
- Provides access to Foster St in vicinity of Littleton / I-495 Commuter Rail Station.
- Sidewalk along northern segment of Taylor St does not connect to Foster St.
- Approximate  $\frac{1}{2}$  mile gap in the sidewalk on the west side between house #119 and Route 2 overpass.
- Majority of roadway segment is too narrow to accommodate bicyclists (10 ft lanes per direction, no shoulders).

Typical section of Taylor St with no sidewalk.

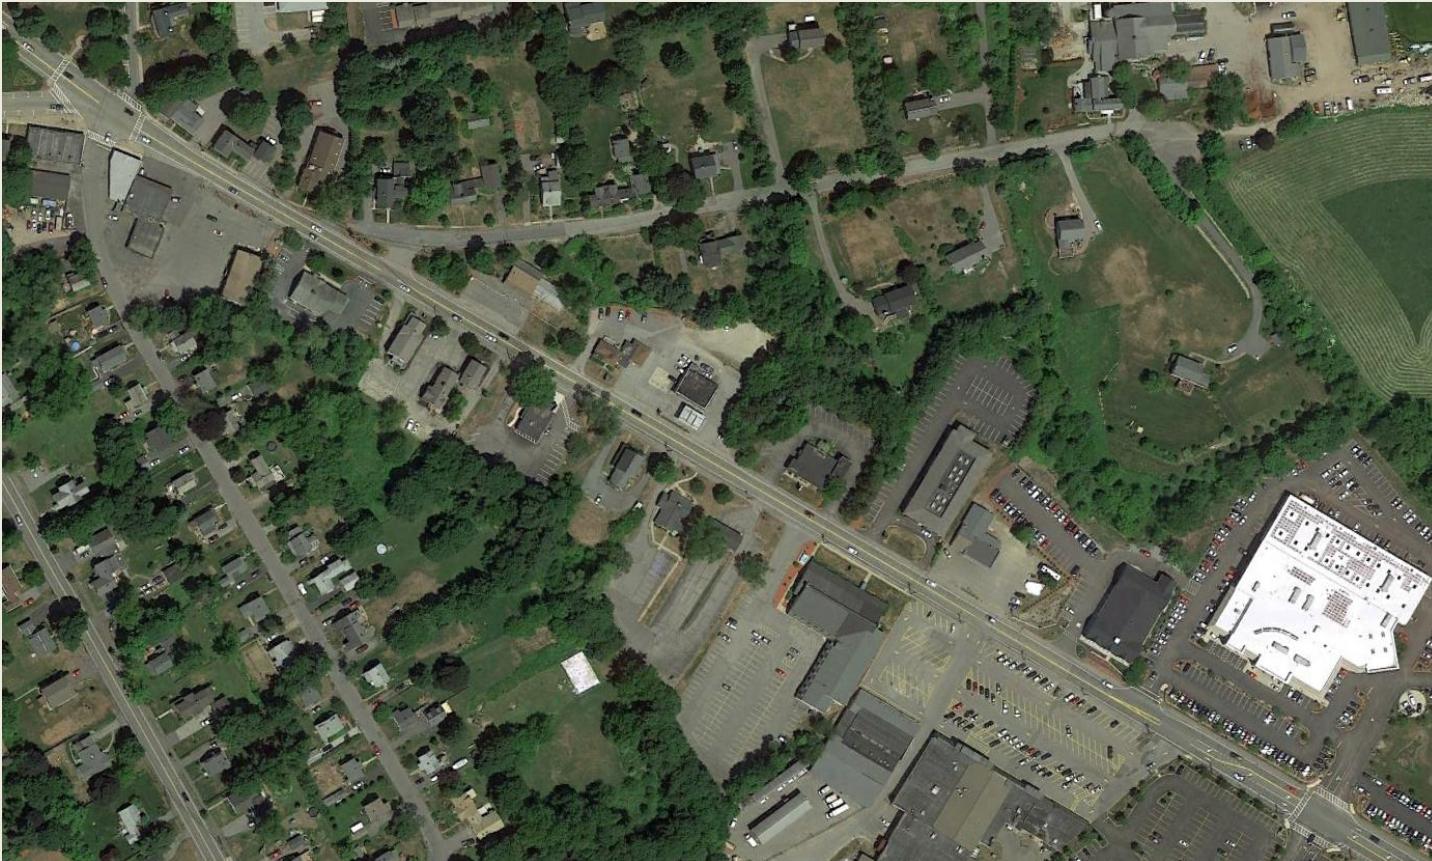
Segment of Great Rd from Littleton Common to Acton Toyota.

- The 2002 Littleton Master Plan expresses interest in a bike path along Great Rd (Rt 2A/119) to allow residents living in the Town's southeastern areas safer access to the Town Common.
- The typical section of Great Rd east of Acton Toyota consists of 11.5 ft travel lanes and 3 ft shoulders.
  - No pedestrian or bicycle accommodations east of Acton Toyota.
- High travel speeds along this segment of Great Rd in addition to no sidewalks or bike lanes / wide shoulders result in unsafe travel conditions for pedestrians and bicycles.

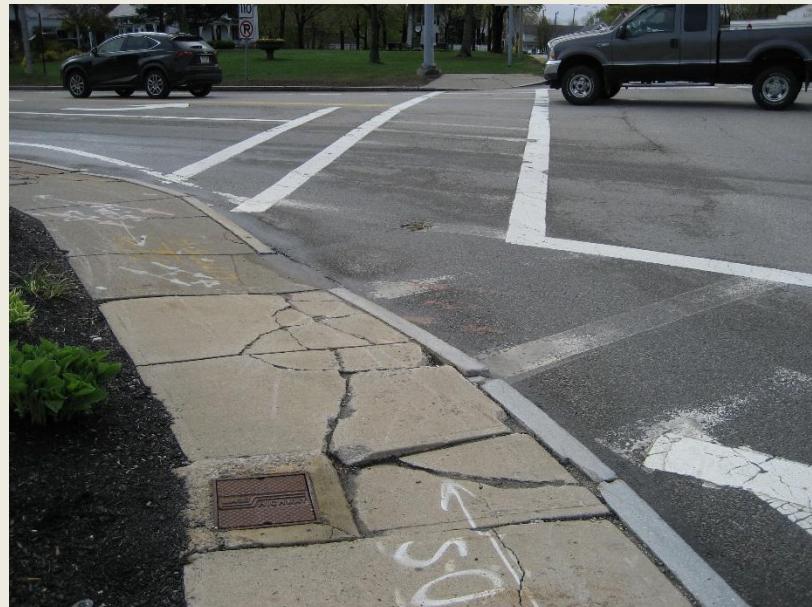
- Curb ramps are shared and likely too steep on all corners of the 4-way signalized intersection.
- Detectable warning panels are not present on any of the curb ramps.
- Pedestrian push buttons are located far distances from the curb ramps on  $\frac{3}{4}$  corners of the intersection.
- No bicycle accommodation at the signalized 4-way intersection.

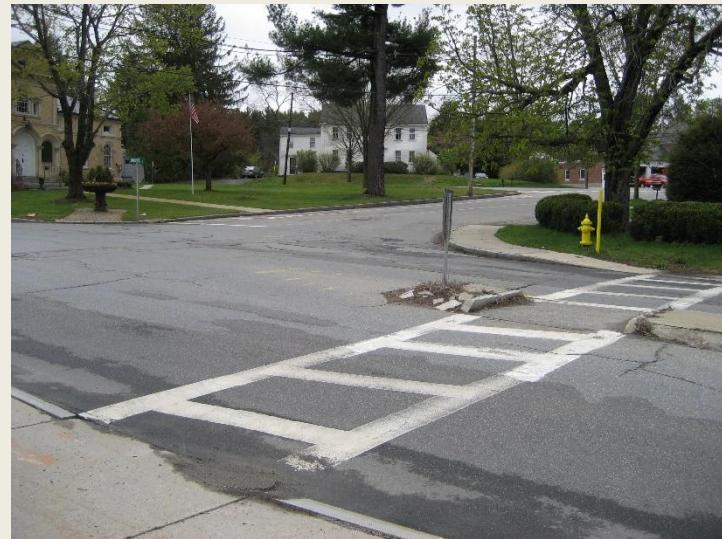
- No detectable warning panels installed on the curb ramps at the crossing.
- Old MUTCD pedestrian warning signs (W11-2) installed at the crosswalk location do not include diagonal downward pointing arrow plaques (16-7P) mounted below.
- Advanced pedestrian warning sign (Old W11-2) with no “Ahead” plaque (W16-9P) provided for WB traffic only, no advanced warning signage provided for EB traffic.

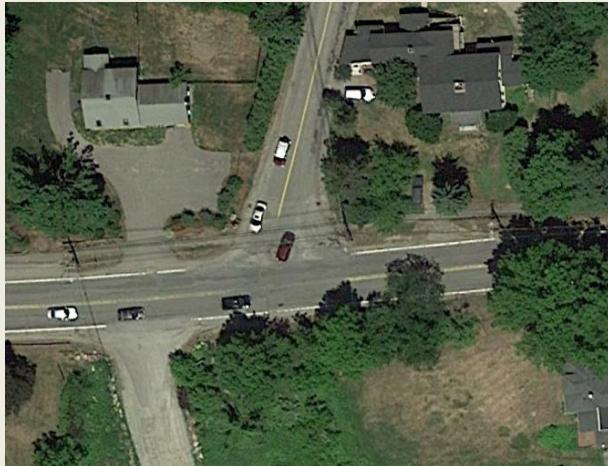
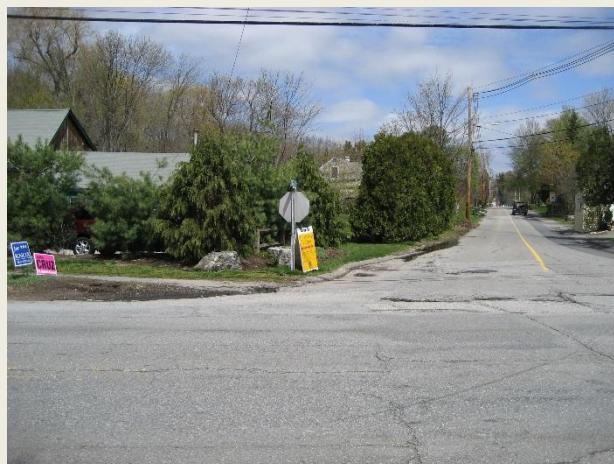
- Curb ramps are in poor shape, with a large pothole present at the transition from the sidewalk to the roadway surface at the northwest corner of the intersection.
- Detectable warning panels are not present on either of the curb ramps.
- No crosswalk across the Russell Street approach for pedestrians traveling along the sidewalk on the north side of King St.
- Sidewalk along north side of King St is in poor condition with trip hazards within the sidewalk path in vicinity of the intersection.

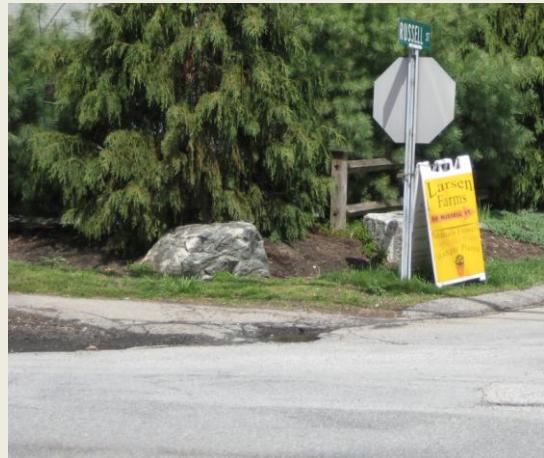
- Sidewalk is in poor condition when it transfers from concrete to asphalt west of the Castle in the Trees Playground.
- Curb ramps, where present, are in poor condition with deteriorating asphalt.
- Few detectable warning panels present (entire corridor).
- Trip hazards are present on the sidewalk due to deteriorating asphalt.

Sidewalk on north side of King St at Russel St.

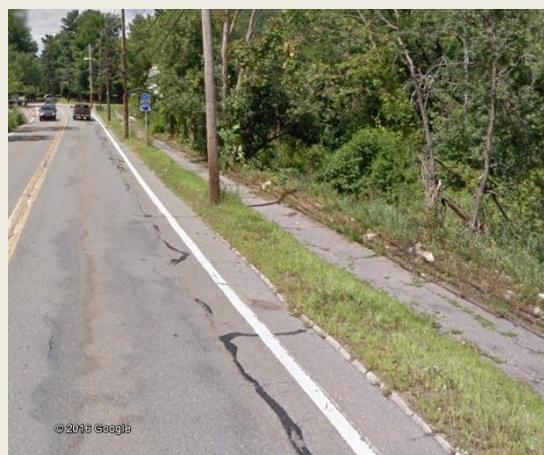
Sidewalk on north side of King St just west of Castle in the Trees Playground.

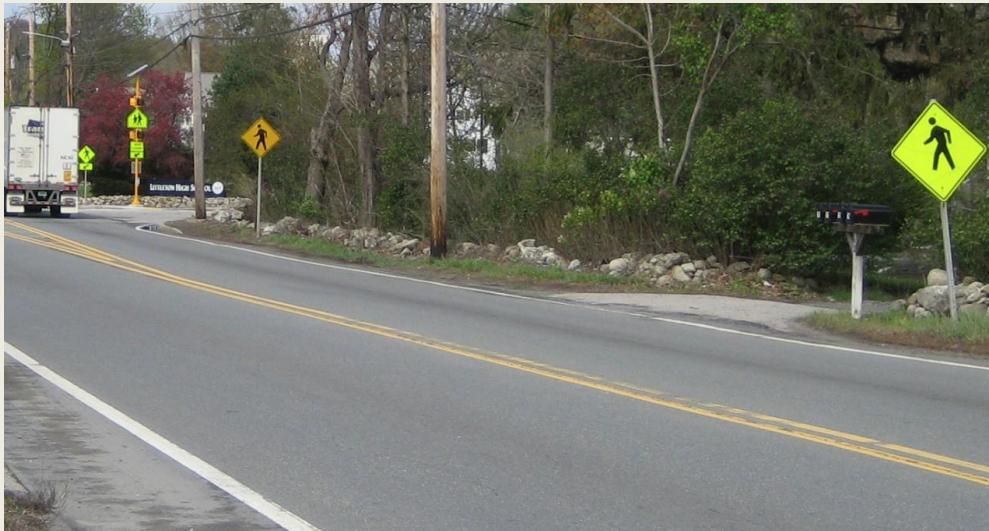
- Yellow background and fluorescent yellow-green background are both used approaching the crossing location.
- Redundant use of pedestrian warning signage at the crossing location, W11-2 sign in addition to S1-1 sign is unnecessary.

King St (Rt 2A/110) traveling WB approaching Littleton High School entrance.

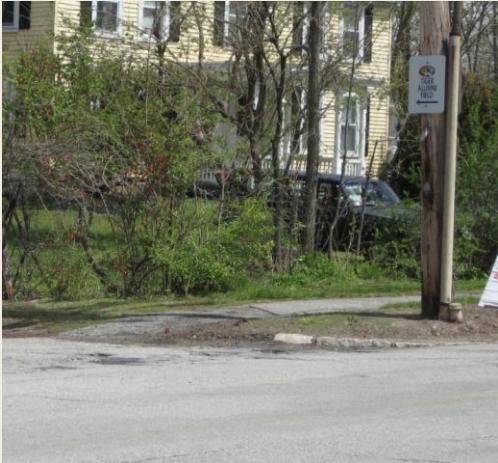
Corner of King St (Rt 2A/110) / Russell St intersection.

# Lack of Detectable Warning Panels

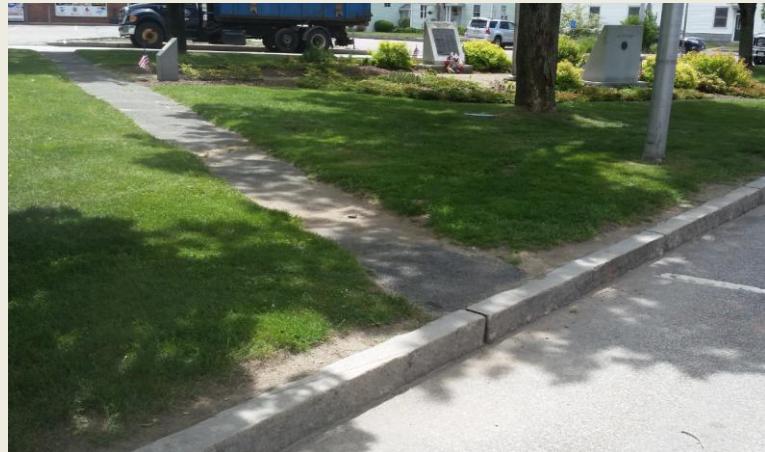
Walkway through grass area in Littleton Common.

# Curb Ramp Deficiencies

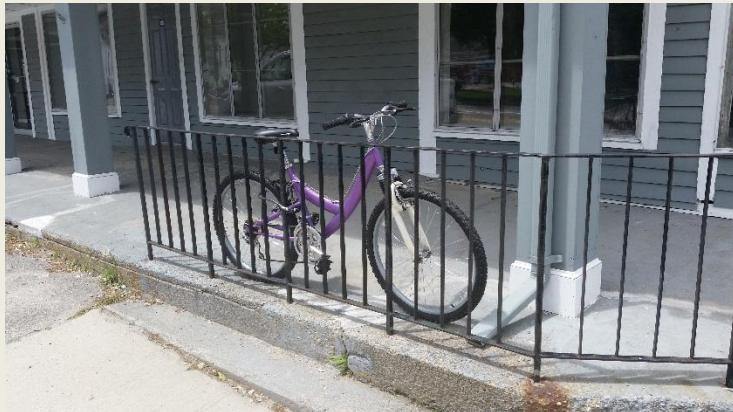
# Lack of Bike Racks in Key Locations

Bike locked to hand railing outside of Littleton Sub Shoppe.

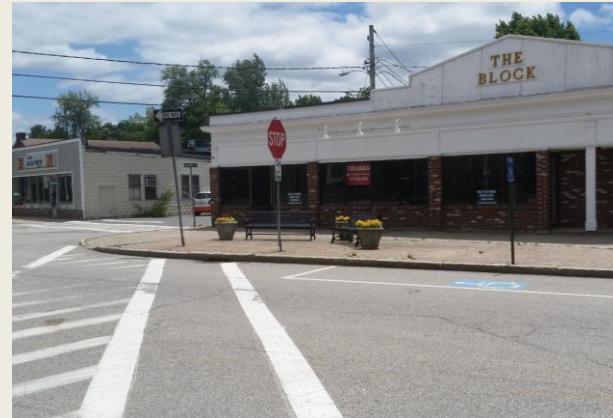
Wide brick buffer between the curb and sidewalk on Stevens St.
