MEMORANDUM

Project Name: Strawberry Farm Subdivision
Subject: Site Visit No. 01
Date: September 9, 2024
Time: 9:00 AM – 10:00 AM
Location: 95 Taylor Street, Littleton, MA
Weather: Sunny, 67 degrees
Prepared by: Joshua Ward
Attendees: Mark Gallagher, Seal Harbor Companies (MG)
Joshua Ward, Green International Affiliates, Inc. (JW)

Site Visit Summary:

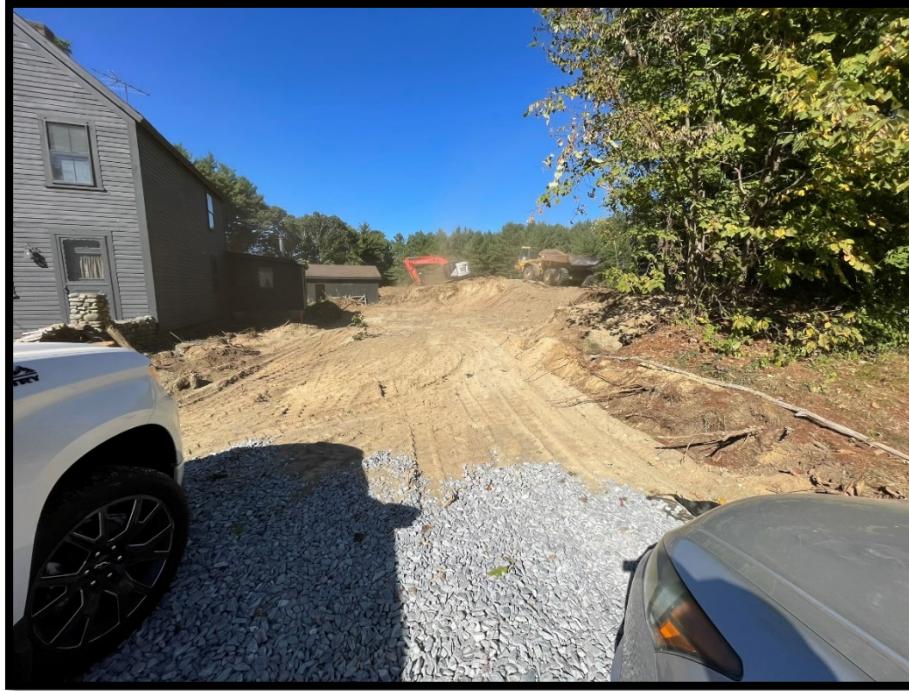
Photo 1
Gravel construction entrance and temporary access corridor.

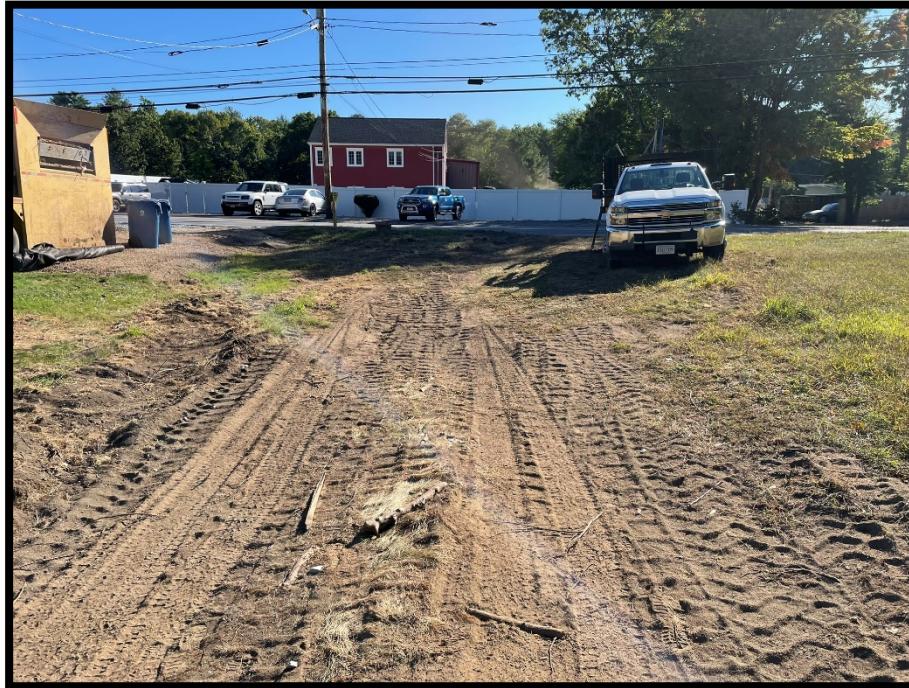
- Gravel construction entrance is in place (see photo 1). Although there appears to be another location where vehicles are entering/leaving the site as well (see photo 2). A construction entrance shall be installed at all locations where vehicles will be entering and leaving the site. The contractor shall provide an additional construction entrance or not use the other location.

Photo 2:
Secondary entrance.

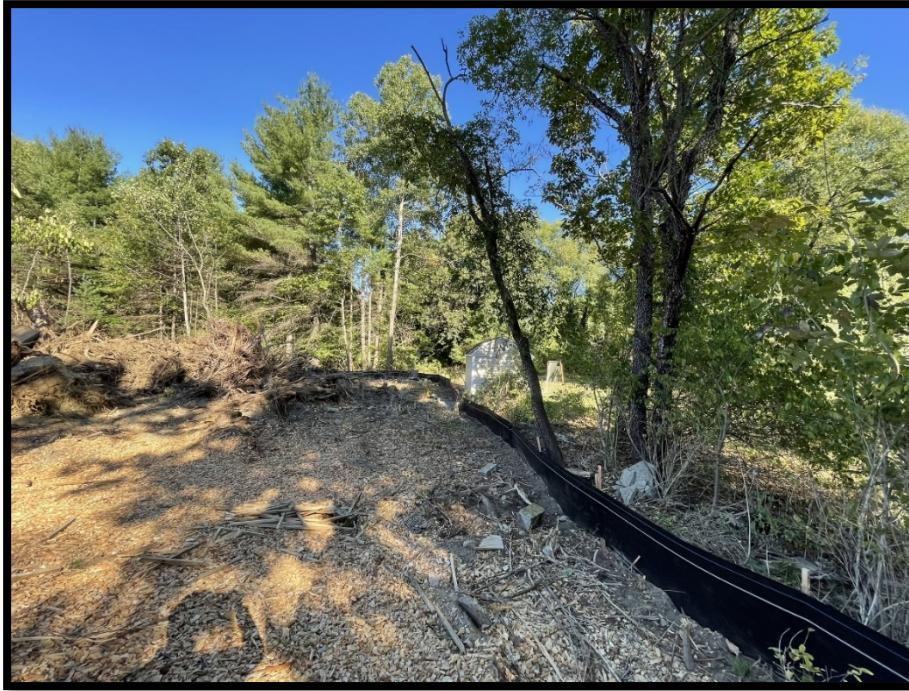
Photo 3:
Erosion and sedimentation controls along the northeast site boundary.

- Siltation barrier has been installed along the perimeter and appears to be in good working order (see photos 3 & 4). The straw wattles were not installed. MG explained that wood chips from the site clearing would be placed adjacent to the perimeter silt fence to improve filtration and prevent erosion. We have no issues with wood chips being placed inside the perimeter of the silt fence but wood chips are not an acceptable alternative to straw wattles. The contractor shall install straw wattles per the design plans.

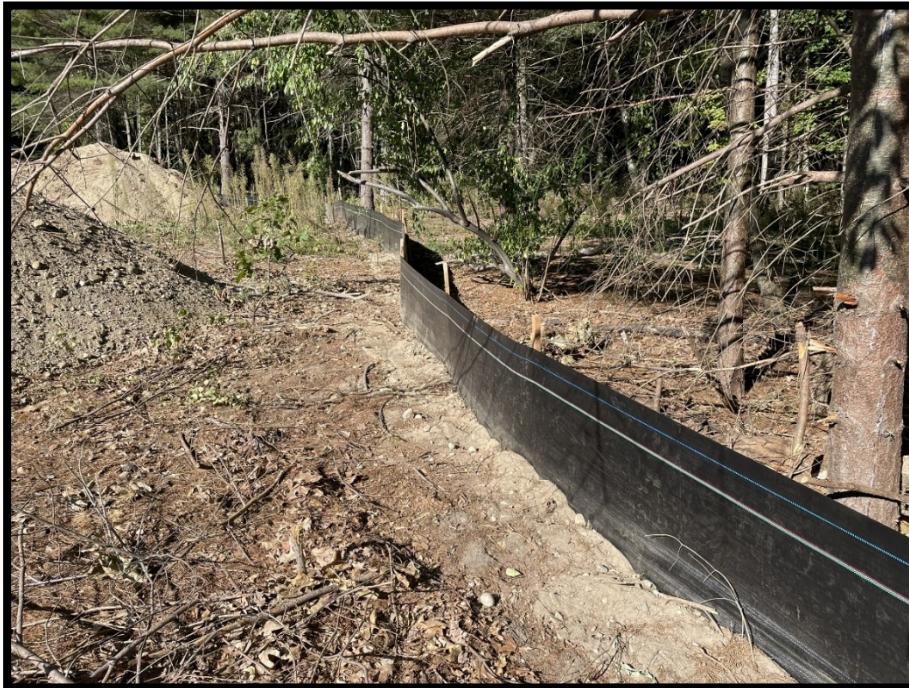
Photo 4:
Erosion and sedimentation controls along the northwest site boundary.

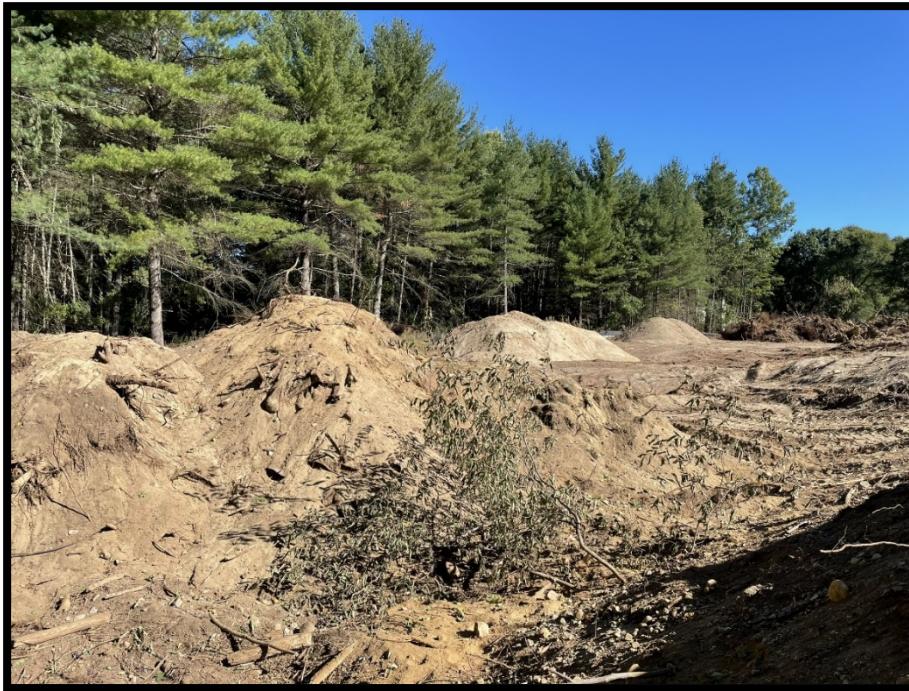
Photo 5:
Stockpiles of loam, sand, and gravel adjacent to the northwest site boundary.

- Soil/sediment stockpiles are not in areas shown on the plan. This is ok if the stockpiles are not located where infiltration BMPs will be installed.
- The stockpiles are not contained with erosion control (see photo 5). Per the design plans, all soil stockpiles shall have erosion control measured around their edges at all times. Soil stockpiles shall be covered with temporary vegetation or fastened tarpaulin sheets.

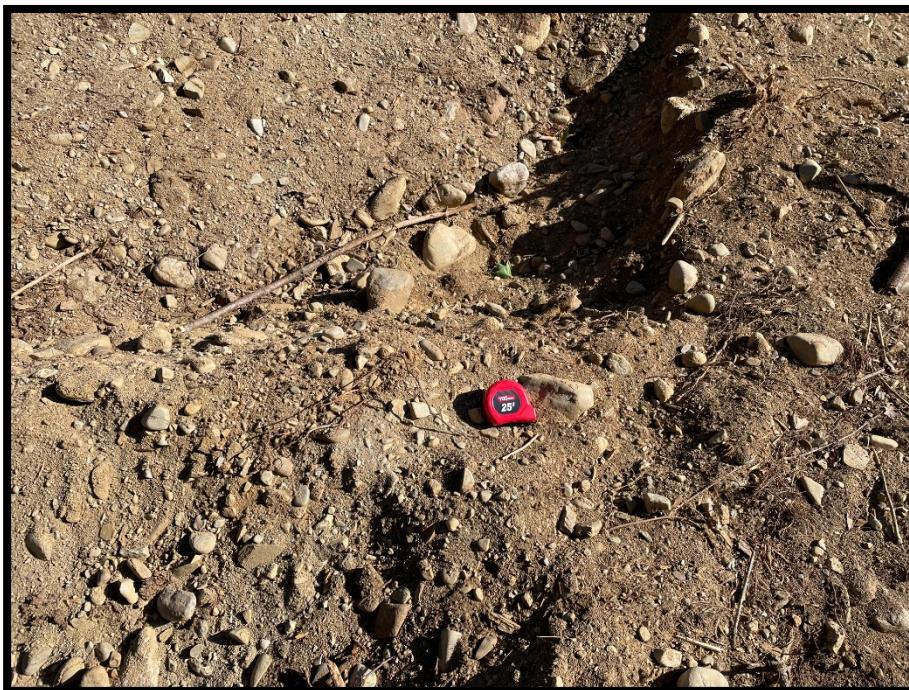
Photo 6:
Soil on site requested for reuse.

- JW observed the gravel material on site that MG requested to use as a subbase for the roadway. MG would not let JW take a sample to bring back to the office since the material on site was not screened. MG is going to screen it and have it tested at a lab. The gravel appears to have large stones and roots and will require screening (see photo 6).

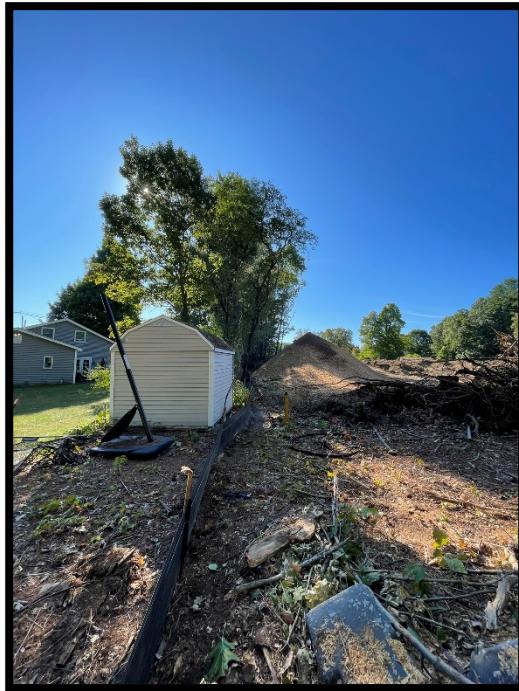
Photo 7:
Tree line along northeast property line.

- Site grubbing and clearing has been completed. Little to no tree line or screening was maintained along the northeast corner of the site (see photo 7 & 8). This does not meet the design plans which show at least 10 feet of tree line maintained along the property line.
- The contractor has started site grading.

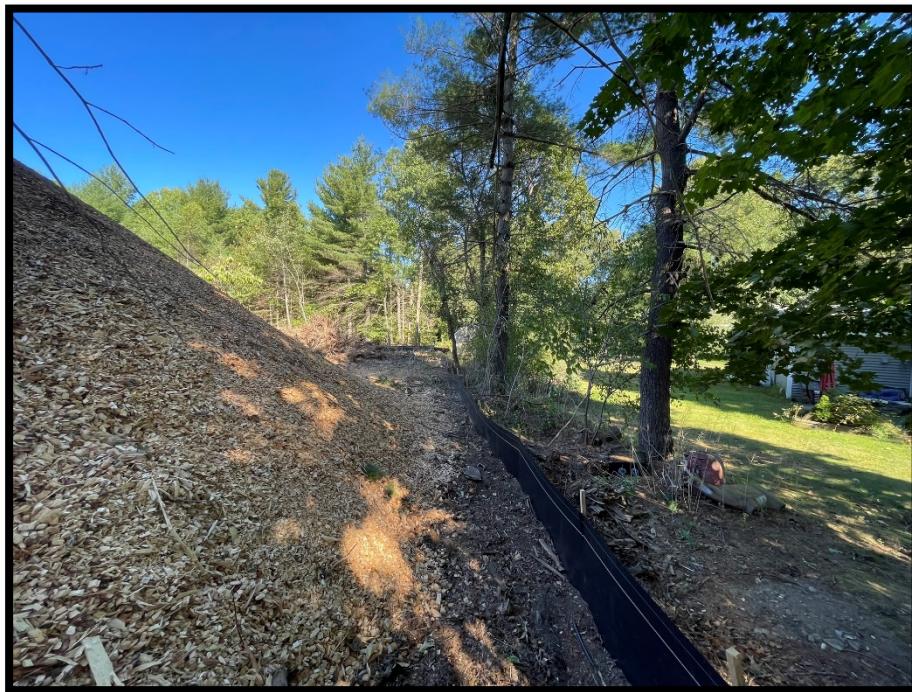
Photo 8:
Tree line along northeast property line.
