## **MEMORANDUM**

**Project Name:** Strawberry Farm Subdivision  
**Subject:** Site Visit No. 03  
**Date:** September 27, 2024  
**Time:** 3:00 PM  
**Location:** 95 Taylor Street, Littleton, MA  
**Weather:** Sunny, 75 degrees  
**Prepared by:** Shaharyar Khan  
**Attendees:** Mark Gallagher Sr., Seal Harbor Companies (MG)  
Shaharyar Khan, Green International Affiliates, Inc. (SK)

**Site Visit Summary:**

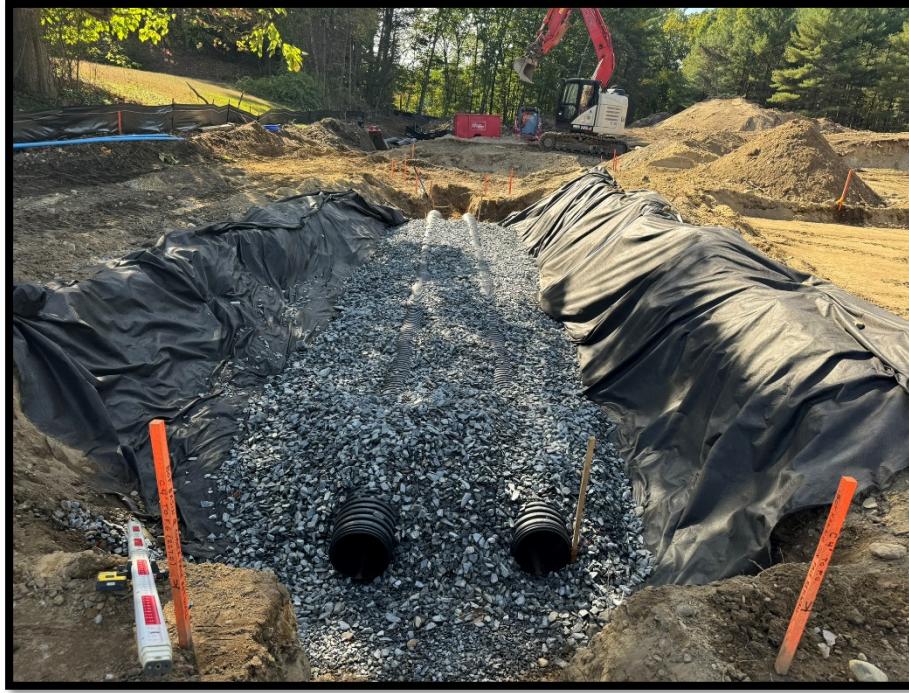
**Photo 1:**  
**(2) 12 Inch Perforated drainpipes for proposed infiltration basins.**

- The (2) 12-inch perforated drainpipes for the proposed infiltration basins had been installed with adequate bedding material around the pipe and filter fabric. MG mentioned that 12" of crushed stone will be installed on top of these pipes and wrapped in the filter fabric. The trench will be filled and compacted with screen sand and gravel on site. (See Photo 1)

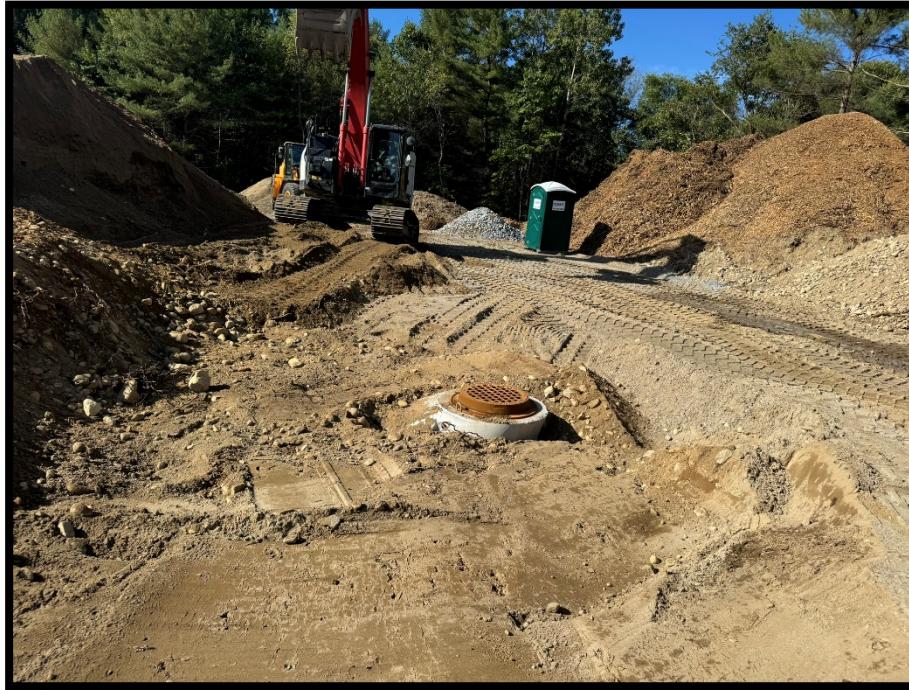
**Photo 2:**  
**Installed AD-3.**

- All drainage structures (2- DMHs, & 3-ADs) also had been installed. MG agreed to share the photos of the installation of these structures since the trenches had already been backfilled before the scheduled the site visit.

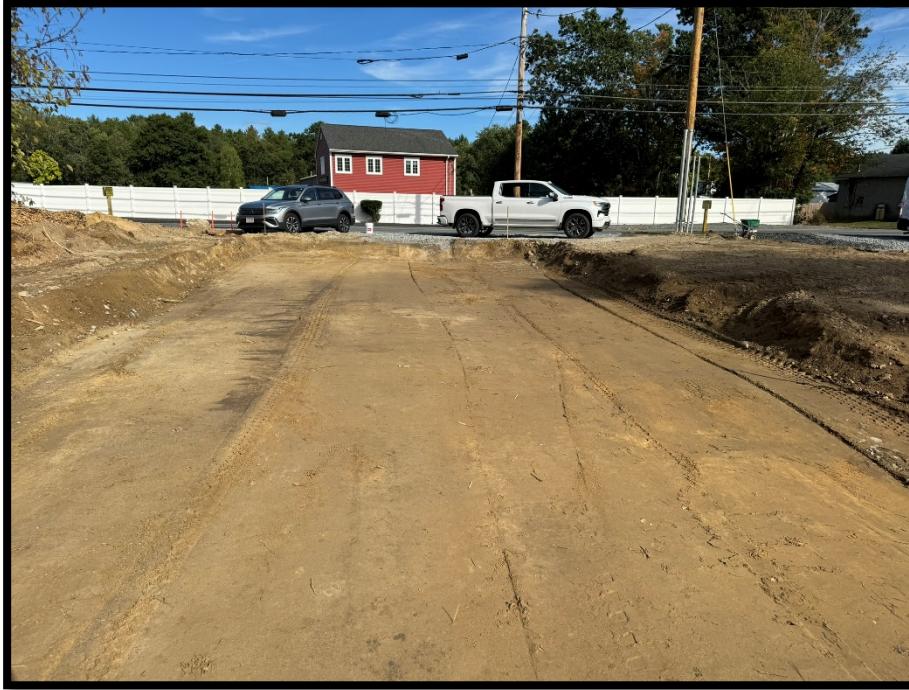
**Photo 6:**  
**Prepared Subgrade for the Strawberry Farm Road.**

- Grade stakes had been placed along proposed driveway. From the current subgrade to the proposed finished grade is 16 inches which is reserved for the roadway subbase material. Subbase material to include, 8 inches of gravel borrow subbase, 4 inches of  $\frac{3}{4}$  inch dense graded crushed stone, 2.5 inches of HMA binder course, and 1.5 inches of HMA top course. (see Photo 6)

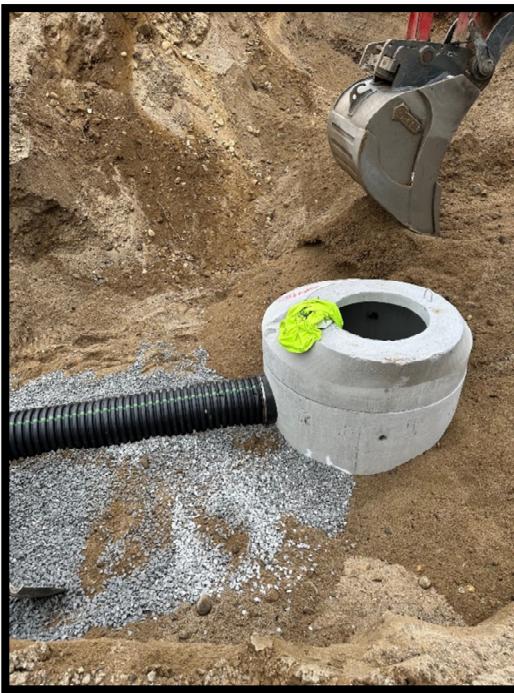
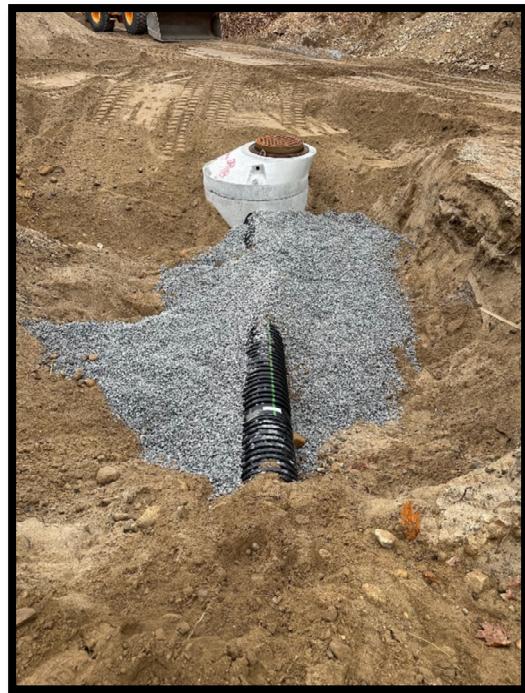
- Please see photos (7-11) received from MG for the drainage structures installed.
- Subgrade had been prepared for the roadway. The subgrade material was observed and is adequate.

Photo 7 & 8 by MG:  
AD-3 installation.

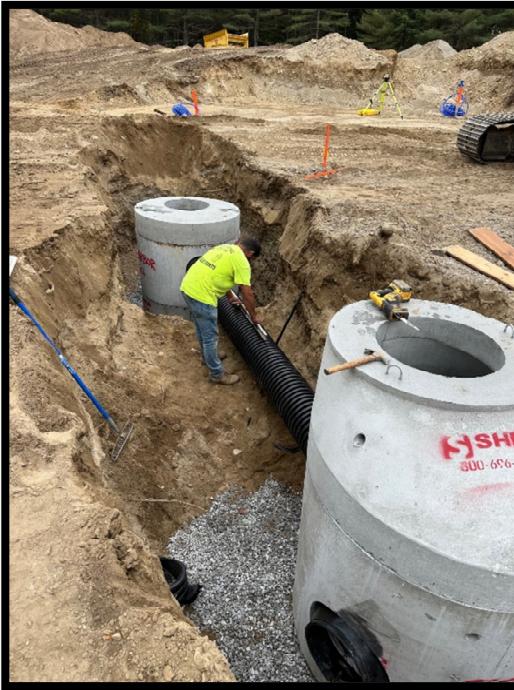
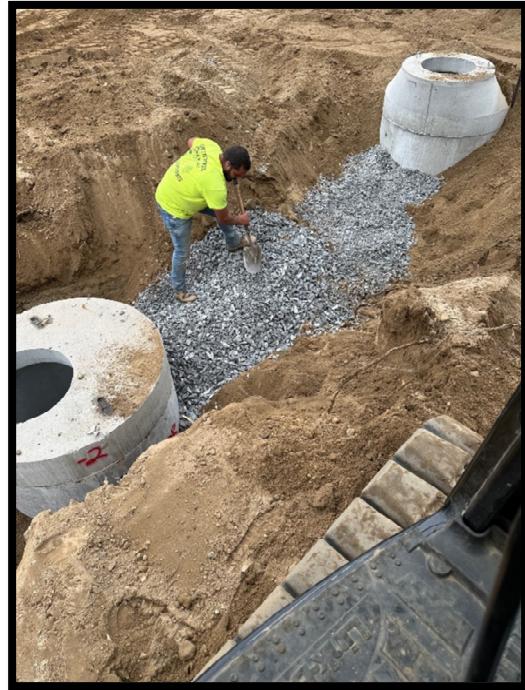
Photo 9 & 10 by MG:  
DMH-2 and AD-2 Installation

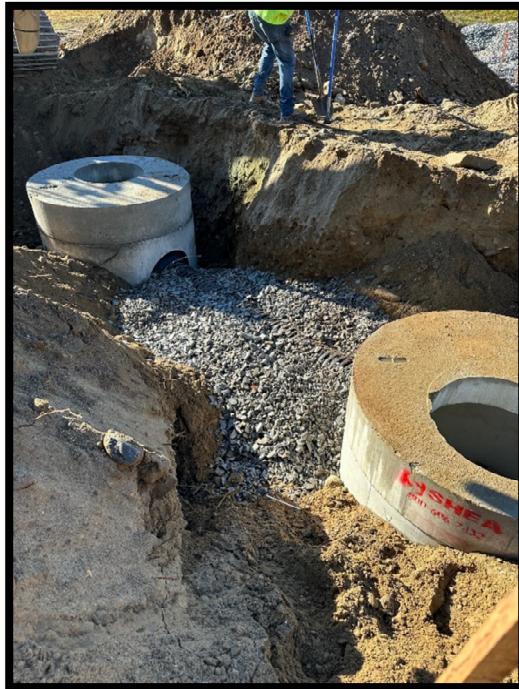
**Photo 11 by MG:**  
**AD-1 & DMH-1 installation.**
