# Existing Conditions

The Original Building is a 2 story, steel frame and brick veneer building which was constructed in 1968. The Building is approximately 72,000 sf and houses grades three, four and five as well as a Kindergarten after school program as part of the "Tiger's Den" program.

Littleton Public Schools - Feasibility Study for Russell Street School

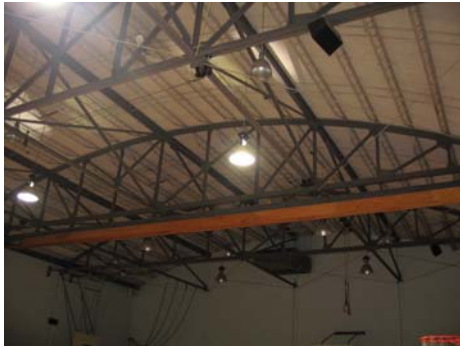
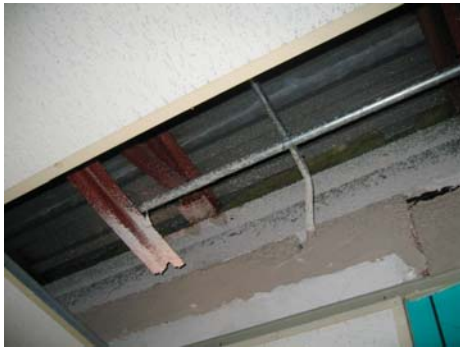
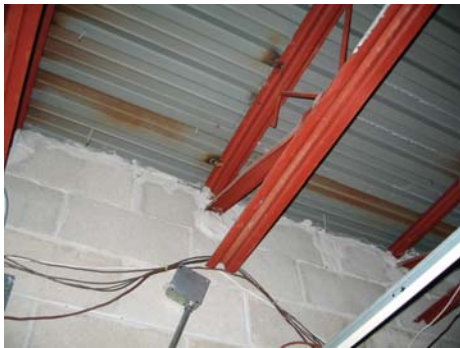
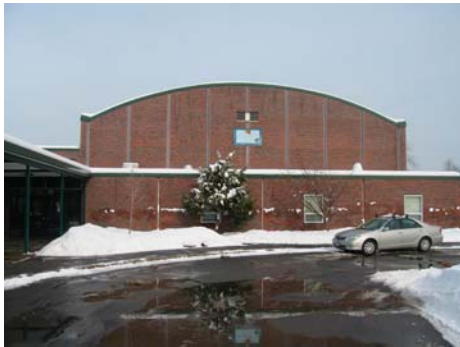
The exterior façade is in good condition and there is no evidence of any distress to the main structural elements.

The existing structure is in sound condition, as is the exterior façade. Even though the structure is performing well, it is not up to the serviceability criteria of modern structures, nor would it be adequate to resist lateral loads as required by code for new construction.

At the time of renovations or upgrade to the school, the structure of the school would have to be upgraded depending on the type of renovations. If the proposed renovations are architectural in nature or involve upgrade or replacement of mechanical or electrical systems, the structure would also have to be upgraded as noted under LEVEL 2 WORK, please note that even though these structural upgrades could be extensive, they would not bring the structure up to compliance with code for new construction. It would not be capable of resisting earthquake or wind loads adequately, as would be expected of modern structures.

If the proposed renovations involve any major reconfiguration to the existing structure, these renovations would trigger the upgrading of other portions of the structure and this could become cost prohibitive. We would recommend that any proposed addition be kept structurally separate from the existing.

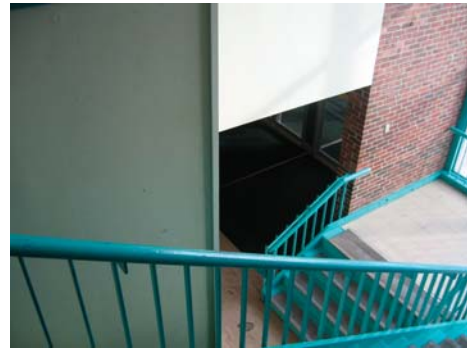
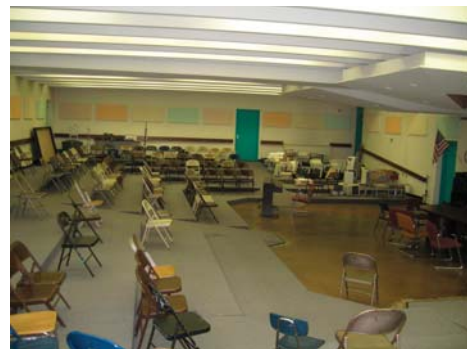
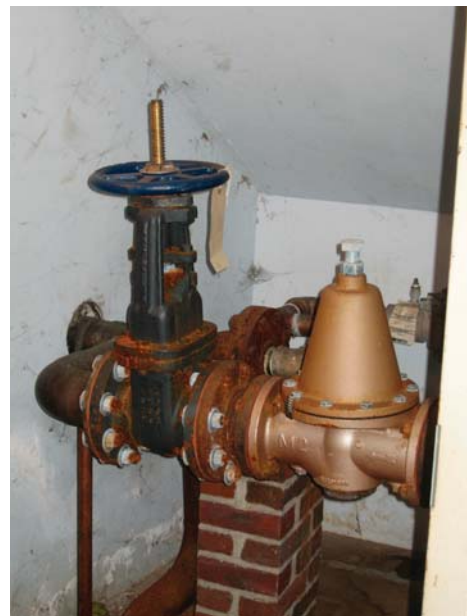
1. The building domestic water service extends below grade from a municipal supply, as a 4" main to the meter room below the south end stair.
2. Condition of water service piping below grade is unknown. Above grade piping is in fair condition, and original to the building.
3. A new domestic water service should be considered under any major renovation project. Meter room location should be changed, so that the stair area can be kept clear of equipment.

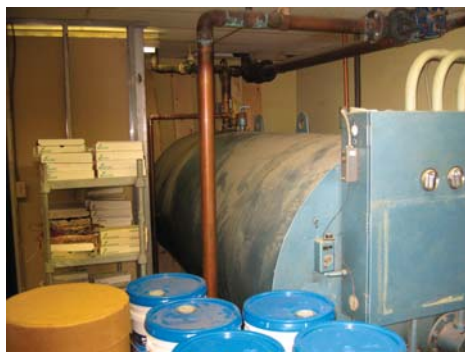
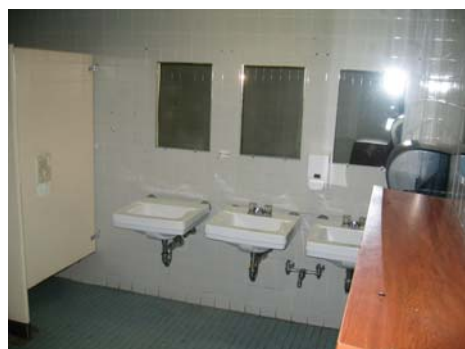
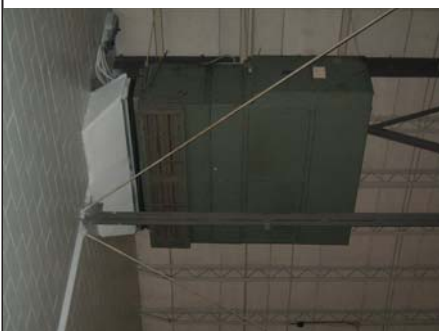
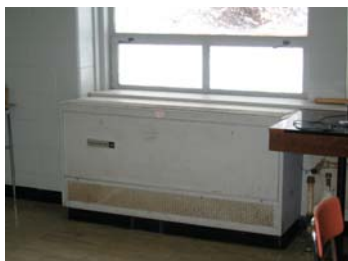
4. Interior supply piping should be replaced as a part of any major renovation, due to age.
5. The existing water heater is a large electrically heated storage type tank. This tank supplies all hot water to the building, with the exception of some kitchen loads. The tank is inefficient to maintain in service. Capacity overall exceeds daily demand, and thus much more electrical energy is used than would be required if the heater and tank system was sized for the actual utilization. Removal of the tank is recommended and a new tank or multiple water heater locations should be considered.

6. Sanitary waste is discharged to a force main pumping system on site. Condition of the pumping station is unknown, but functions correctly per building staff. The existing sanitary main from the building to the pump station should be snaked, and scoped as a part of a major renovation. Should there be piping perforations or other indications of piping failure, piping would require replacement or corrective action. Interior above grade piping appeared to be in fair condition. Interior below slab waste piping has failed in at least one location and will require further investigation as indicated above for exterior piping.
