Request to Littleton Conservation Commission

Request to remove two hazardous trees

DEP File No. 204-901

49 Matawanakee Trail
David and Patricia Barr
978-201-9524
barrdt@gmail.com

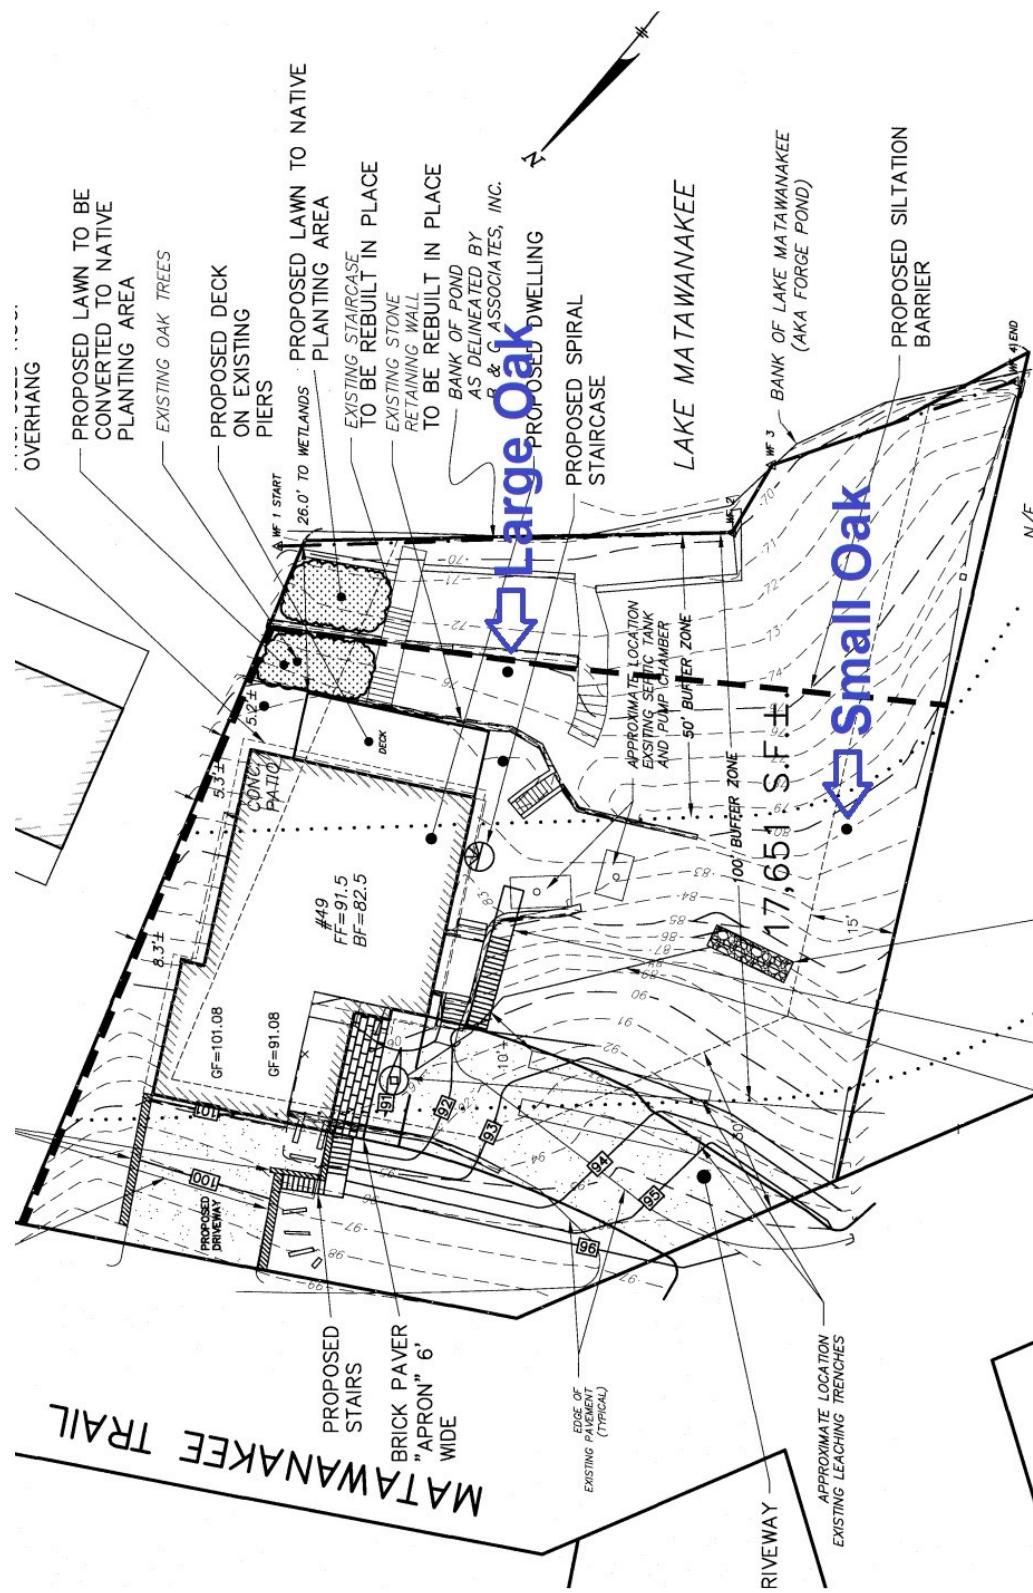
Location of trees:

One tree (a large oak) is within the 50-foot buffer zone for Lake Matawanakee. The other tree (a smaller oak) is within the 100-foot buffer zone for Lake Matawanakee.

The tree was on a steep slope between the house and lake, and the grade had been disturbed in the past and presently. The ground was compacted, and a number of retaining walls were either present or under construction. I noted that the tree had a crack in the main crotch about 30 feet up, and that there was a large cavity in the buttress roots.

The critical root zone of a tree is commonly defined as a radius in feet around the tree equivalent to the diameter of the tree in inches. All excavation and disturbance in the Critical Root Zone should be avoided or mitigated. The Critical Root Zone of this tree is about 27 feet in radius or 54 feet in diameter. Virtually the entire critical rootzone of the tree has been compromised. This fact, plus the obvious flaws noted above (crack in crotch and cavity in root buttress), leads me to the recommendation that the only safe course of action would be to remove the tree. This is a standing hazard tree.

The tree was leaning towards the residence at #45 Matawanakee, and I noted cavities in the tree at around four feet above grade. I probed the cavities and noted that the entire center of the tree is hollow and the two cavities, on opposite sides of the tree, almost connect. The tree trunk is like a soda straw with two holes in it, and it is at risk of failure, falling onto the adjacent home. The only safe course of action would be to remove the tree. This is a standing hazard tree.

If the decision is made to retain the tree, further excavation should be avoided, and a Certified Arborist hired to install a cable secured with through bolted eye bolts installed to attempt to hold the two leaders together. That said, my original recommendation stands.
