Littleton Town Hall Building & Space Needs Assessment

Volume II: Shattuck Street Municipal Complex, Existing Conditions Report

Littleton Town Hall Complex
37 Shattuck Street
Littleton, MA 01609

March 2021

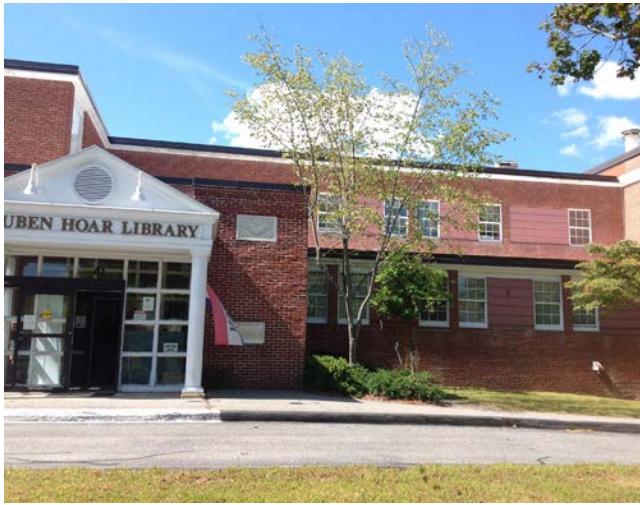
View of front entrance to library. Sidewalk slope may pose an accessibility issue. (Library Wing - Shattuck Street Side)

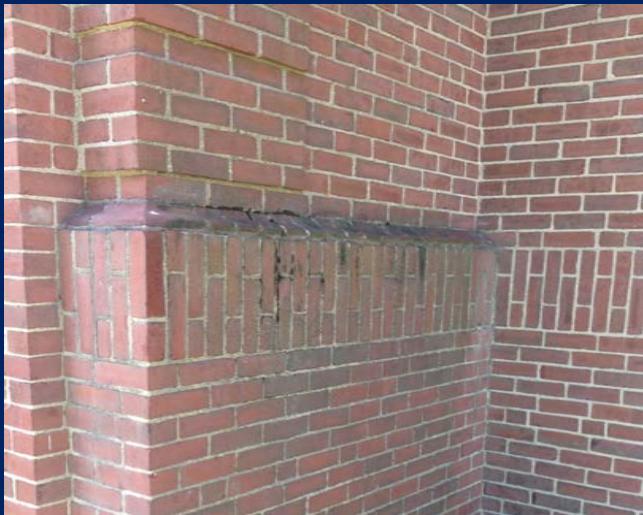
Evidence of staining/soiling, most likely from water damage. (Library Wing - Shattuck Street Side)

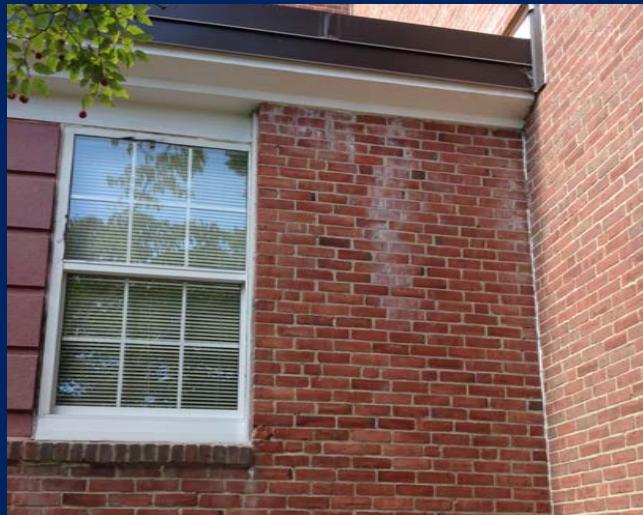
Evidence of efflorescence near window opening. (Library Wing - Shattuck Street Side)

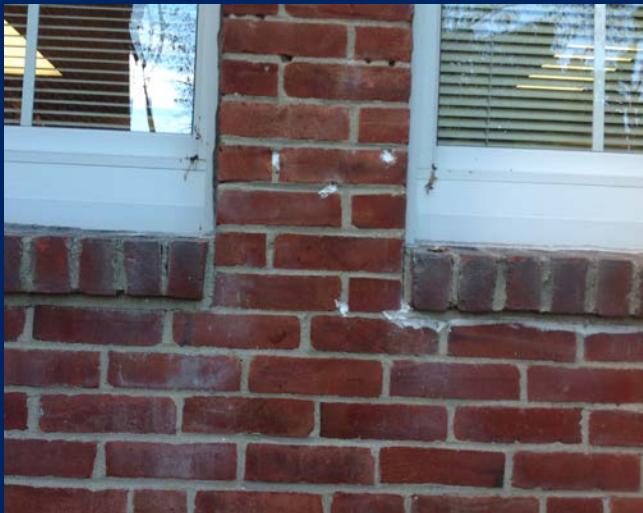
Evidence of staining/soiling at window sills. (Library Wing - Shattuck Street Side)

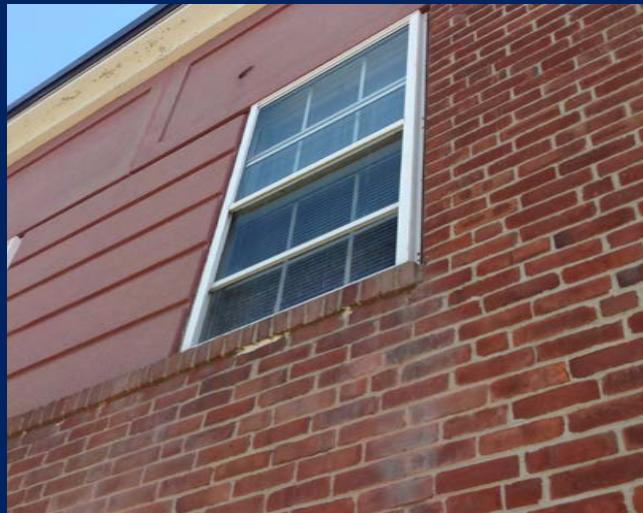
Evidence of staining/soiling at window sills; typical at all window openings on all buildings. (Library Wing - Parking Lot Side)

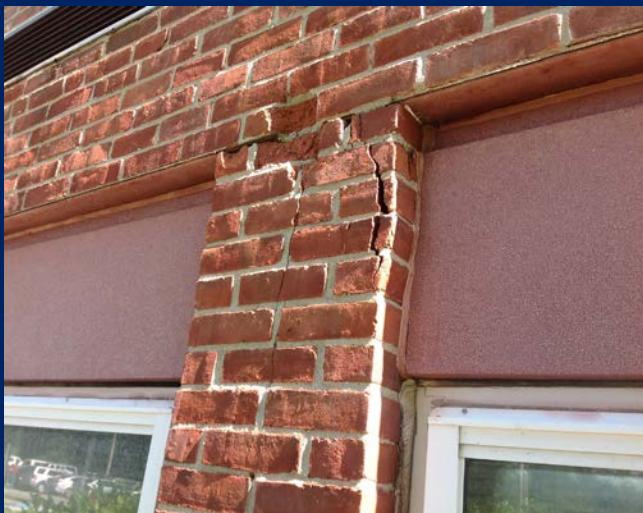
Evidence of brick spalling, most likely from uneven compression and/or water damage. (Library Wing - Parking Lot Side)

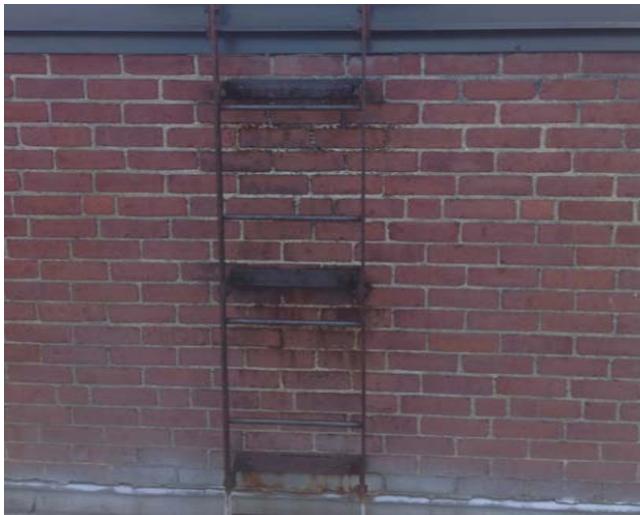
Visible rust and water damage behind access ladder on roof. (Multi-Use Wing to Classroom Wing)

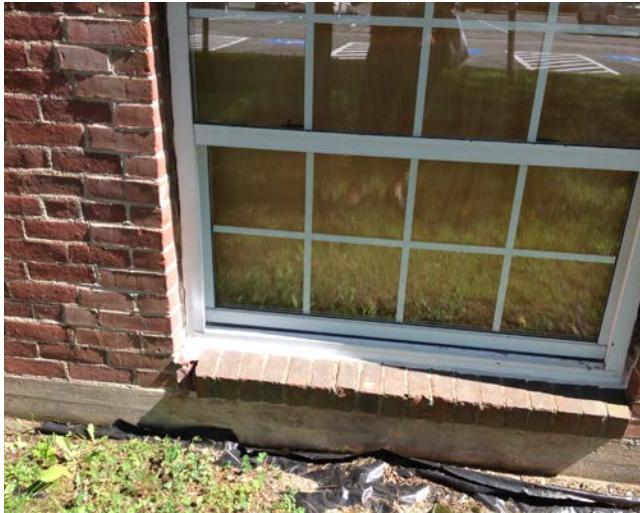
Evidence of brick delaminating and eroding mortar at window sill. (Classroom Wing - Parking Lot Side)

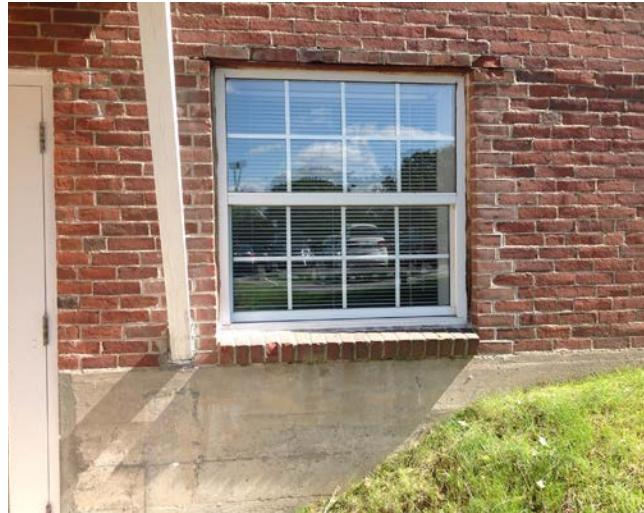
Evidence of brick delaminating and eroding mortar at window opening. (Classroom Wing - Parking Lot Side)

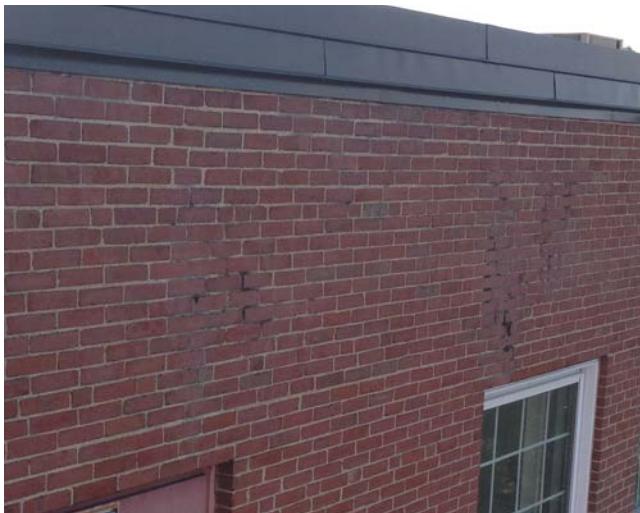
Evidence of staining/soiling on third floor, most likely from water damage. (Classroom Wing - Parking Lot Side)

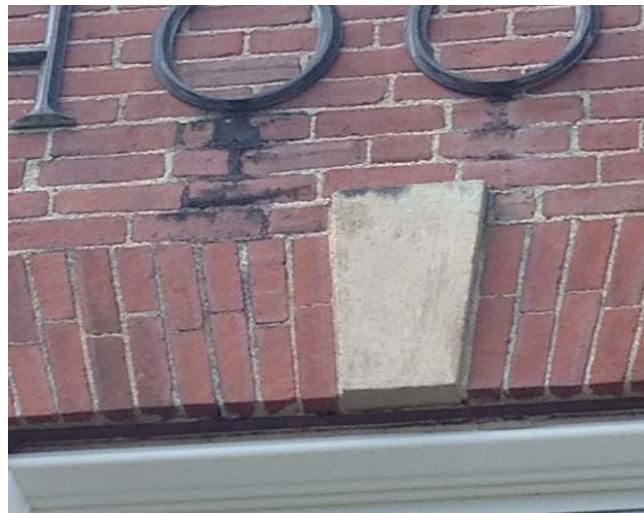
Evidence of staining/soiling, most likely from water damage. (Multi-Use Wing - Shattuck Street Side)

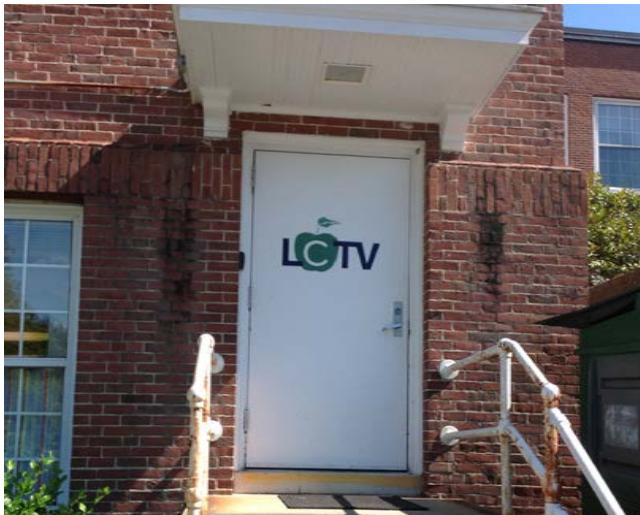
Evidence of staining/soiling on either side of door. (Multi-Use Wing - Parking Lot Side)

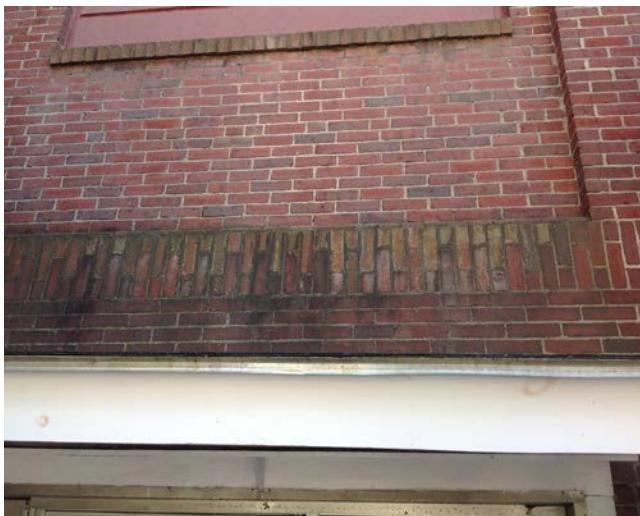
Evidence of staining/soiling, most likely from water damage. (Multi-Use Wing - Parking Lot Side)

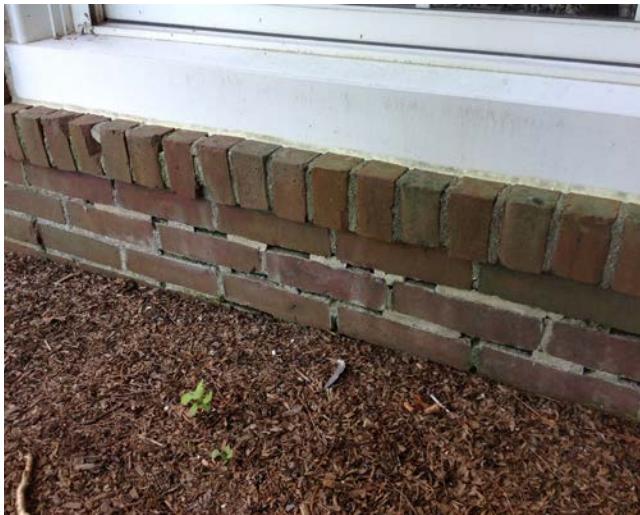
Evidence of staining/soiling and mortar erosion at window sill, most likely from water damage. (Office Wing - Parking Lot Side)

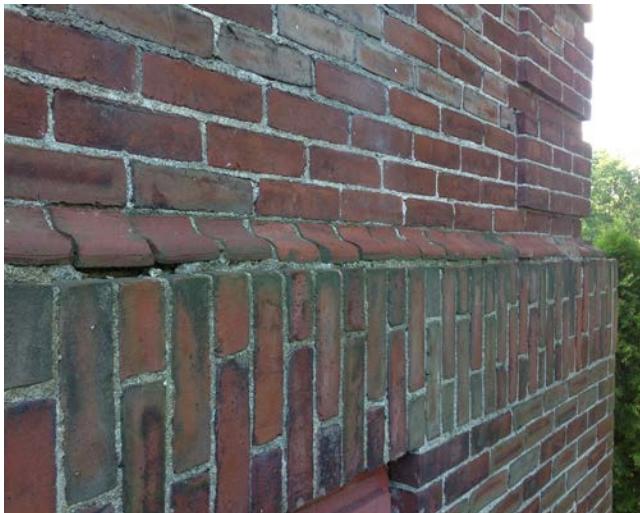
Evidence of staining/soiling, most likely from water damage. (Office Wing - Tennis Court Side)

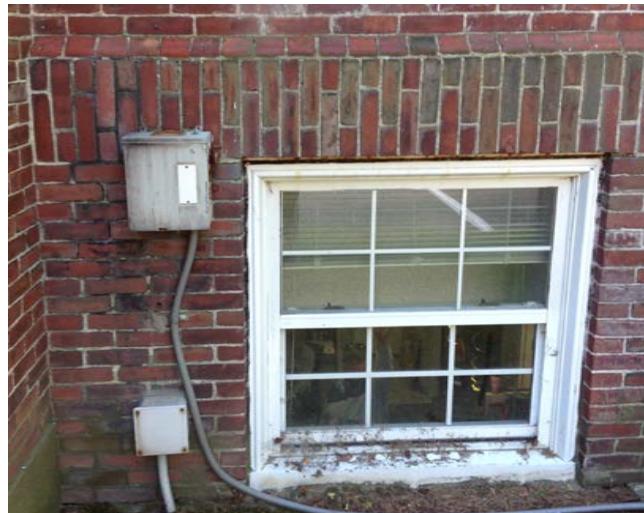
Evidence of staining/soiling near window opening. (Office Wing - Tennis Court Side)

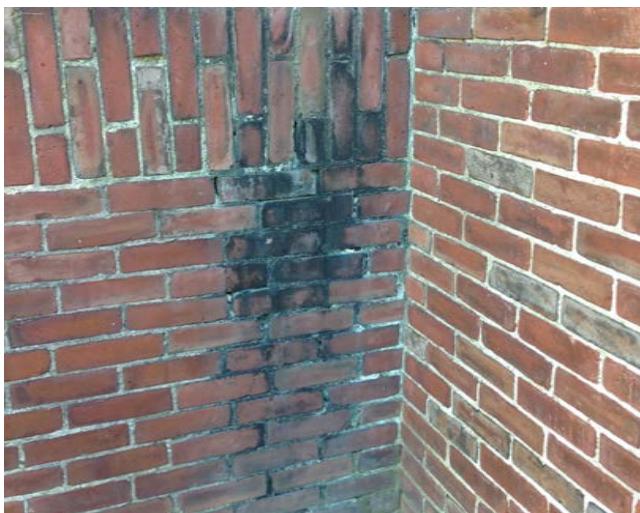
Evidence of staining/soiling, most likely from water damage or fire. (Office Wing - Tennis Court Side)

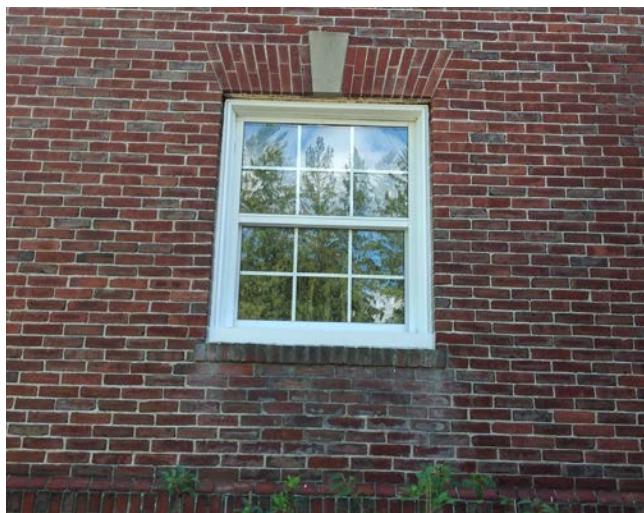
Evidence of staining/soiling at window sill. (Office Wing - Tennis Court Side)

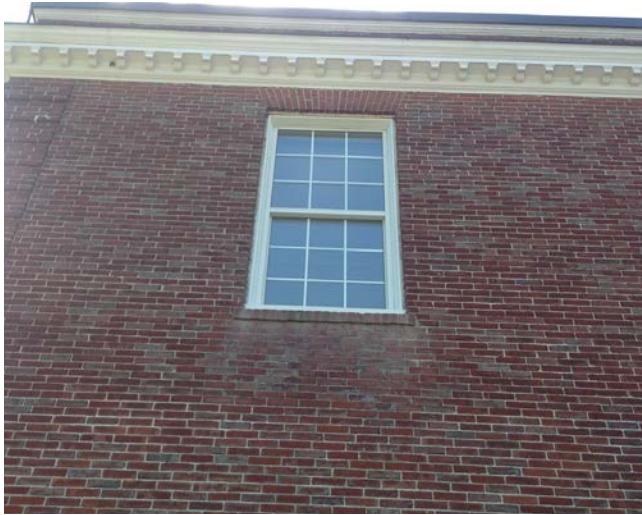
Evidence of staining/soiling at window sill.
(Office Wing - Tennis Court Side)

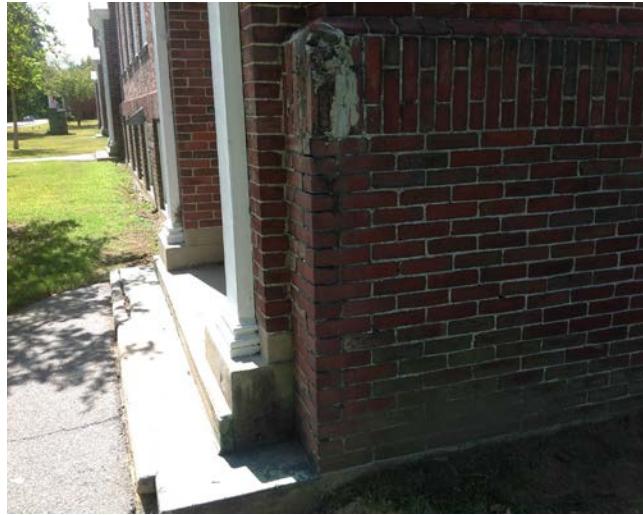
Evidence of attempted patch of corner with mortar and areas of missing mortar. (Office Wing - Shattuck Street Side)

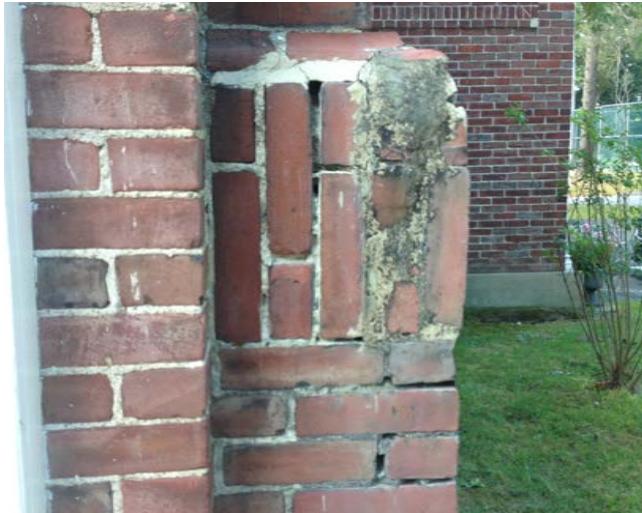
Evidence of attempted patch of corner with mortar and areas of missing mortar. (Office Wing - Shattuck Street Side)

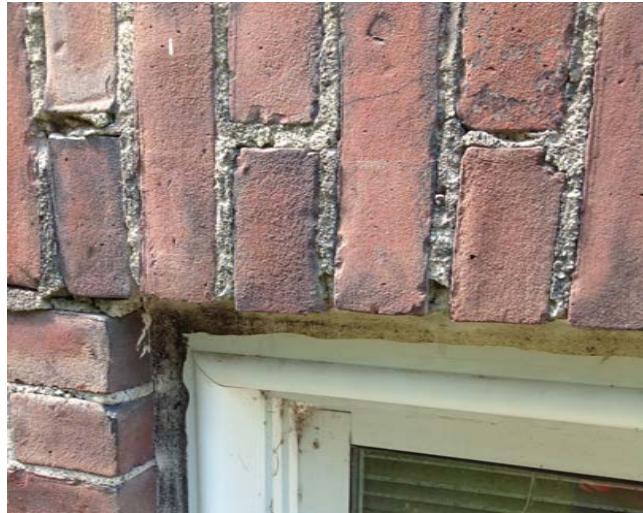
Evidence of eroded mortar joint near window opening. (Office Wing - Shattuck Street Side)

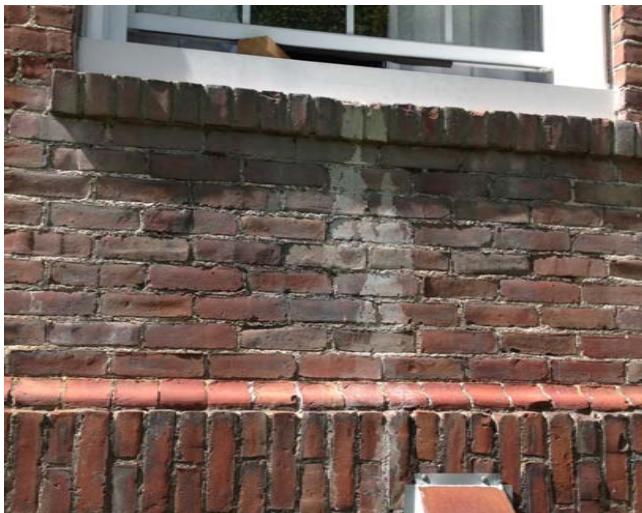
Evidence of efflorescence near window opening.
(Office Wing - Shattuck Street Side)

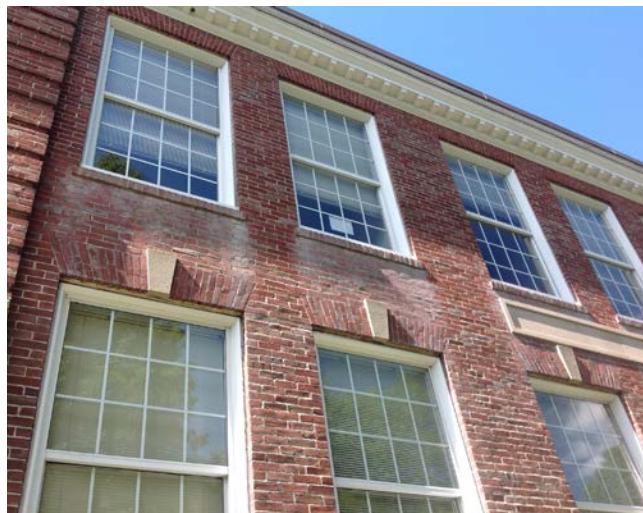
Evidence of staining/soiling at window sills.
(Office Wing - Shattuck Street Side)

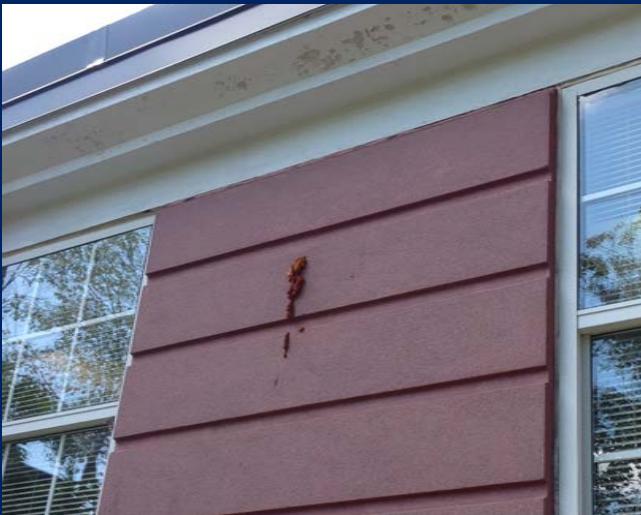
Damage from nesting birds that has been reactively filled with spray foam that does not match finish of Dryvit. (Library Wing - Shattuck Street Side)

There are penetrations due to nesting birds and other failures which have been filled with non-matching expanding foam. Patch with material to match existing surrounding and refinish all.

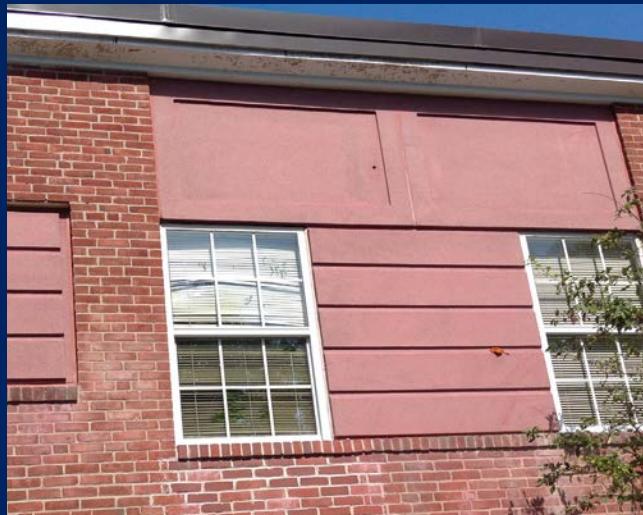
Damage from nesting birds that has been reactively filled with spray foam that does not match finish of Dryvit. (Library Wing - Parking Lot Side)

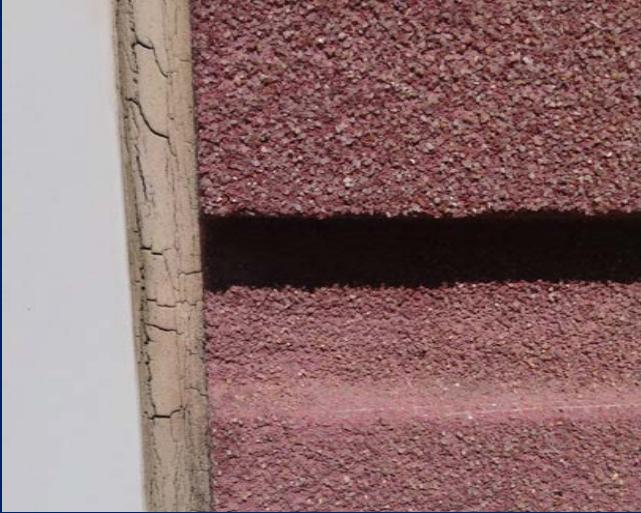
Evidence of eroding sealant between EIFS and window. (Library Wing - Parking Lot Side)

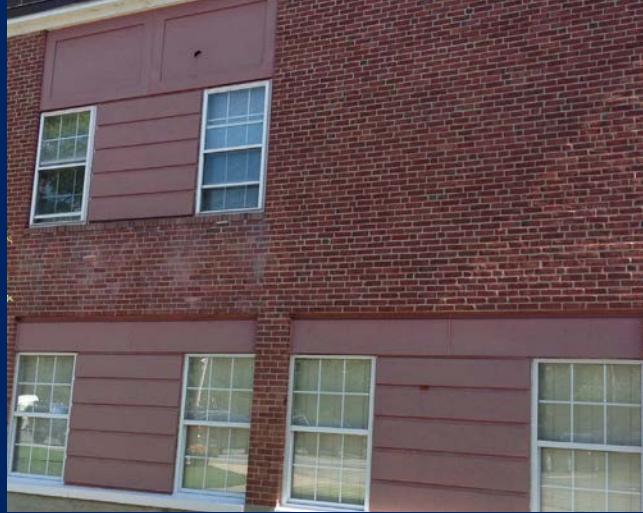
Evidence of mold/fungi growth on EIFS on ground level and damage on second floor. (Library Wing - Parking Lot Side)

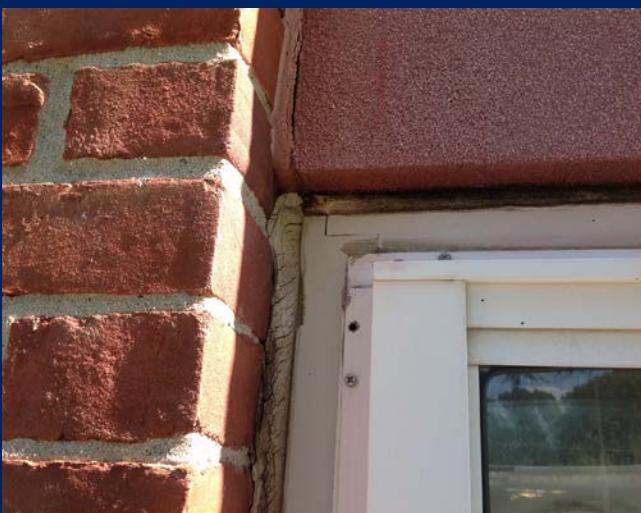
Evidence of cracked sealant between EIFS, masonry, and window. (Library Wing - Parking Lot Side)

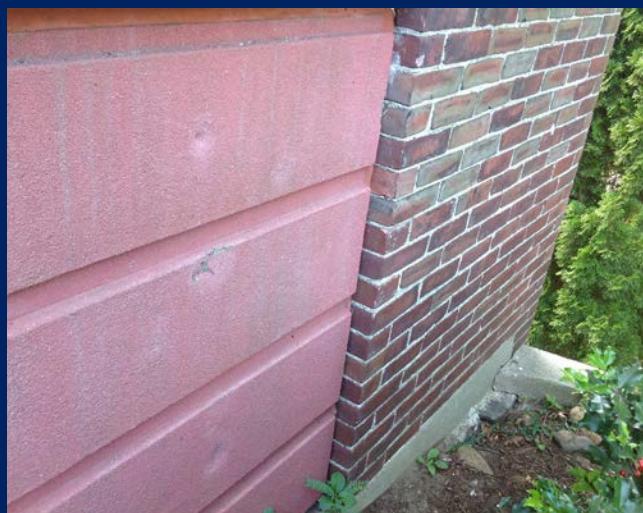
Evidence of damage to EIFS. (Multi-Use Wing - Parking Lot Side)

Maintain/ repair as required.

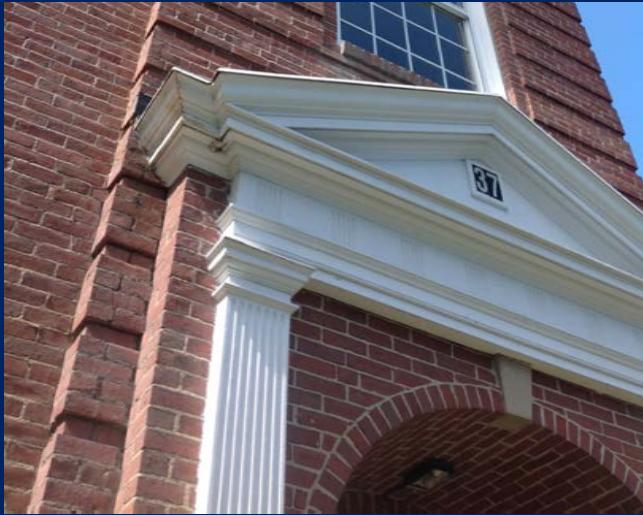
Observed vertical wall trim board. (Classroom Wing - Shattuck Street Side)

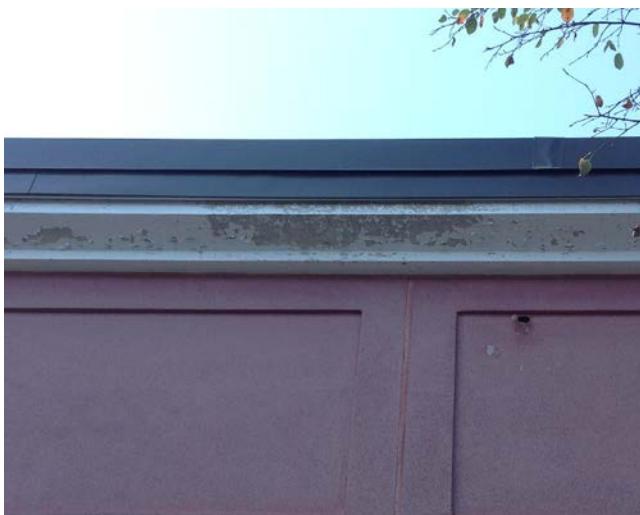
Observed peeled paint on trim board.
(Library Wing - Shattuck Street Side)

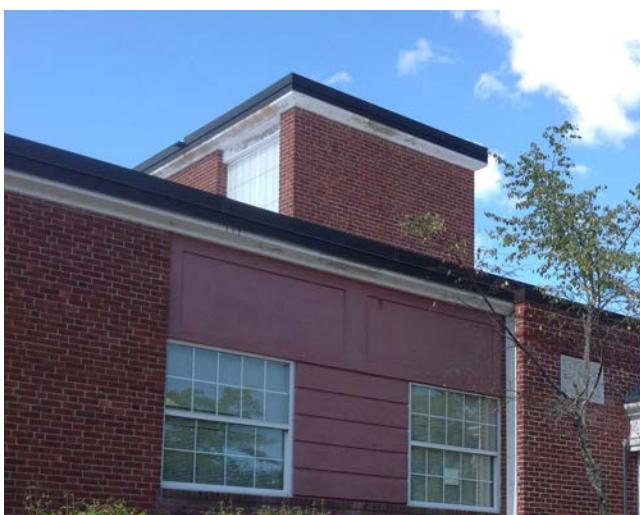
Observed peeled paint on trim board.
(Library Wing - Shattuck Street Side)

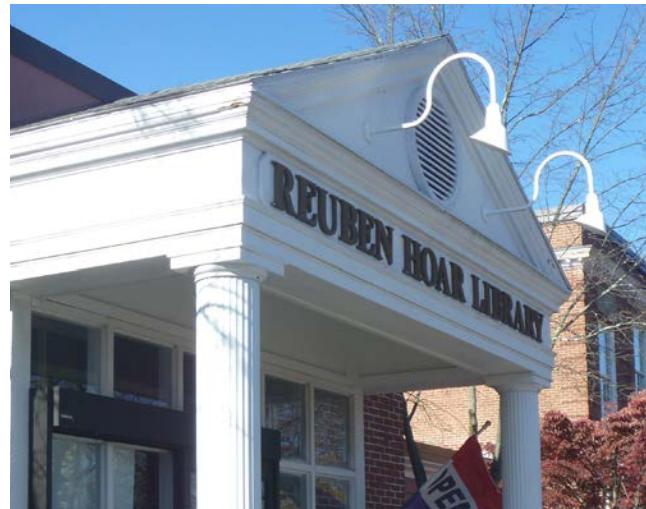
Evidence of damage to trim, most likely from an animal. (Library Wing - Shattuck Street Side)

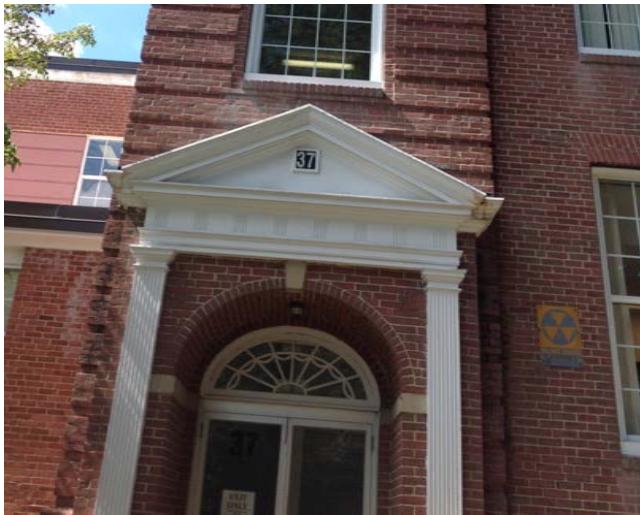
Evidence of water damage on pediment trim.
(Classroom Wing - Shattuck Street Side)

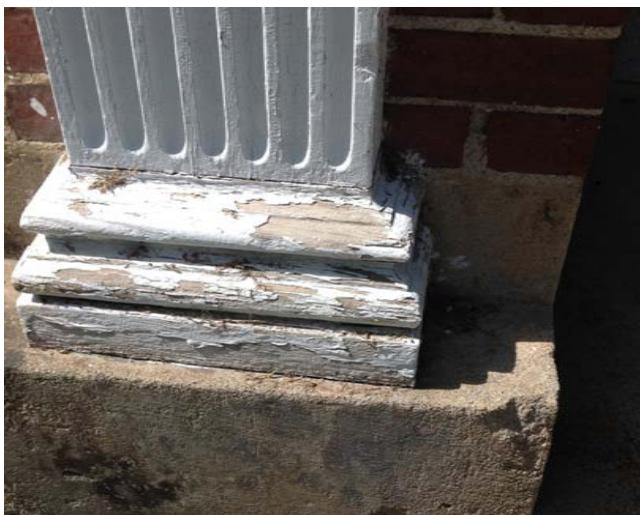
Observed peeled paint on trim board.
(Library Wing - Shattuck Street Side)

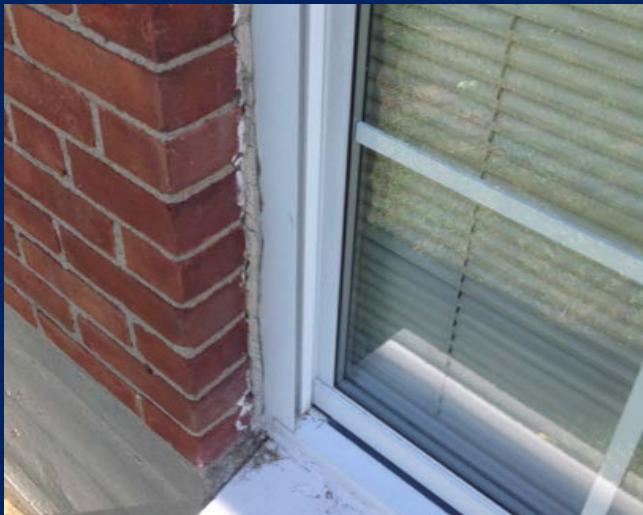
Evidence of cracked caulking at window opening.
(Library Wing - Parking Lot Side)

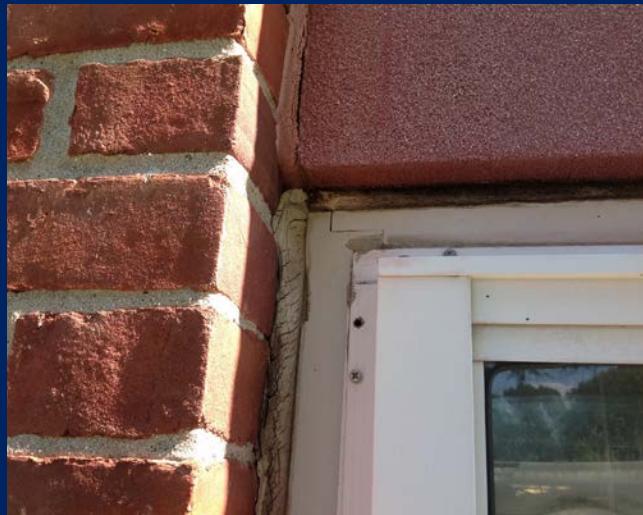
Evidence of cracked caulking at window opening.
(Library Wing - Parking Lot Side)

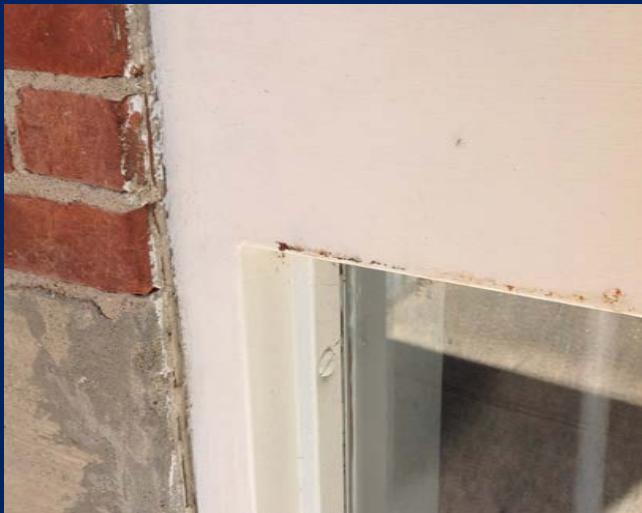
Evidence of minor rust and chipped paint on window frame.
(Classroom Wing - Parking Lot Side)

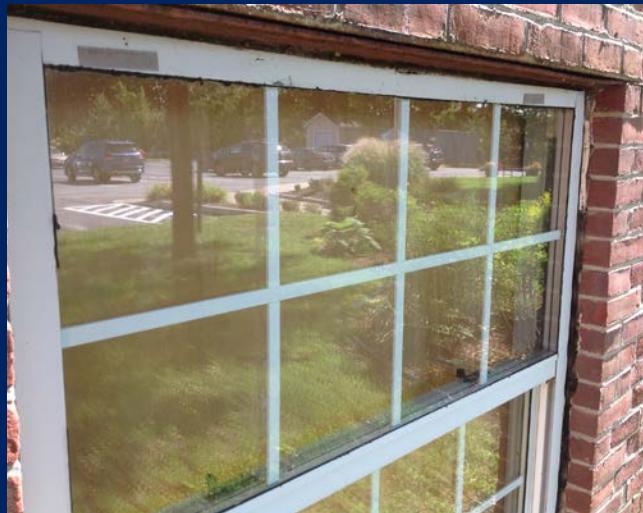
Evidence of cracked caulking and discoloration at window opening.
(Classroom Wing - Parking Lot Side)

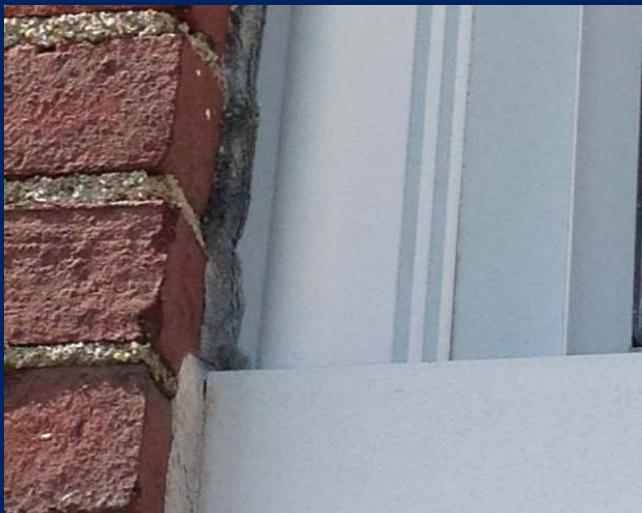
Evidence of cracked caulking and discoloration at window opening.
(Multi-Use Wing - Parking Lot Side)

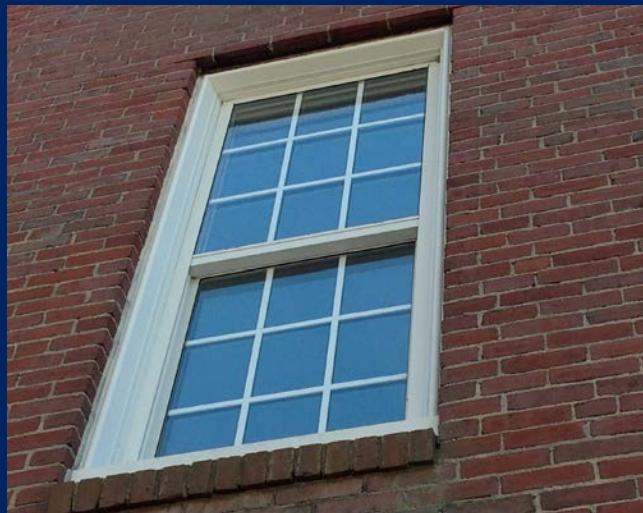
Typical condition of aluminium windows.
(Multi-Use Wing - Parking Lot Side)

Windows units are typically difficult and dangerous to operate. There is also evidence of cracked caulking, rust, and other discoloration at the window openings. It is recommended to remove existing windows and replace with a more efficient option, reflash, and reseal.

Replace

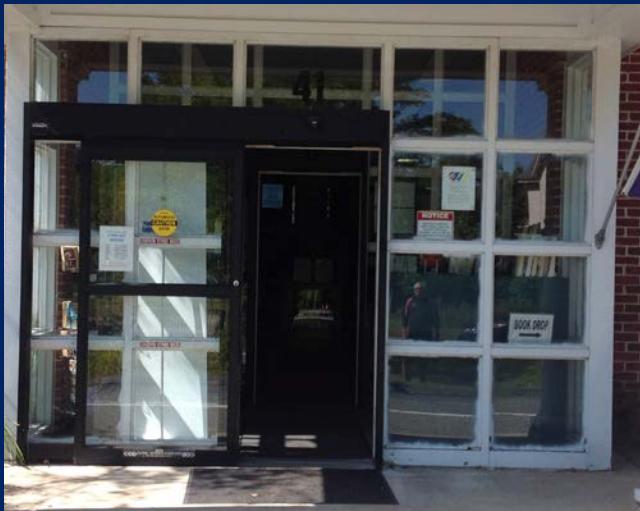
Evidence of damaged & deteriorated paint finish, and rotting (loss) of core material. (Library Wing - Shattuck Street Side)

It is recommended that most doors be replaced.

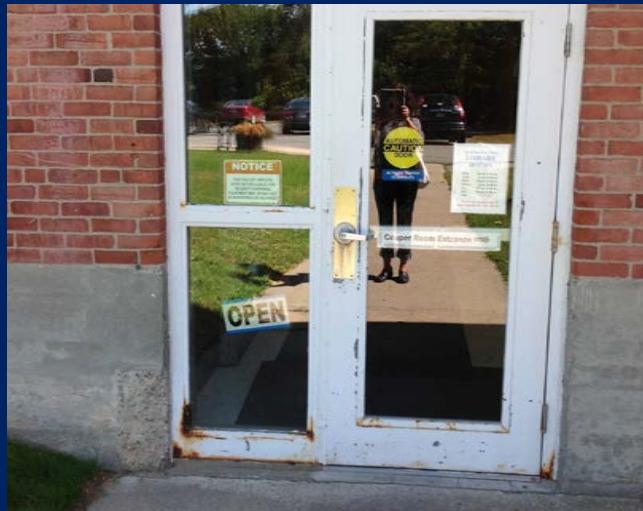
Evidence of damaged & deteriorated paint finish, and rotting (loss) of core material. (Library Wing - Parking Lot Side)

0-2 years. Many exterior doors are in poor condition and at the end of their useful life. Others require maintenance for continued use.

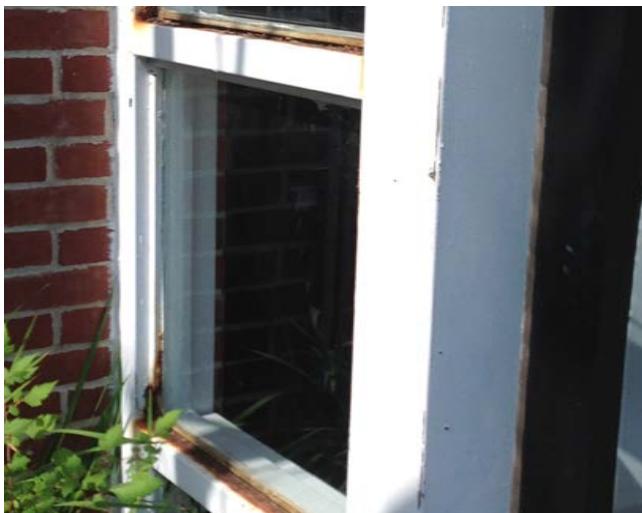
Overall view of aluminum and glass door at library main entrance. (Library Wing - Shattuck Street Side)

1952 Library: The automatic sliding entrance/egress door system with accessible push-button appears to be newer than the storefront system and to operate adequately. The bottom rail is not ADA compliant. This door is not expected to require replacement in 10+ years, however the storefront it is set in will require work before that time. The exiting steel storefront system is visibly rusting to the point of significant deterioration. This is recommended for replacement in the next two years. Two steel exterior doors and frames, one with a full with wit side lite are recommended for replacement as described in typical conditions.

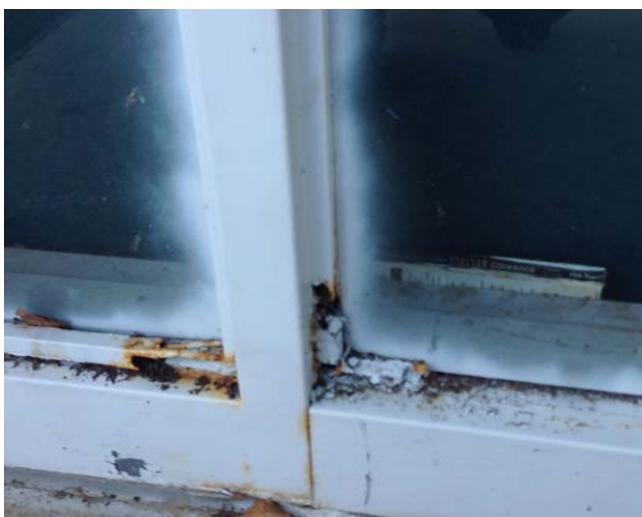
Close-up at of aluminum sidelight sill at library main entrance. (Library Wing - Shattuck Street Side)

All exterior steel doors, side lites, and storefront systems are visibly rusting. Steel frames are especially bad. It is recommended that these be removed and replaced with new ADA compliant storefront door systems including frame, leaf, threshold, and hardware; reflash and reseal in the next two years.. The +/- 30" width and base rail of all pairs of aluminum doors with full glass lites are not ADA compliant. Their operation is adequate; however, the doors appear aged and to provide poor thermal performance. It is recommended that these be removed and replace with single, thermally broken, ADA compliant storefront door system with full lite and sidelight including frame, leaf, threshold, and hardware; in the next two years.

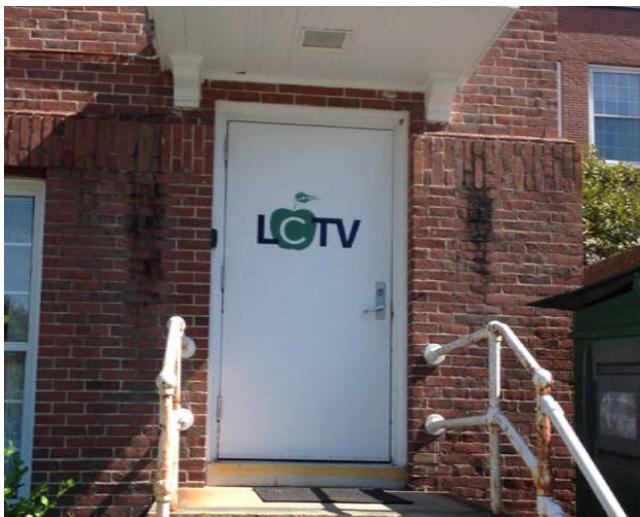
1938 Classroom Wing & 1938 Multi-Use: Two pair of aluminum doors and three sets of single steel exterior doors and frames(one with sidelight) are recommended for replacement as described in typical conditions.

Exterior doors on the west facade showing signs of rust on the sills. (Multi-Use Wing - Parking Lot Side)

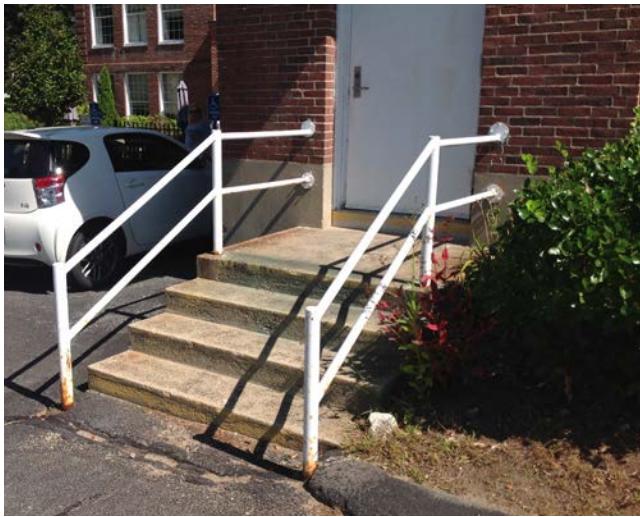
Exterior doors on the west facade showing signs of rust. (Multi-Use Wing - Parking Lot Side)

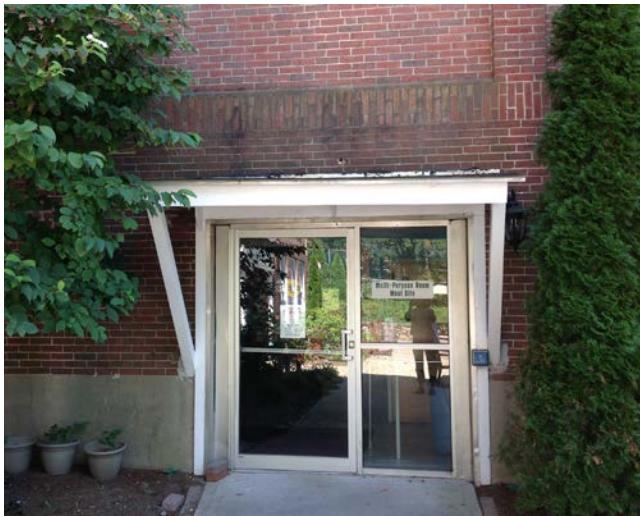
Evidence of damaged exterior door framing. (Multi-Use Wing - Parking Lot Side)

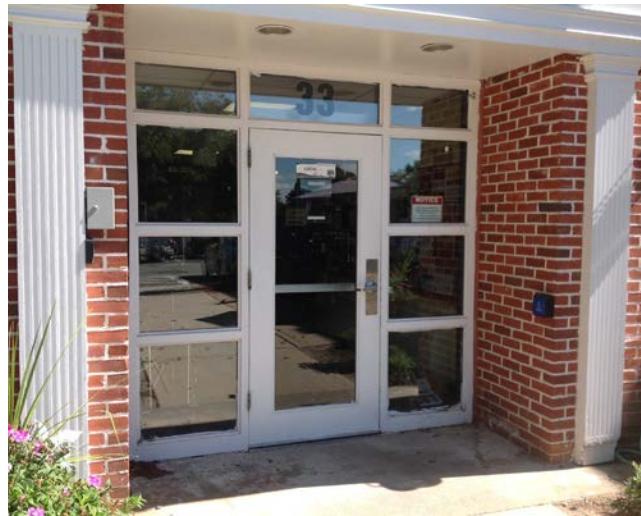
Evidence of damaged & deteriorated paint finish, and rotting (loss) of core material. (Office Wing - Parking Lot Side)

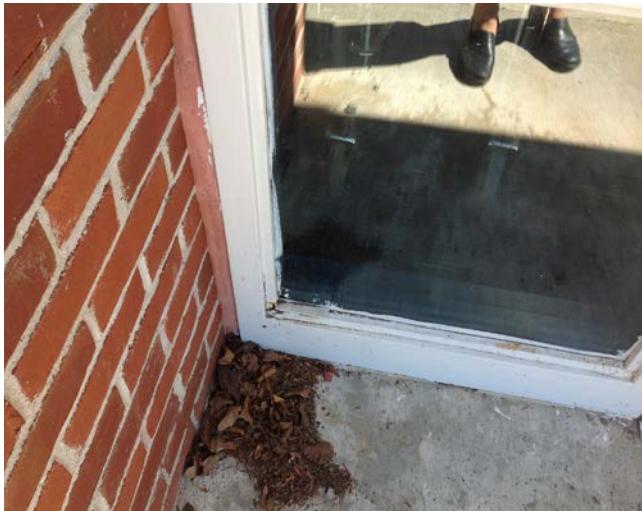
Evidence of damaged & deteriorated paint finish, and rotting (loss) of core material. (Office Wing - Parking Lot Side)

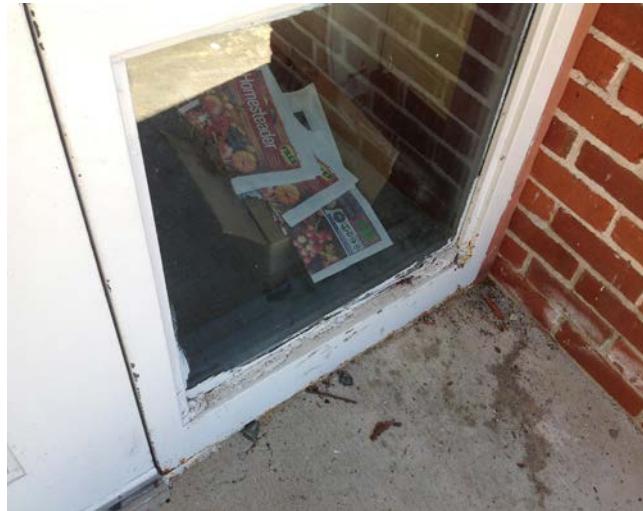
Evidence of damaged & deteriorated paint finish, and rotting (loss) of core material. (Office Wing - Parking Lot Side)

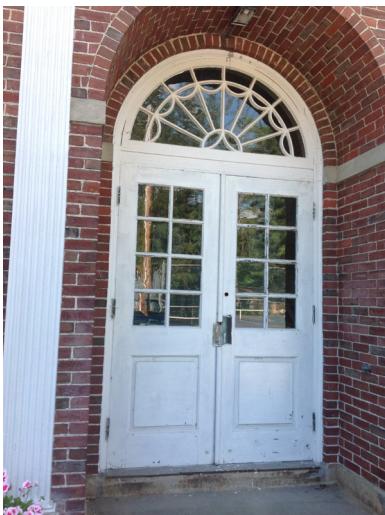
Evidence of damaged & deteriorated paint finish. (Office Wing - Tennis Court Side)

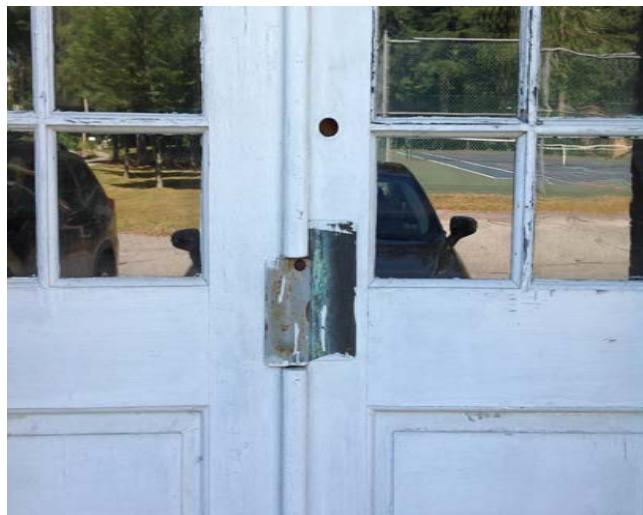
Evidence of damaged & deteriorated paint finish. (Office Wing - Tennis Court Side)

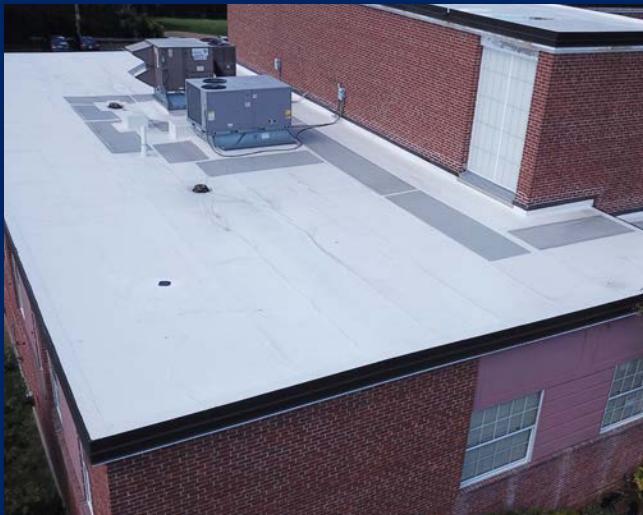
Evidence of rippling at roof membrane seams which could be indicative of water leakage. (Library Wing - Roof 1)

Both the upper and lower roofs appear to be new and in good condition with the exception of some blackened areas indicating pooling water with decomposing organic matter and some wrinkles/ loose membrane material which in some cases traps water. Remove membrane and replace any damaged insulation, substrates, flashing, copings, and system components. Replace with new TPO (white) roofing before end of warranty period/ useful life.

Report and address failures as required to maintain warranty/ Replace prior to warranty expiration.

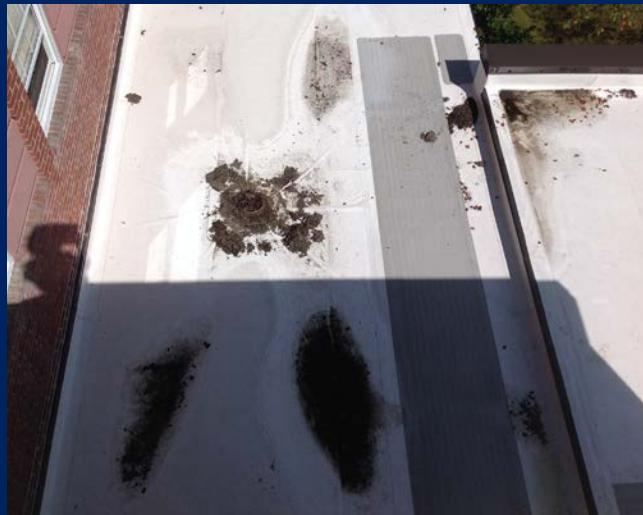
Evidence of ponding of water and debris near roof drain. (Library Wing - Roofs 3 & 4)

Two internal roof drains are present on the upper low slope roof and four are present at the lower low slope roof. The slope to the drains appears to be adequate. Discoloration at all drains suggest organic matter periodically collects and needs be cleared from drains. An extreme amount of decomposing organic matter was seen at the front lower roof due to the proximity of a large tree. (This drain may be in the process of being cleaned out.) The NRCA Roofing Manual: Membrane Roofing Systems states: "The criterion for judging proper slope for drainage is that there be no ponding water on the roof 48 hours after a rain during conditions conductive to drying." Continue to maintain drains by periodically removing organic matter.

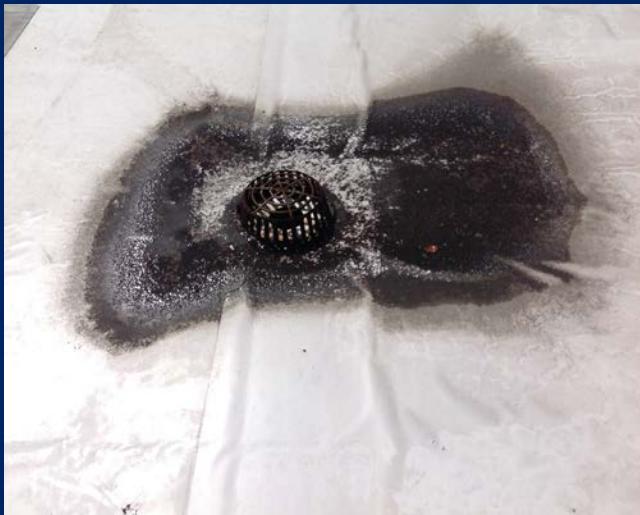
Evidence of ponding of water and debris near roof drain. (Library Wing - Roof 2)

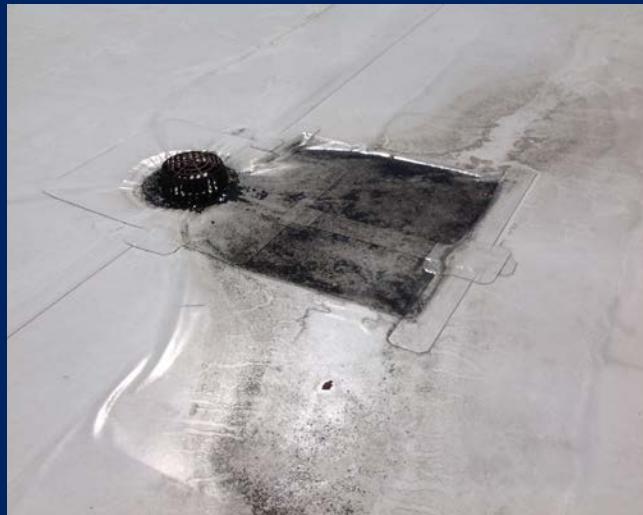
Evidence of ponding of water and debris near roof drain. (Library Wing - Roof 2)

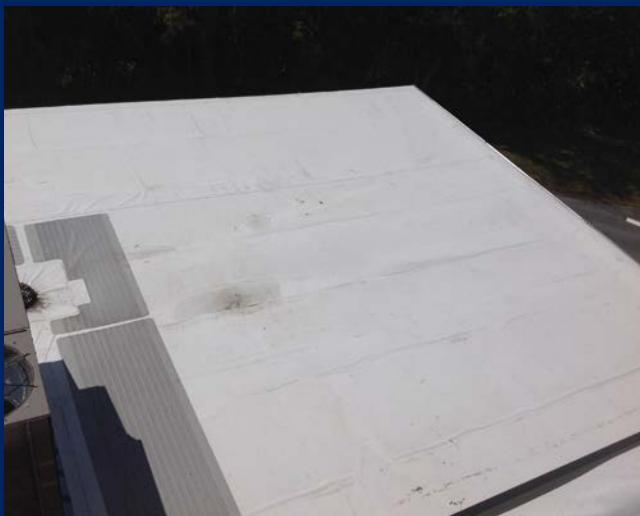
Evidence of rippling at roof membrane seams which could be indicative of water leakage. (Library Wing - Roof 2)

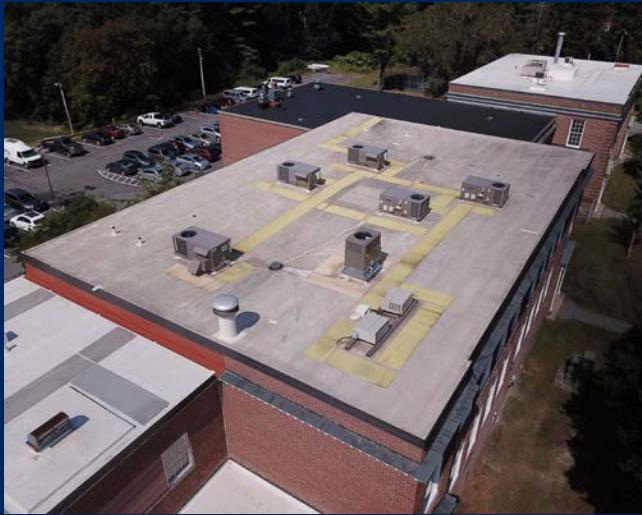
Overall discoloration of roof. (Classroom Wing - Roof 5)

The System is not reported to leak but has isolated deficiencies. Walk pads are in place. Roof discoloration, wrinkled membrane, and multiple patches, and loose perimeter flashing make it appear older than install date would suggest. 8 RTUs and multiple penetrations are present. Remove membrane and replace any damaged insulation, substrates, flashing, copings, and system components. Replace with new TPO (white) roofing before end of warranty period/useful life.

Report and address failures as required to maintain warranty/ Replace prior to warranty expiration.

0-2 years. Roof integrity is of primary importance to protect property from costly damage.

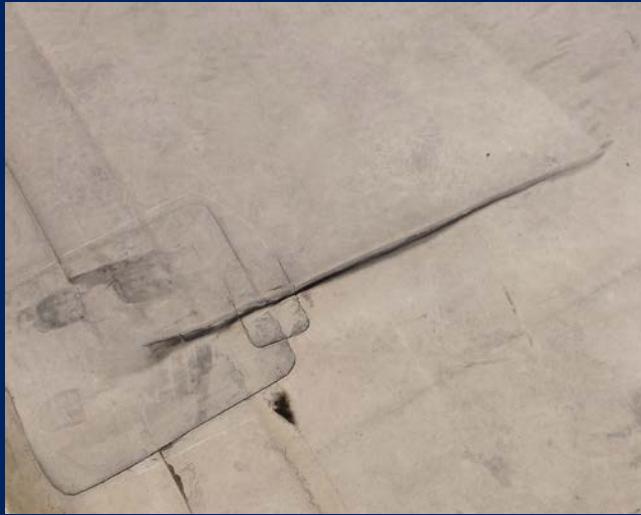
Wrinkled membrane poses a tripping hazard. (Classroom Wing - Roof 5)

Roof membrane and perimeter flashing/ coping is loose/failing in many locations. Some wrinkles in field membrane indicate it may not be well adhered. They appear to show signs of "pulling back" and shrinking. No reported or observed leaks; however, leaks could result if this issue persists. Inform Seaman Corp. of any roof system leaks within 30 days. Inspect entire perimeter to further assess condition, Repair/replace membrane and coping flashing as required.
