Littleton Town Hall Building & Space Needs Assessment

Volume II: Shattuck Street Municipal Complex, Existing Conditions Report

Littleton Town Hall Complex
37 Shattuck Street
Littleton, MA 01609

March 2021

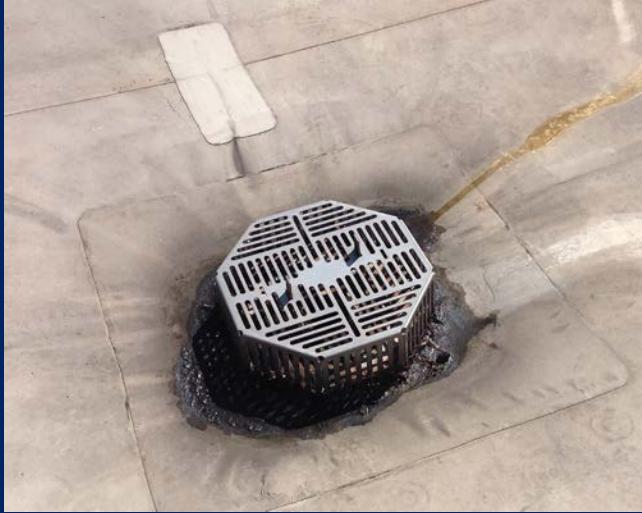
Evidence of ponding of water near roof drain. (Classroom Wing - Roof 5)

Two internal roof drains are present. The slope to drains appears to be adequate. Discoloration at drains suggest organic matter may periodically collect and will need to be cleared from drains. Two scuppers have been cut into the perimeter to direct overflow water to adjacent roofs. Continue to periodically clear drains of organic debris.

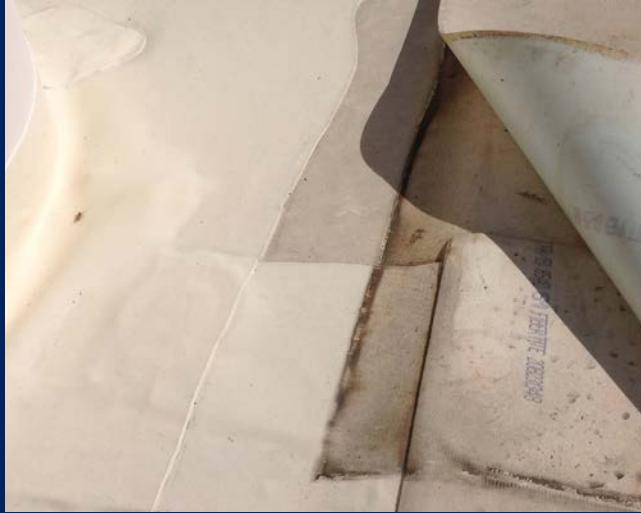
Separation of an already repaired joint (via applied darker coating) occurring in mansard wall. (Classroom Wing - Roof 5)

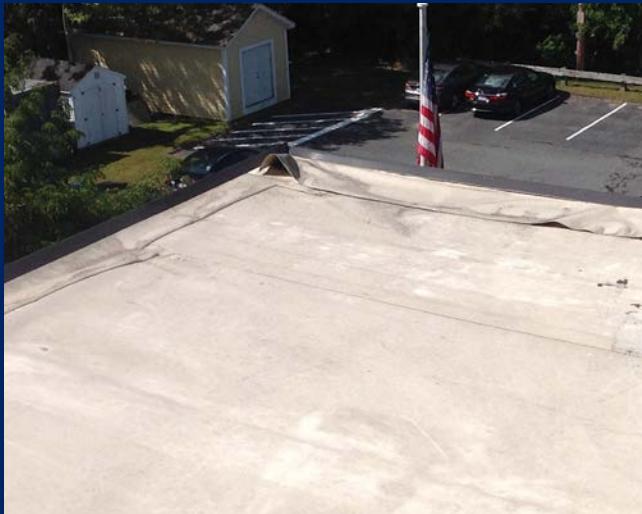
Evidence of water ponding, signs of aged flashings can be seen where membranes separate, or "pull back". (Classroom Wing- Roof 5)

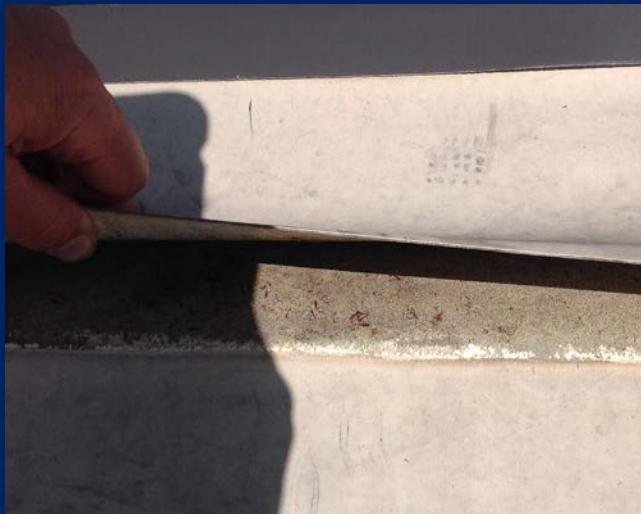
Evidence of water ponding, signs of aged flashings can be seen where membranes separate, or "pull back". (Classroom Wing - Roof 5)

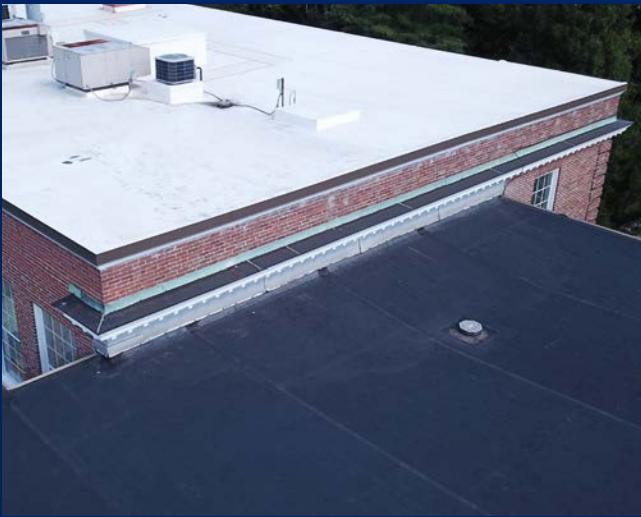
Discoloration of roof shows evidence of ponding on roofing near roof drain. (Multi-Use Wing - Roof 6)

The upper low-slope roof is a fastened, black EPDM with aluminum flashing, +/- 4300 SF. It appears sound and is assumed to be the oldest roof in the complex based on type. There are some insulation voids at drains, with minor ponding at one drain. Remove membrane and replace any damaged insulation, substrates, flashing, copings, and system components. Replace with new TPO (white) roofing before end of warranty period/useful life.

Report and address failures as required to maintain warranty/ Replace prior to warranty expiration.

0-2 years. Roof appears to be past its warranty period. Roof integrity is of primary importance to protect property from costly damage.

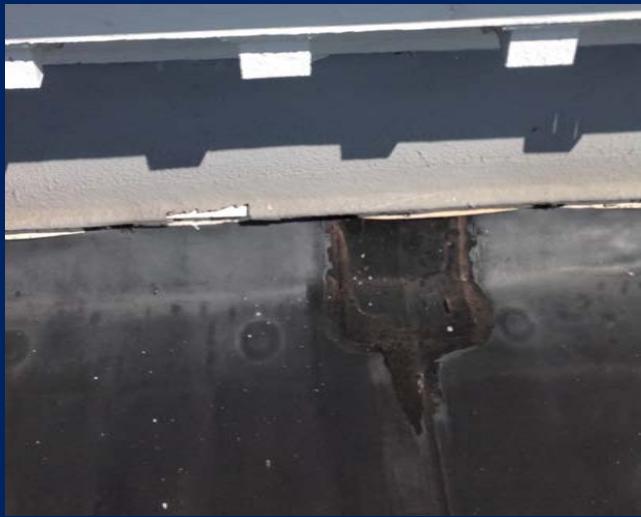
Evidence of damage to roofing where it meets the office wing. (Multi-Use Wing - Roof 6)

Coated metal, presumably copper, sidewall flashings are deteriorating. Where EPDM roof meets the 1938 Classroom Building and the 1922 Office Building. Further investigate integrity of flashings and repair/replacement options.

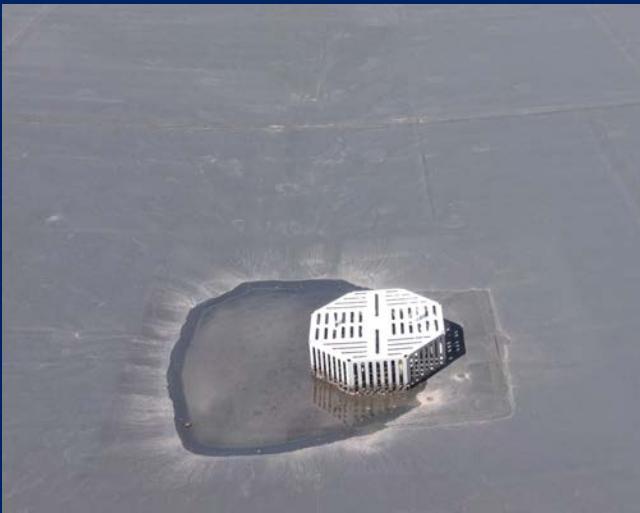
Evidence of ponding of water near roof drain. (Multi-Use Wing - Roof 6)

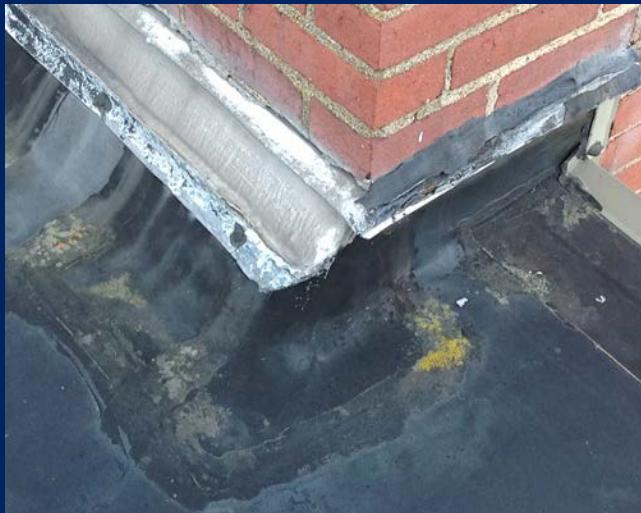
Organic growth around base flashing and gap in flashing near Classroom Wing. (Multi-Use Wing - Roof 6)

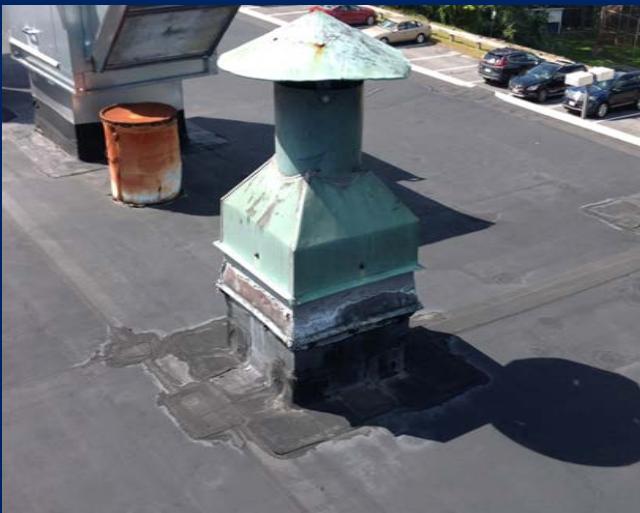
Evidence of a lot of patching previously done, making this a weak spot for water leakage in the future. (Multi-Use Wing - Roof 6)

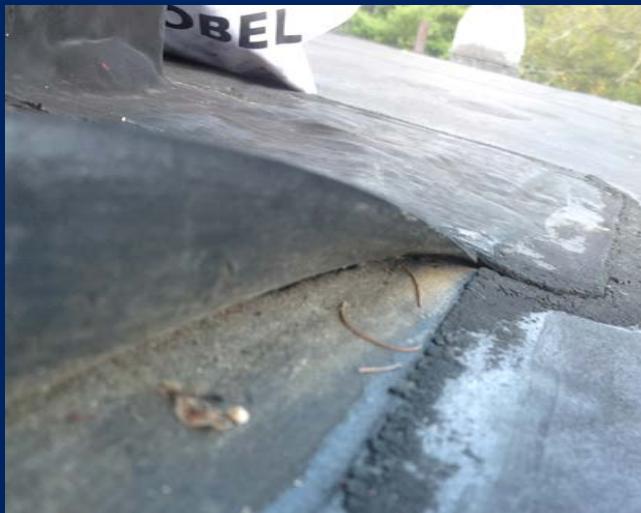
Evidence of water ponding, signs of aged flashings can be seen where membranes separate, or "pull back". (Multi-Use Wing - Roof 6)

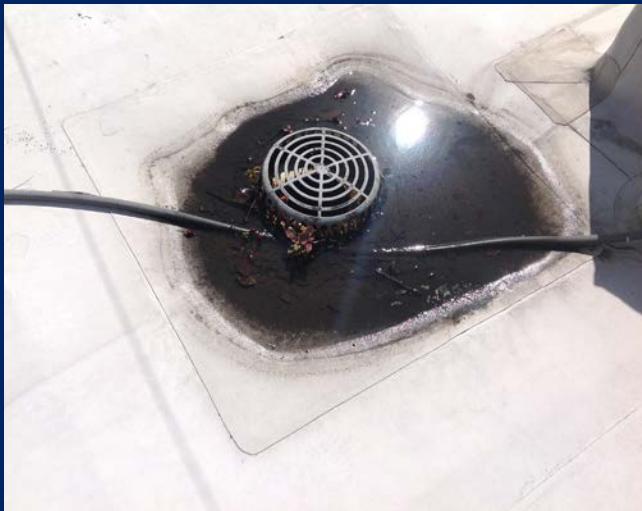
Evidence of cracked roofing membrane, due to moisture damage / ponding of water. (Office Wing - Roof 8)

The Office roof is also white TPO with aluminum copings. Membranes appear sound. There is isolated ponding water near roof drains and RTUs. Remove membrane and replace any damaged insulation, substrates, flashing, copings, and system components. Replace with new TPO (white) roofing before end of warranty period/useful life.

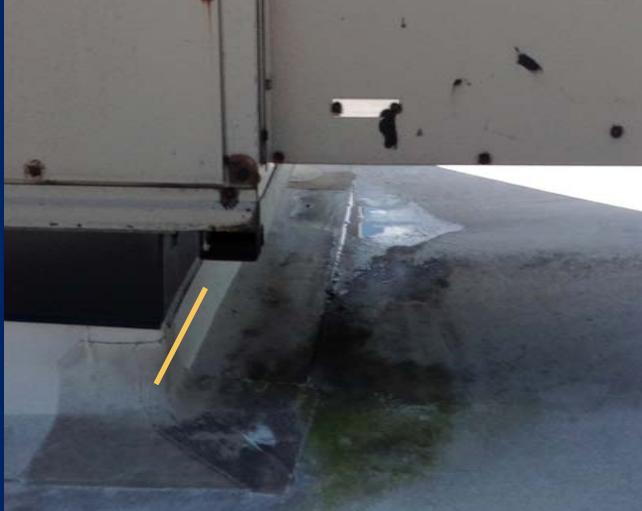
Evidence of ponding of water near mechanical unit. Gap in base flashing. (Office Wing - Roof 8)

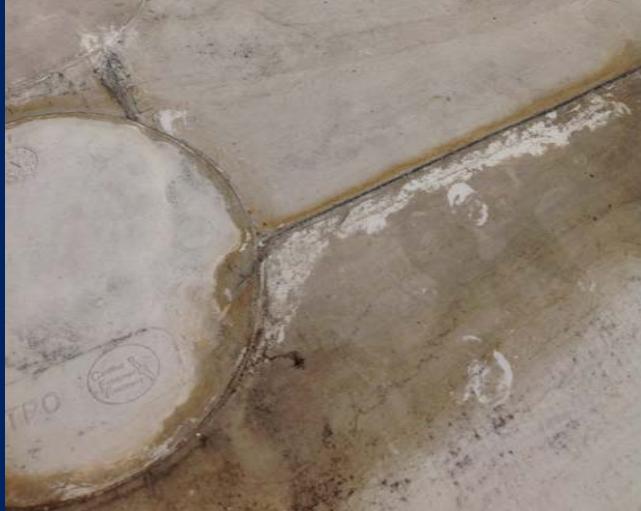
Evidence of moisture damage / ponding of water near roof seams. (Office Wing - Roof 8)

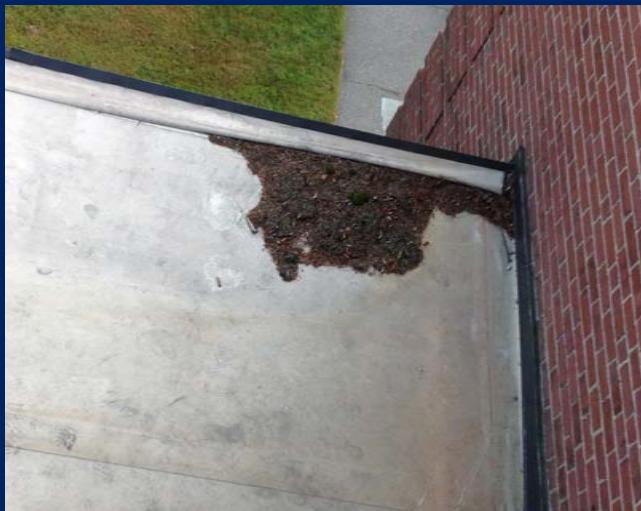
Organic growth around base flashing and gap in flashing. (Multi-Use Wing - Roof 7)

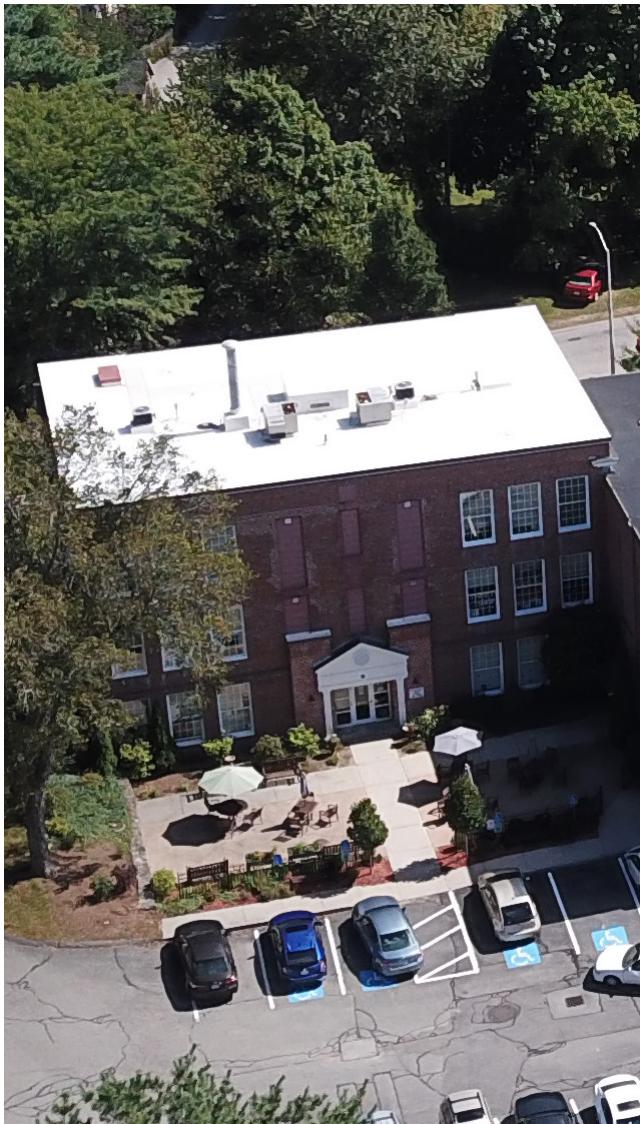
Drone view of roofs and mechanical equipment. (Office Wing - Roof 8)

Conduit/water and power lines at RTU are exposed, and in some cases, they appear rusted at roof penetrations. There are also some cracks in the conduit flashings. Multiple patches area noted on the roof; however, no leaks have been reported or observed. Further investigate safety and integrity of roof penetrations and equipment lines.

Maintain/ Replace prior to warranty expiration. Report and address failures as required to maintain warranty.

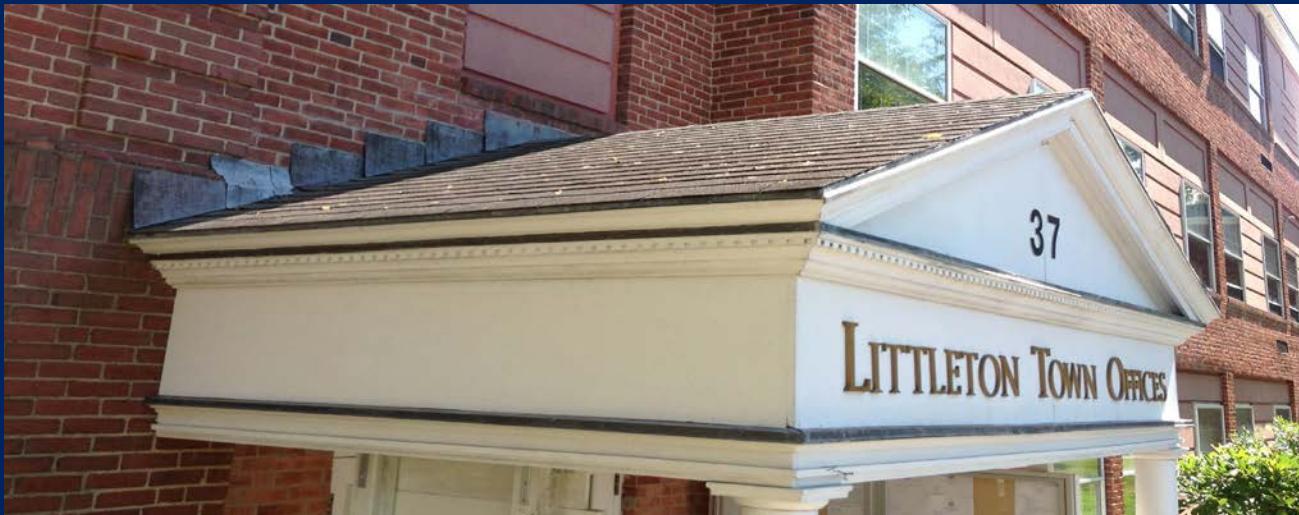
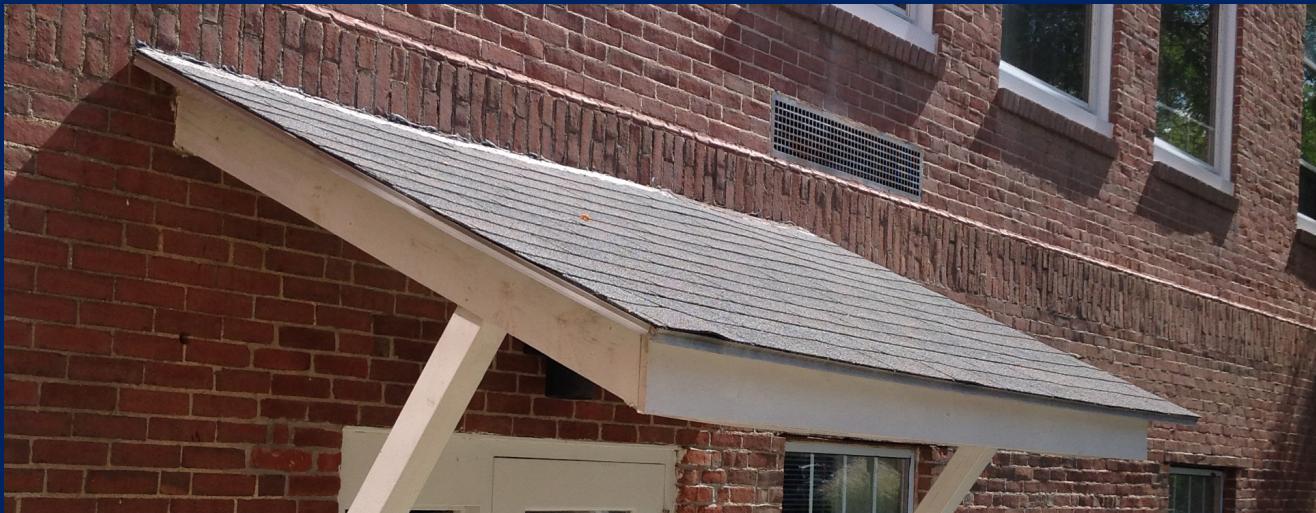
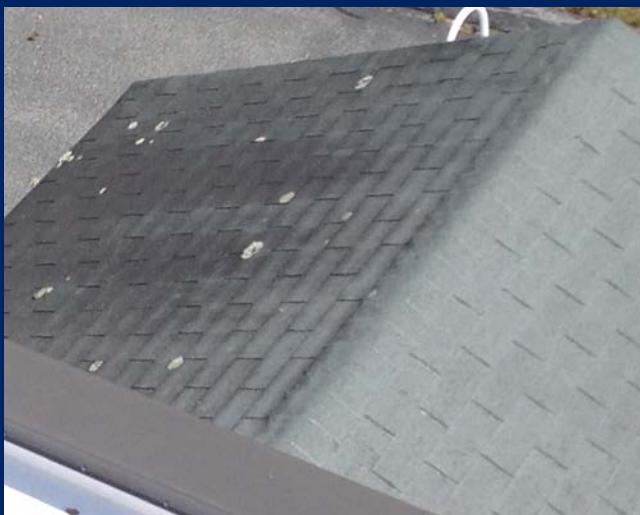
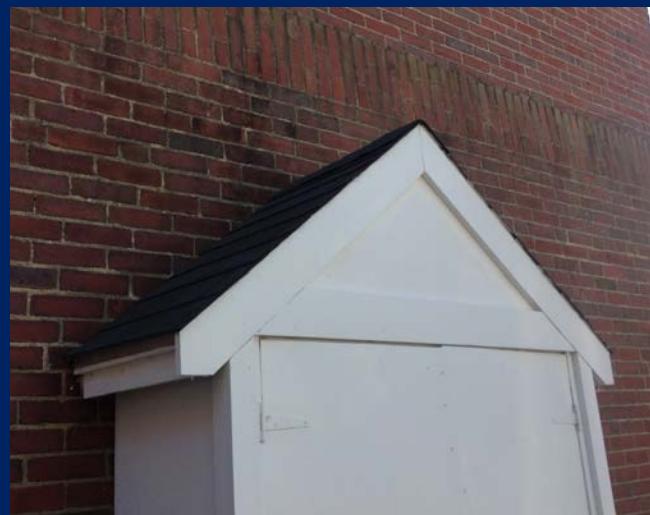
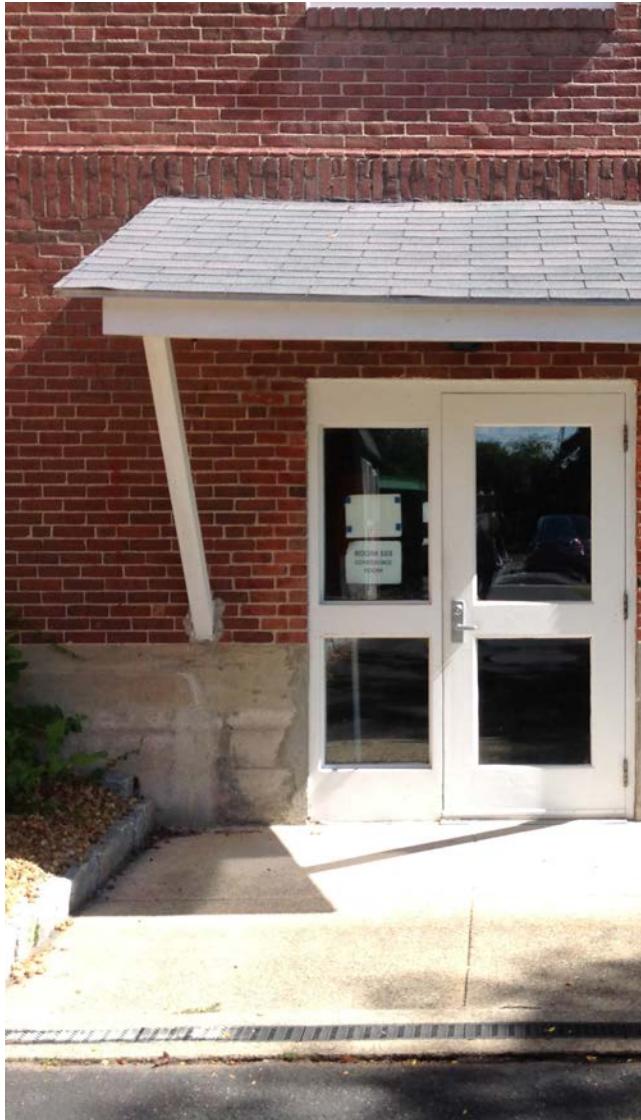
Example asphalt shingle roof. (Classroom Wing)

Typical view from upper roof looking down at the asphalt shingle roof. (Library Wing)

Example asphalt shingle roof. (Multi-Use Wing)

Asphalt shingle roofing system is reaching the end of its life expectancy; consider replacement during building renovations.

The roofs appear sound, with some lichen growth indicating age. There have been no leaks reported. Remove and replace existing asphalt roofing and under-layment and replace with new architectural asphalt roofing.

Replace

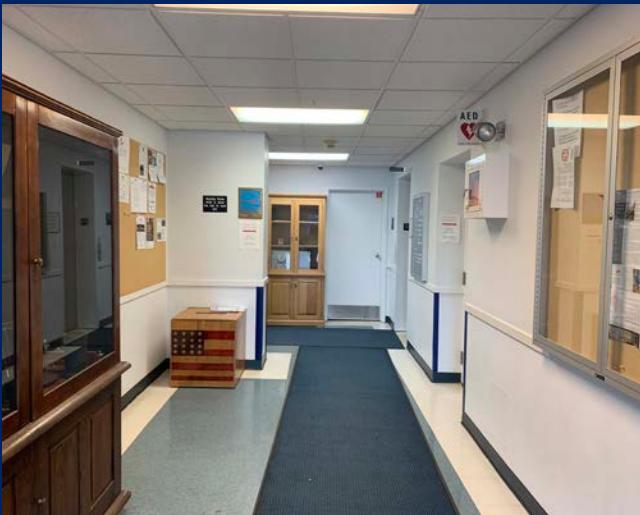
Offices are difficult to locate if you have never been to the building before. No clear way finding. (Library Wing - First Floor)

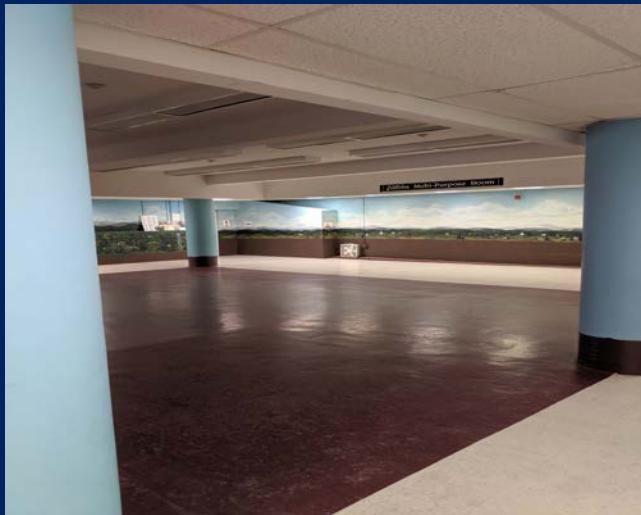
The EHS use multipurpose space has very poor acoustics, no natural light, lacks storage space, and serves as a connecting corridor between wings (Multi-Use Wing - First Floor)

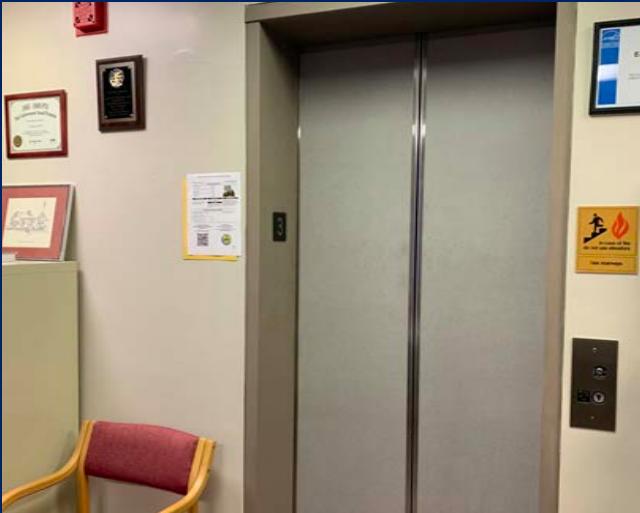
The complex generally lacks security, there are multiple entrance and no public buffer. Offices, like the school department, require card access. (Office Wing - Third Floor)

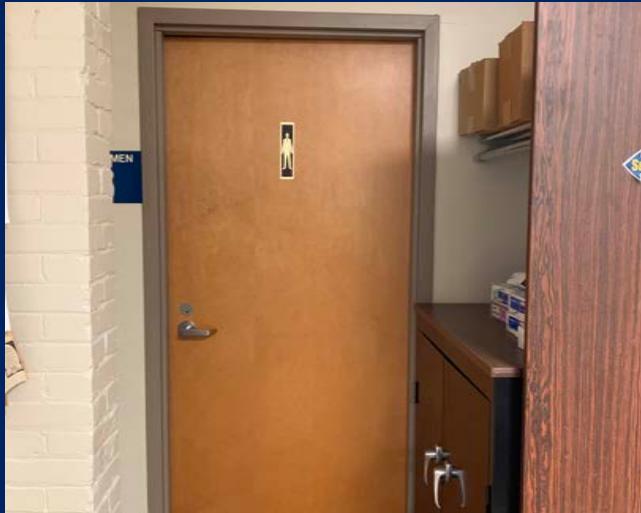
Some offices lack access to enough bathrooms for typical use. (Office Wing - Third Floor)

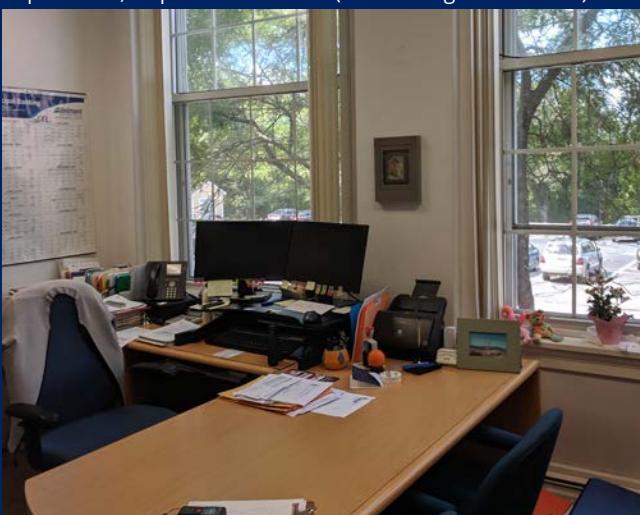
Many offices are uncomfortable cold due, this may be due to both HVAC system and large, drafty windows. (Classroom Wing - Second Floor)

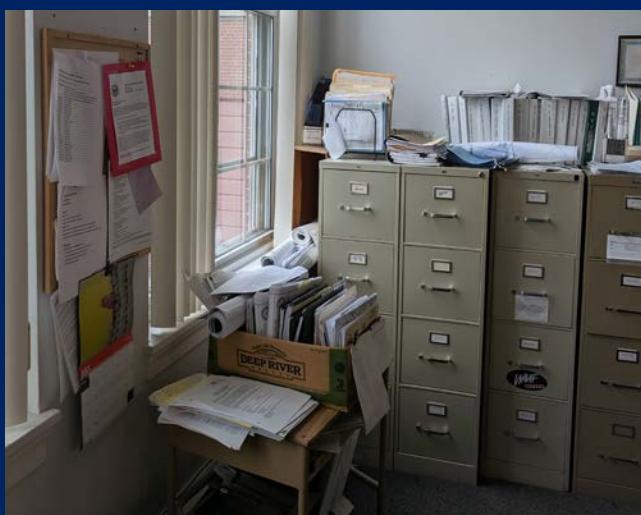
The lack of proper storage has made many offices cluttered and uncomfortable. (Classroom Wing - Third Floor)

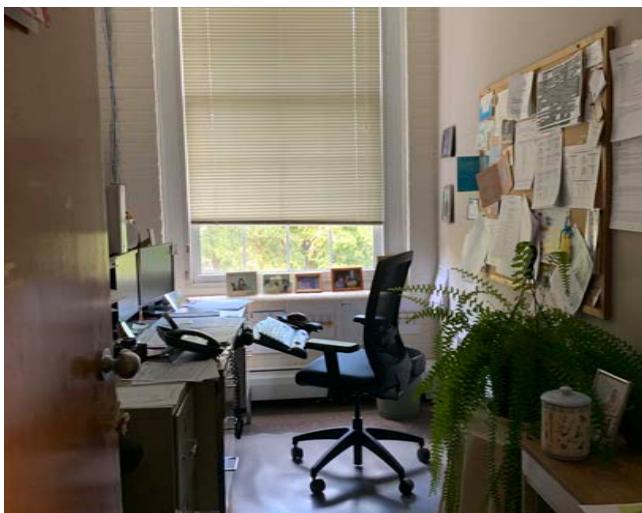
Some private offices, however, are definitely too small and crowded. (Office Wing - Third Floor)

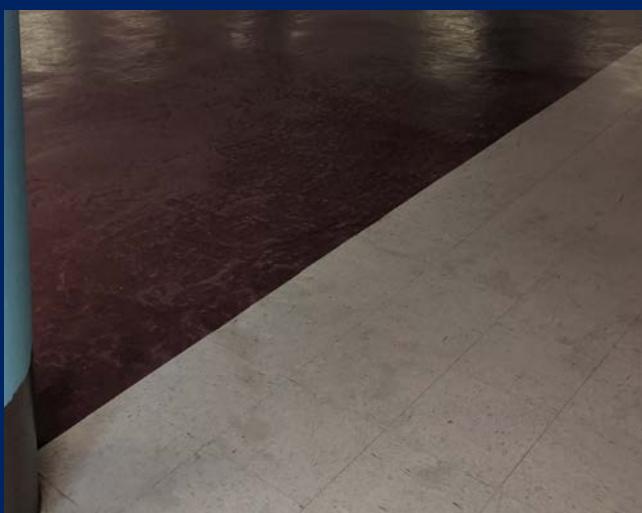
Worn VCT condition in multi-purpose room.
(Multi-Use Wing - First Floor)

1938 Multi-Use: Floor finishes include VCT, and hardwood (on the 2nd floor) and carpet. These are somewhat worn and generally in fair condition and expected to be due for replacement or refinishing in 2-5 years. Minor areas of VCT on the 2nd floor show gaps between joints, mismatched tiles, or cracked tiles these are recommended to be replaced. Carpet in about 250 sf of the TV areas loose edges that may pose a trip hazard. This will need immediate attention as it poses a safety risk. In back of house spaces on the 3rd level, floors are unfinished plywood with a loose walk off mat which may pose a trip hazard. It is recommended that the walk-off mat be removed and replaced with VCT and resilient base. Back of house floors on lower levels are unfinished concrete.

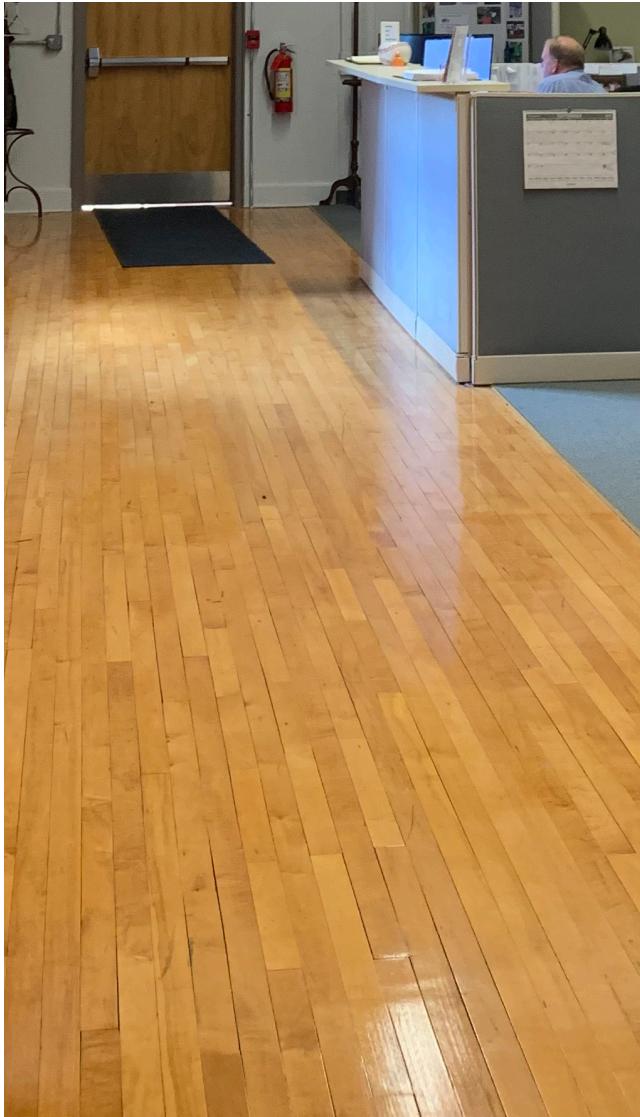
Old gym's wood floors are in fair condition & well maintained; partially covered with carpet. (Multi-Use Wing - Second Floor)

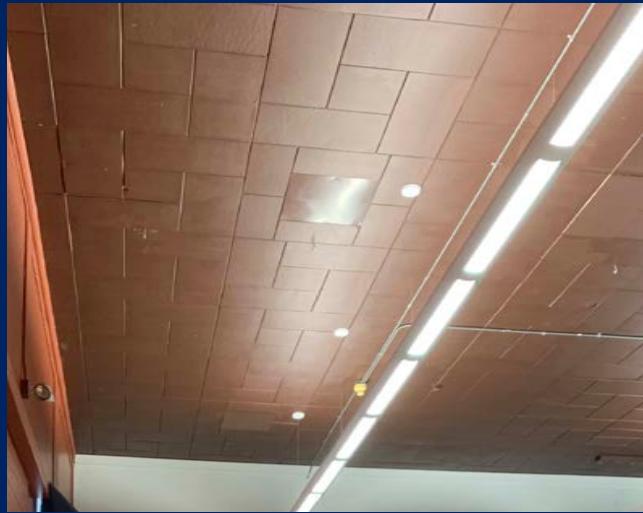
Old glued acoustical ceiling system, painted finish may compromise performance in LCTV Studio. (Multi-Use Wing - Second Floor)

1938 Multi-Use Wing: There is glued acoustic tile in the TV Studio/old gym. Its performance may be compromised by painted finish. The finish appears to be in good condition. About 10 tiles on the first level are stained or damaged.

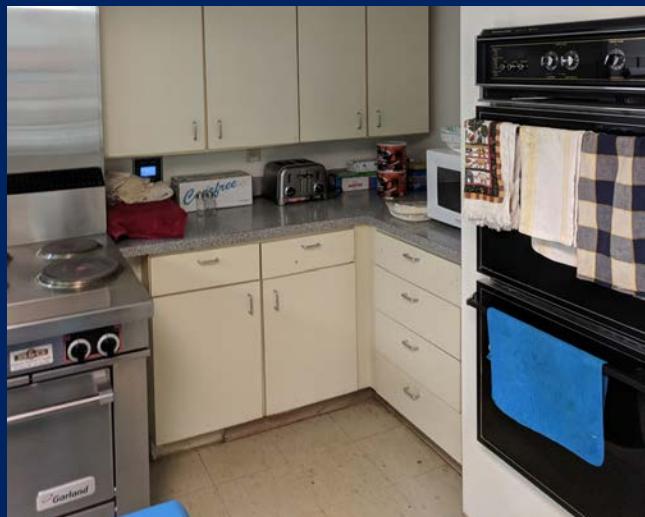
Kitchen ovens in adequate condition.
(Multi-Use Wing - First Floor)

The equipment generally appears to be functional, in good condition, and to serve the purposes intended. If the kitchen is to continue in use, the equipment should be maintained.

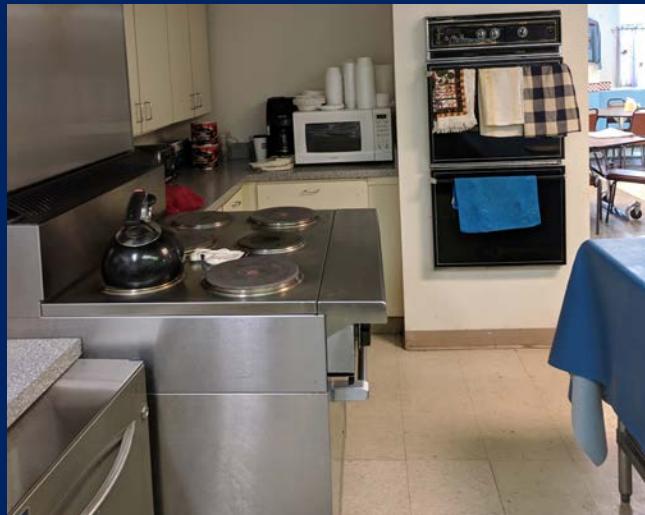
Relatively new kitchen stove in good condition.
(Multi-Use Wing - First Floor)

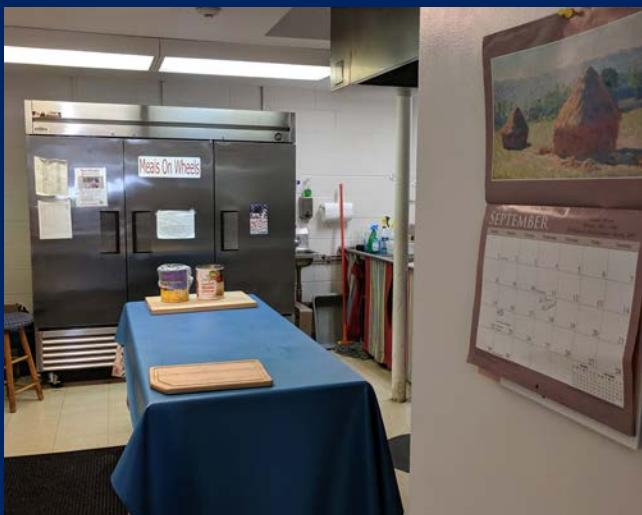
Relatively new kitchen refrigerators in good condition.
(Multi-Use Wing - First Floor)

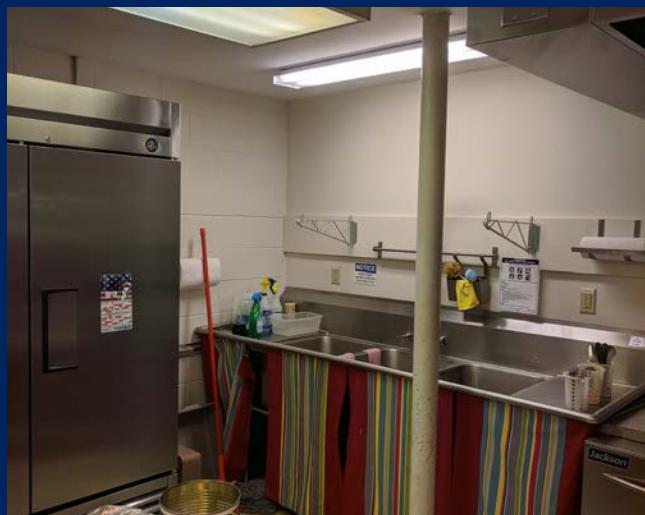
Relatively new kitchen sink in good condition.
(Multi-Use Wing - First Floor)

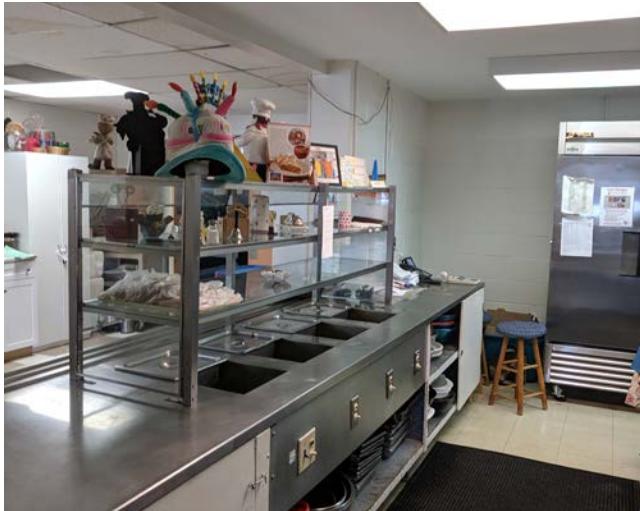
Relatively new food service counter in good condition. (Multi-Use Wing - First Floor)

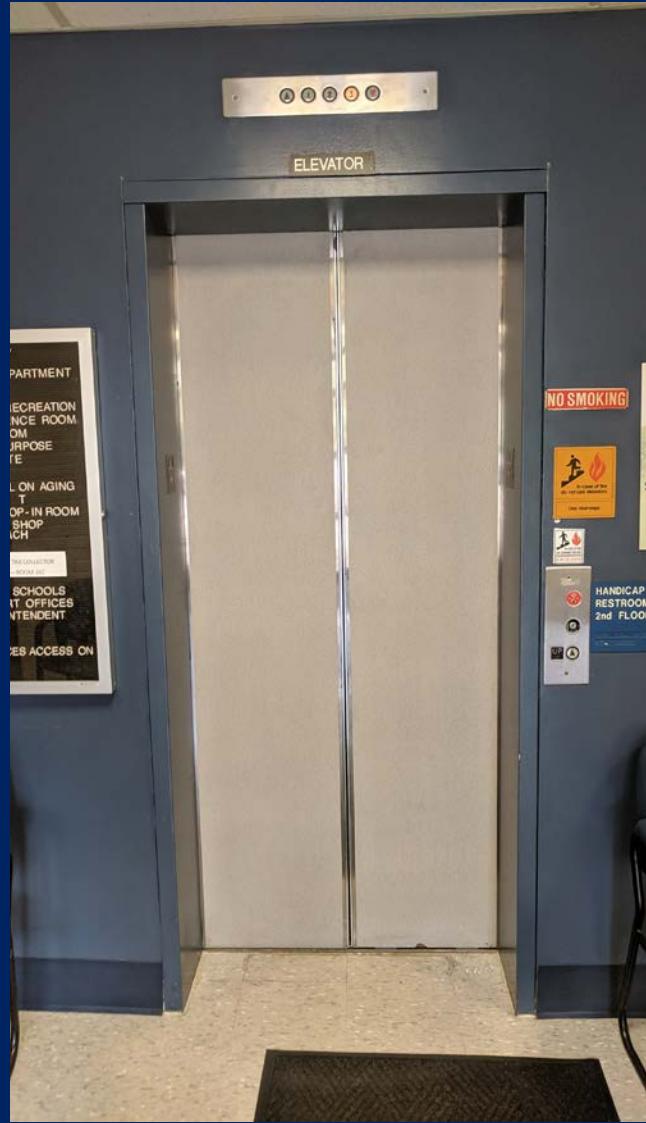
View of existing elevator. Creates a bottle neck in circulation. (Office Wing - First Floor)

It is recommend that the elevator be further evaluated by a certified elevator maintenance company and improved or maintained based on their recommendations.

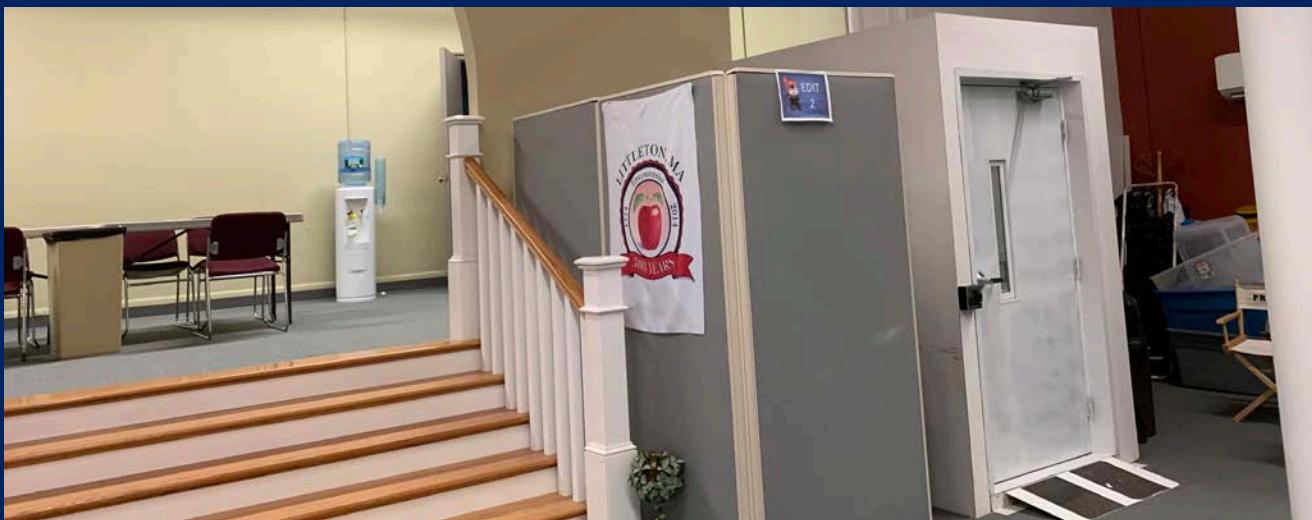
View of existing lift in LCTV Studio. (Multi-Use Wing - Second Floor)

Maintain or replace in future renovations.

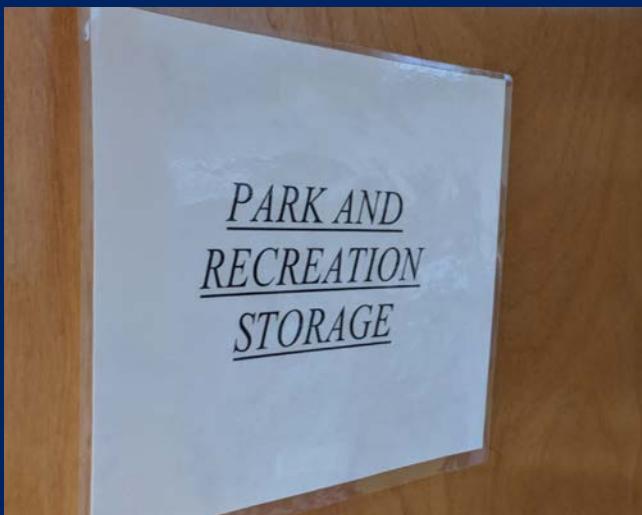
Some rooms lack proper signage and have signs taped to their doors. (Office Wing - First Floor)

It is recommended that interior space signage be supplemented as required for all uses that are to remain and completely removed and replaced if the structure is to undergo a full renovation.

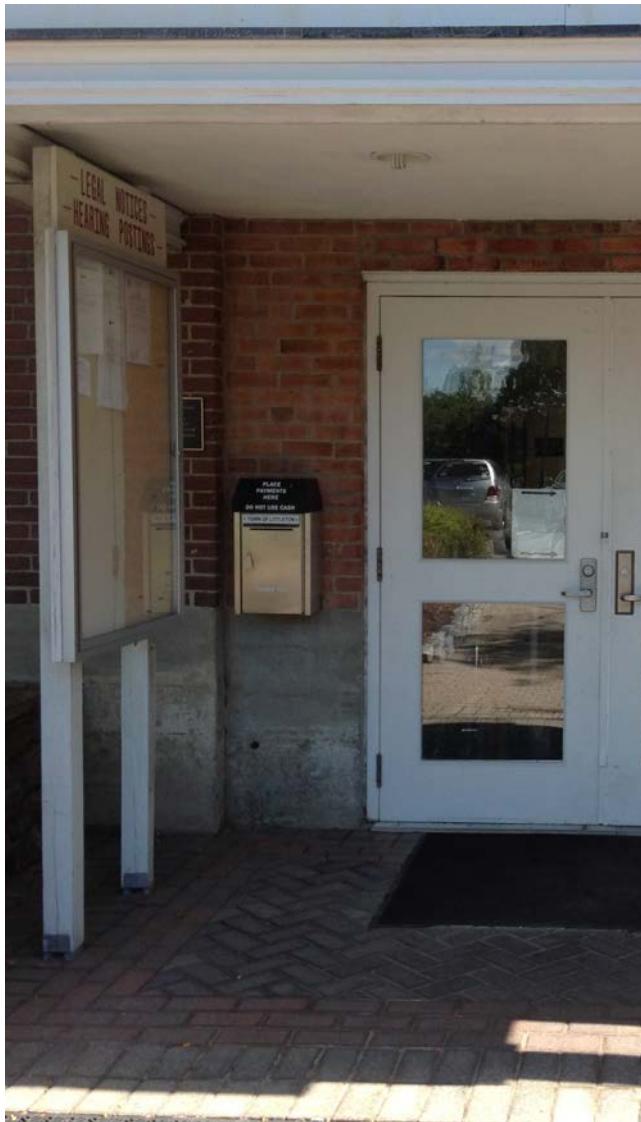
Notice boards at main entrance. (Office Wing- Parking Lot Side)

It is recommended that exterior signage be improved to more clearly convey the location of departments.

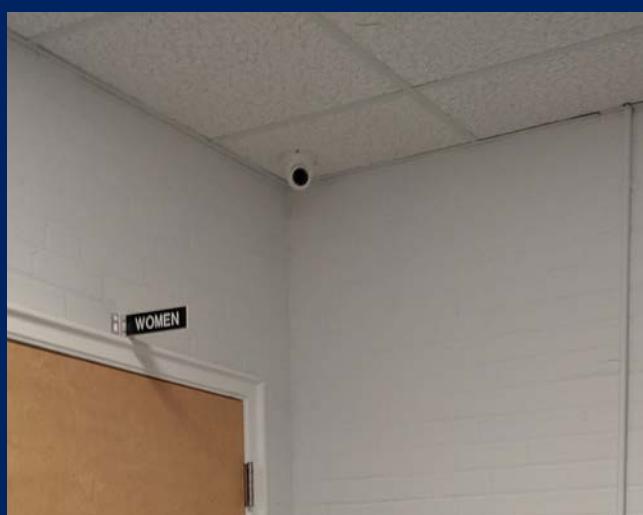
Security camera at end of corridor. (Classroom Wing - Second Floor)

Additionally, the current security cameras and monitoring system is recommended to be made more robust as indicated in the report by others. Monitoring of these cameras and a system of saving videos should be implemented as recommended by others.

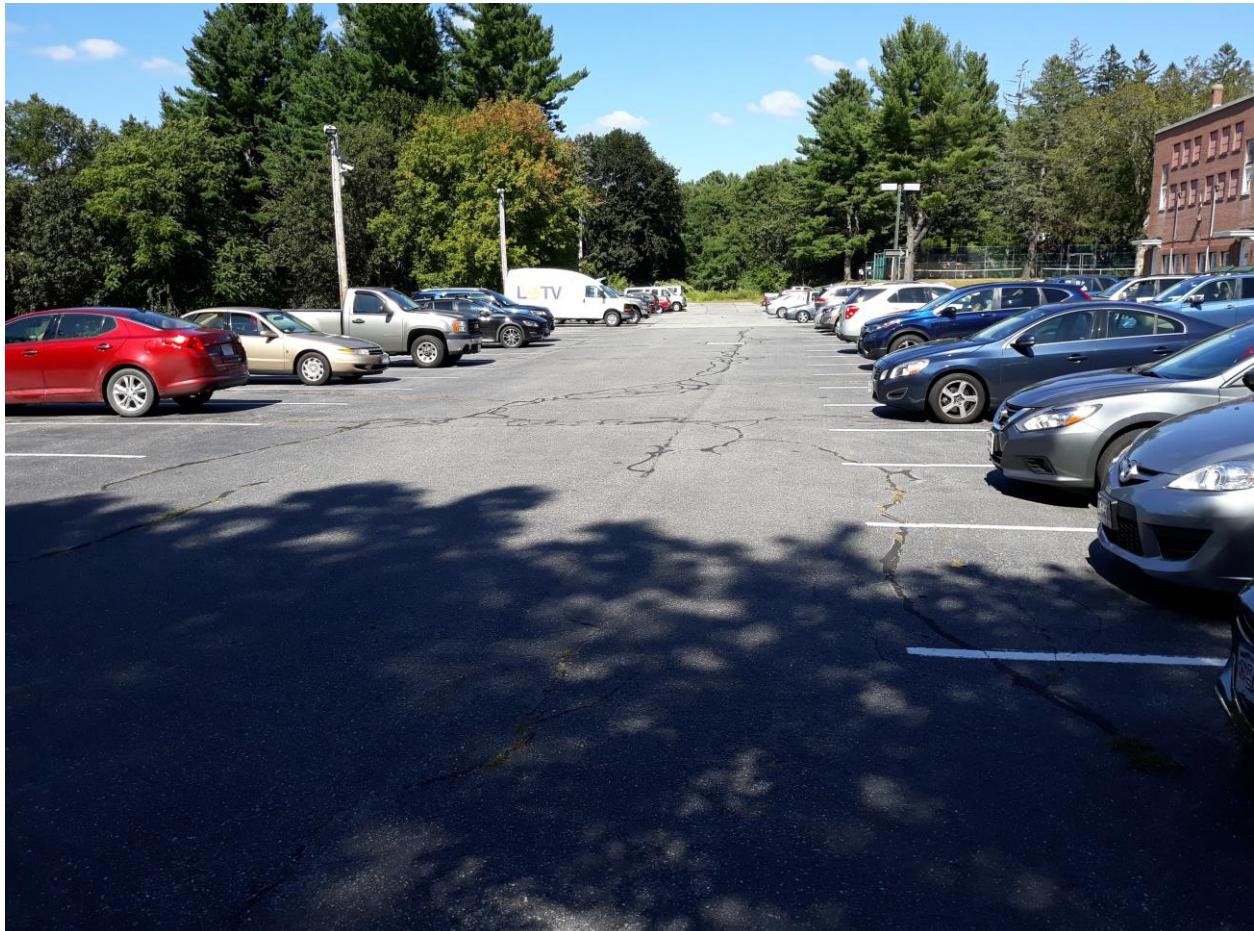
Rear Parking Area

Overall, the pavement is in fair condition. There is evidence of crack sealant along the majority of the parking area. The pavement near the dumpster in the rear parking area shows depressions from the vehicle traffic loading and unloading the dumpster.

CDW recommends removing the existing pavement and re-grading the subbase before applying a new binder and top coat of asphalt.

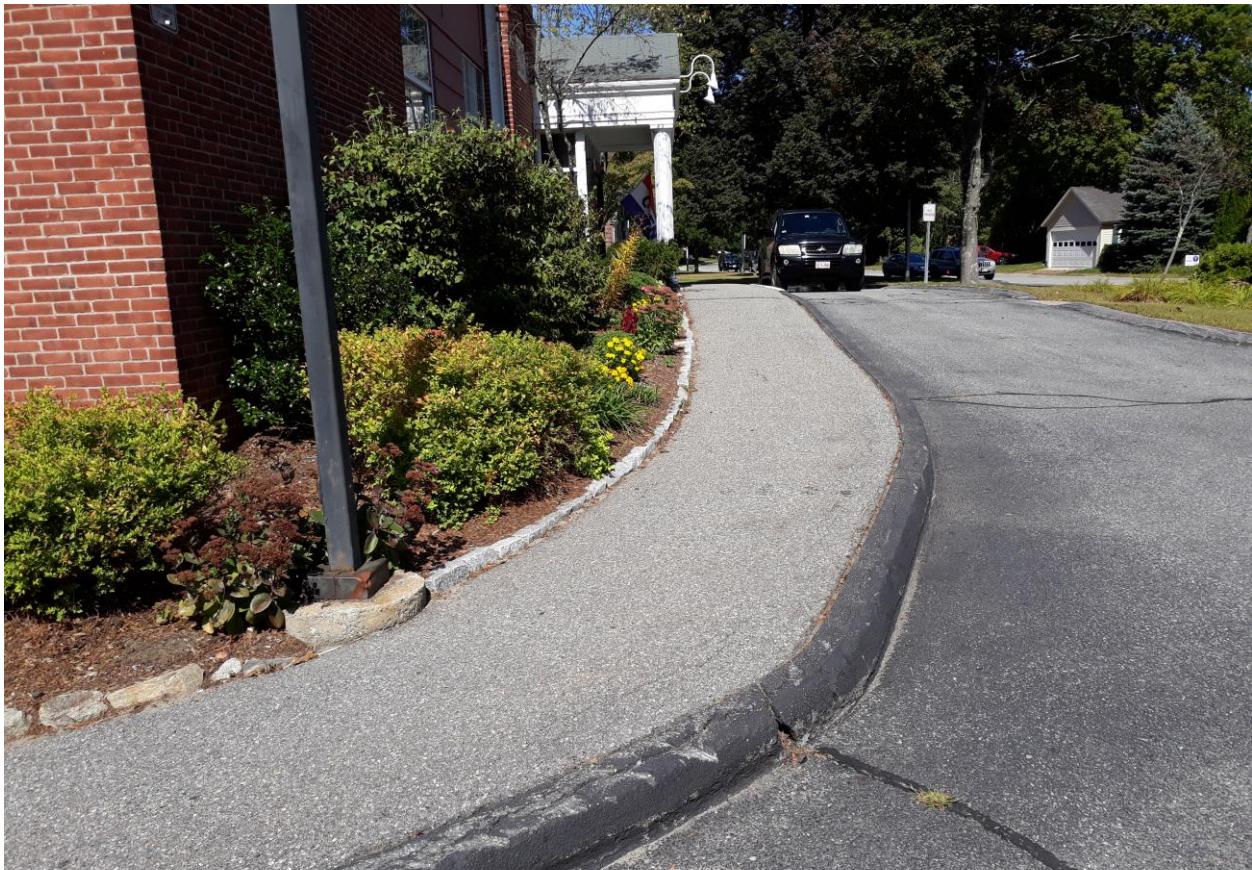
Walkway at West Side of Library

Most of the bituminous walkways are in good shape except for the walkway under the bridge leading into the west side of the building. This walkway should be replaced along with the handicap ramp leading up to the walkway.

- Asphalt walkways (4) at front of building leading to concrete steps as well as asphalt sidewalk at Library entrance and west side leading to rear parking in fair condition. Recommend excavating asphalt and replacing with new binder course and top course within two years.
- Rear concrete walks leading to building except asphalt at Room 103.
- Brick pavers at Town entrance.

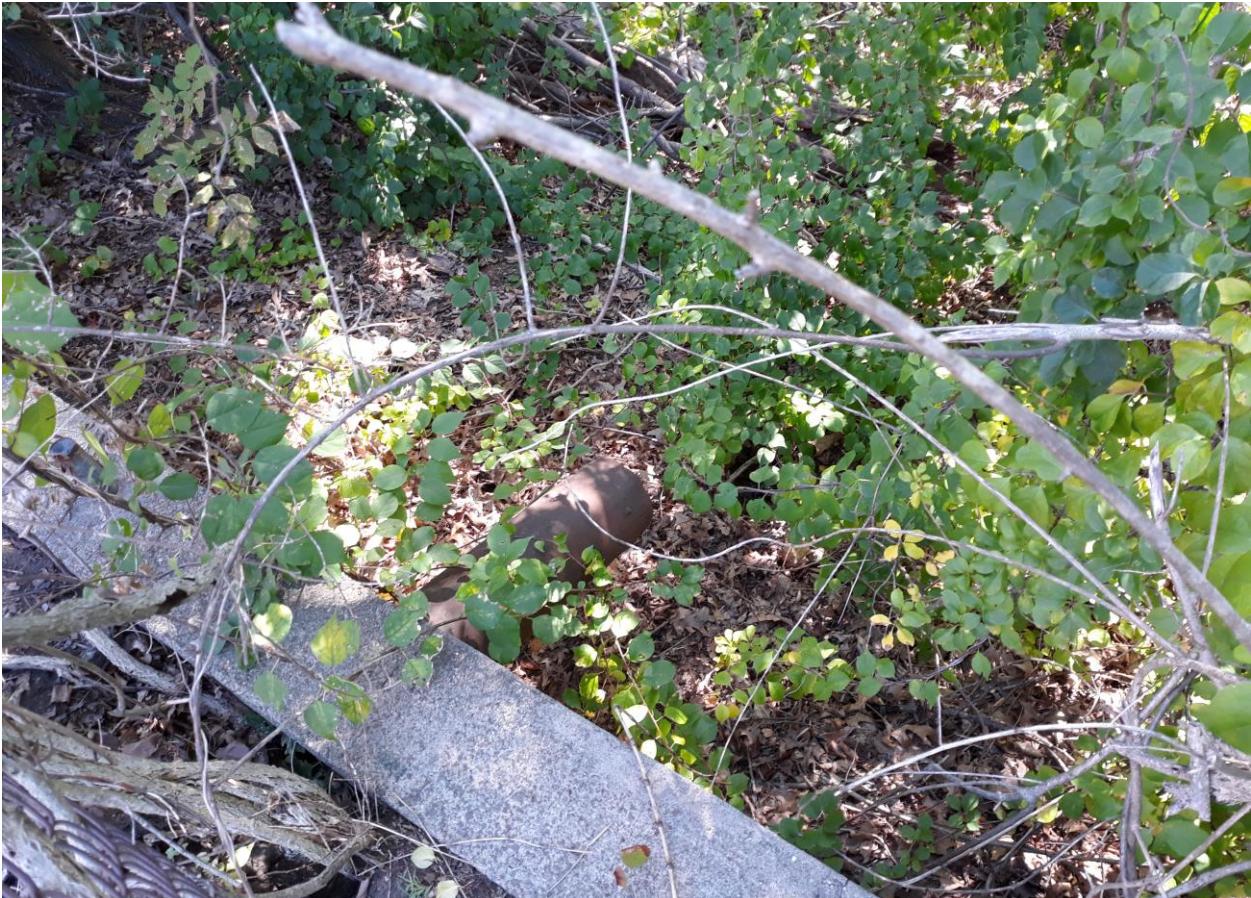
Electric Manholes

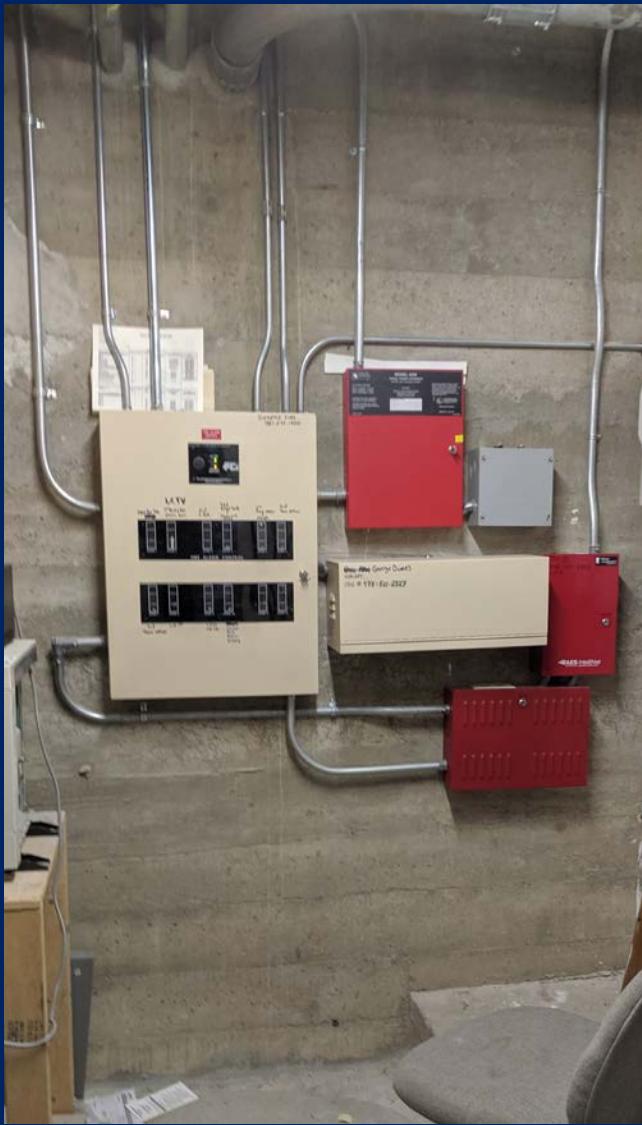
Fire protection system electrical panels.
(Classroom Wing - First Floor)
