Littleton Town Hall Building & Space Needs Assessment

Volume II: Shattuck Street Municipal Complex, Existing Conditions Report

Littleton Town Hall Complex
37 Shattuck Street
Littleton, MA 01609

March 2021

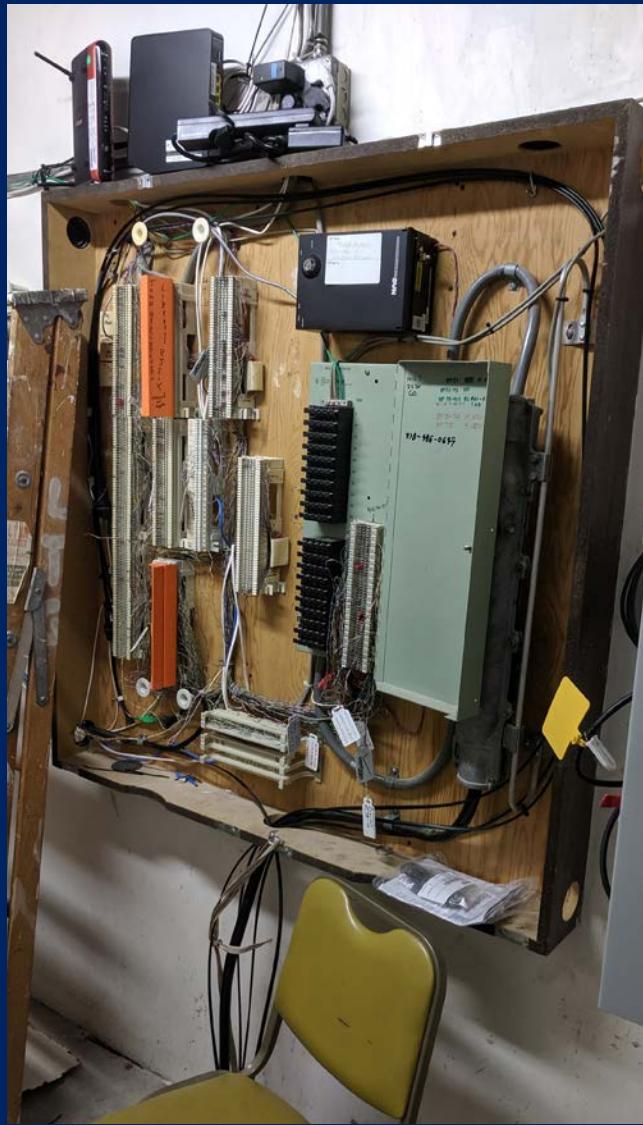
Main tele/data panel. (Classroom Wing - First Floor)

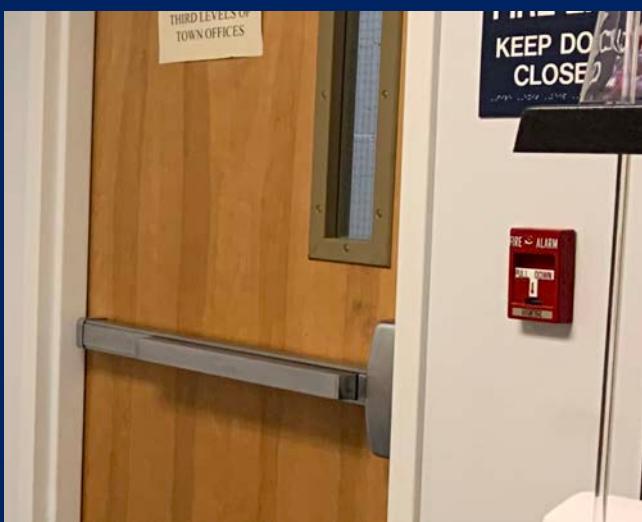
Typical fire alarm pull located throughout the building. (Library Wing - First Floor)

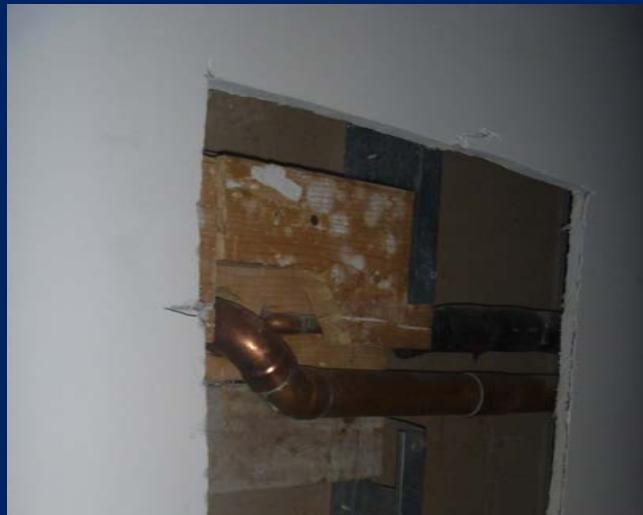
3" copper piping for domestic water distribution. (Library Wing)

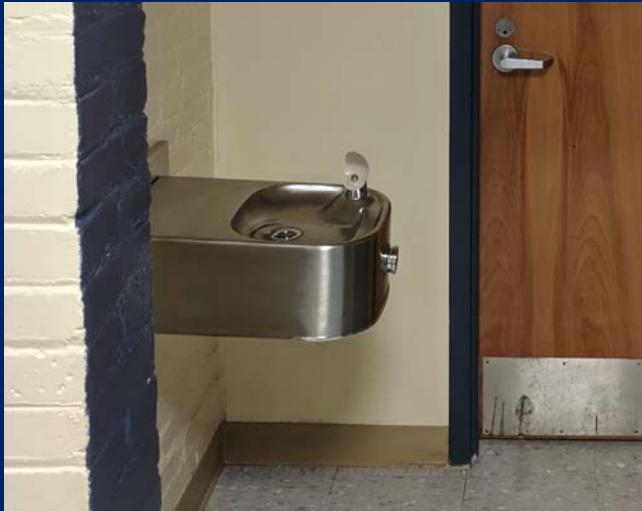
Existing fixtures appear adequate for fixture use. (Office Wing - First Floor)

Fixtures and accessories appeared to be adequate for future use. Existing fixtures should be evaluated based on any modifications for new program use of the building. If fixtures are replaced, low-flow fixtures are recommended.

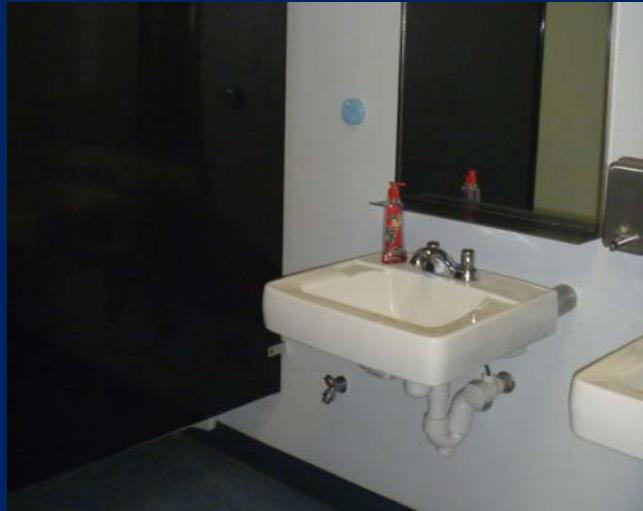
Existing fixtures appear adequate for fixture use. (Classroom Wing - Third Floor)

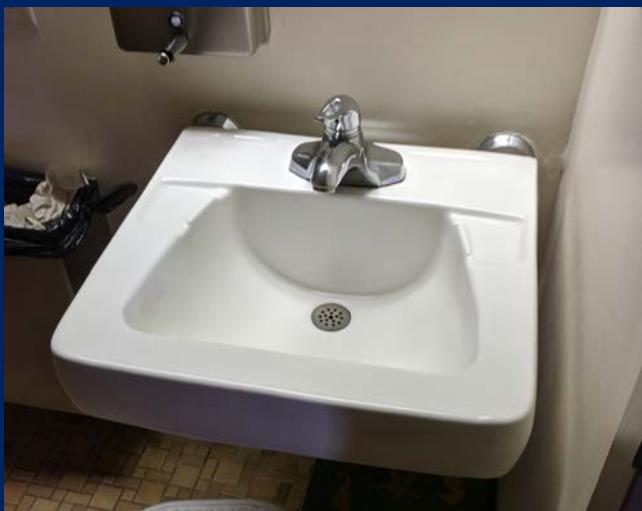
Existing fixtures appear adequate for fixture use. (Library Wing - Third Floor)

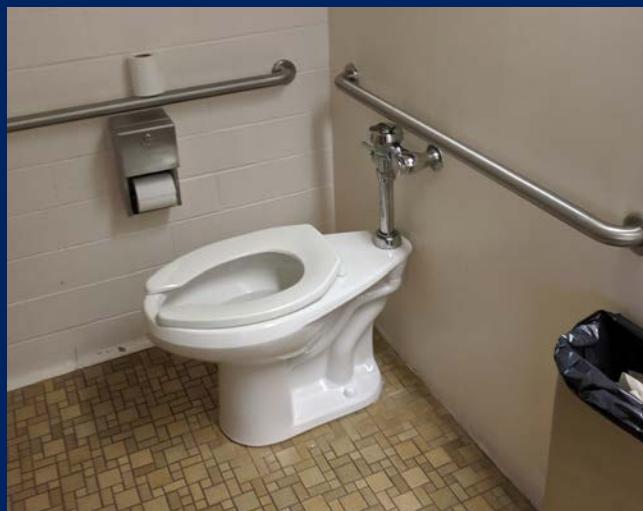
Existing fixtures appear adequate for fixture use. (Library Wing - Third Floor)

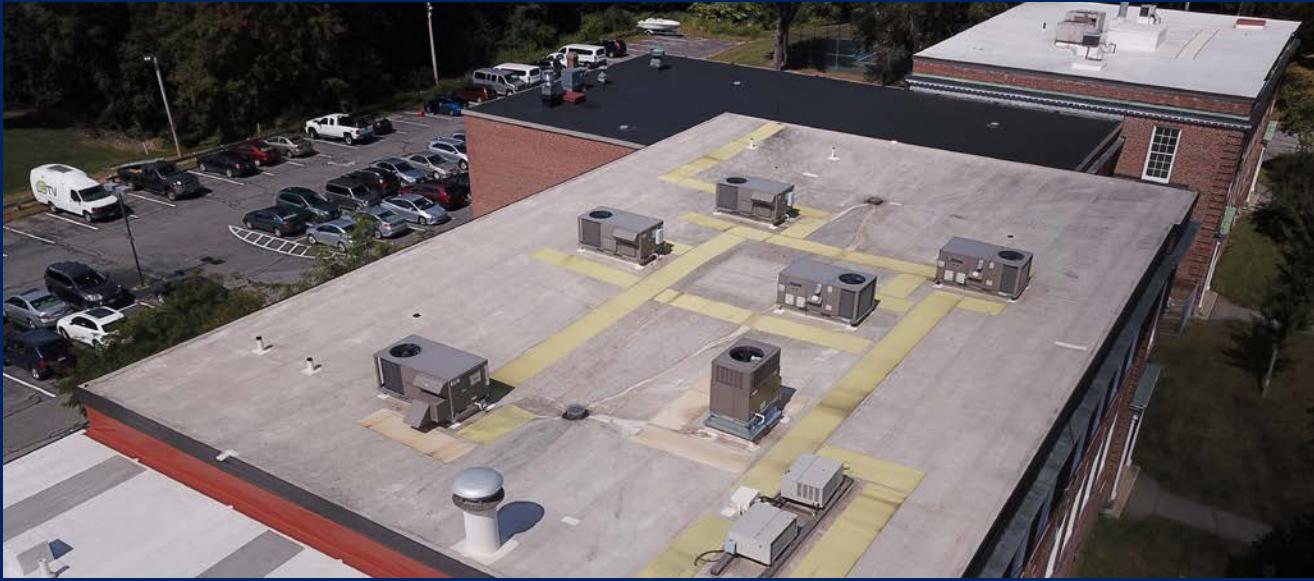
Numerous relatively new rooftop air handling unit (RTUs) located on the Classroom roof. (Classroom Wing - Roof 5)

Some of the air handling equipment appears to be past its expected life and will require replacement, including the split air handling systems and several roof top air handlers. Other rooftop air handlers appear to be in operable condition and should be evaluated by a service technician. Air handling systems serving the 1938 Multi-Use Wing and the 1922 Office Wing appear corroded but functional, and may remain in operation while anticipating replacement in the near future. Air handling systems serving the 1938 Classroom Wing and the 1952 Library Wing were reportedly installed 5 years ago and are assumed to be in full operational condition. Any new ductwork shall be insulated to meet current energy codes and standards, and any existing duct insulation should be investigated and repaired accordingly.

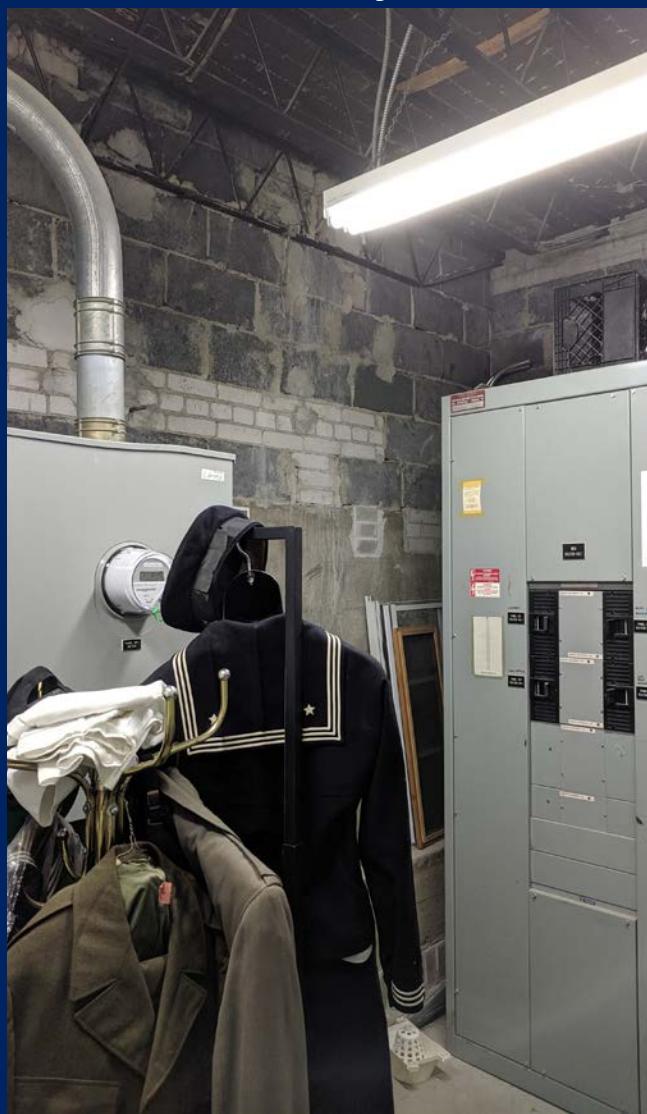
Electrical main and meters for each building. (Classroom Wing - First Floor)

The electrical distribution equipment is in good condition. If individual electrical bills are not required, then electric utility company current transformers may be installed on the secondary side of the electric utility company pad mount transformer with the electric utility company meter installed at the electric utility pad mount transformer. The four (4) electric utility company meters located in the Main Electric Room may be deleted. (Note: The electric utility company has a cost of approximately \$25.00 for the electric company utility meter on the electric utility company bill.) The existing fluorescent lighting fixtures shall be replaced with LED lighting fixtures. The existing emergency lighting system shall be replaced with emergency inverters installed in the new LED lighting fixtures as required to provide the Code specified emergency lighting requirements. The existing conventional fire alarm system is old and new replacement parts are being phased out. The existing fire alarm system shall be replaced with a new addressable fire alarm system. The existing fire alarm radio master box may be reused.

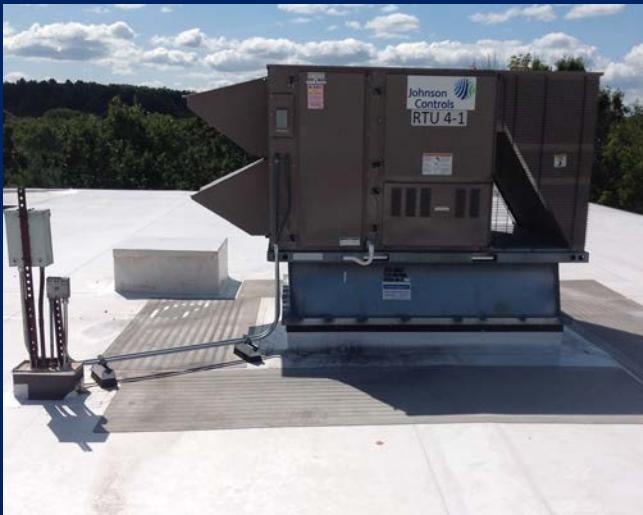
One of a few relatively new rooftop air handling unit (RTUs) located on the Library roofs. (Library Wing - Roof 2)

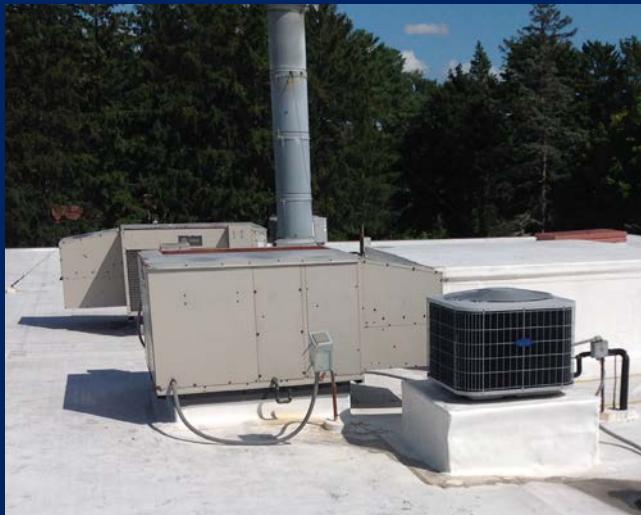
One of a few older rooftop air handling unit (RTUs) located on the Multi-Use & Office roofs. (Office Wing - Roof 8)

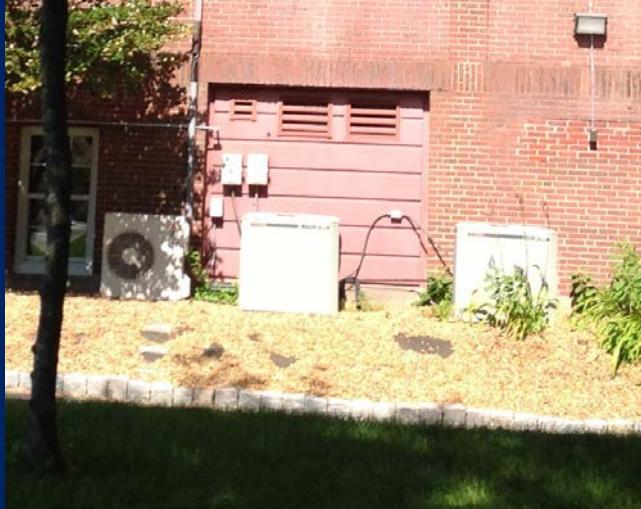
On grade split air handling units with condensing unit and compressor. (Multi-Use Wing - Parking Lot Side)

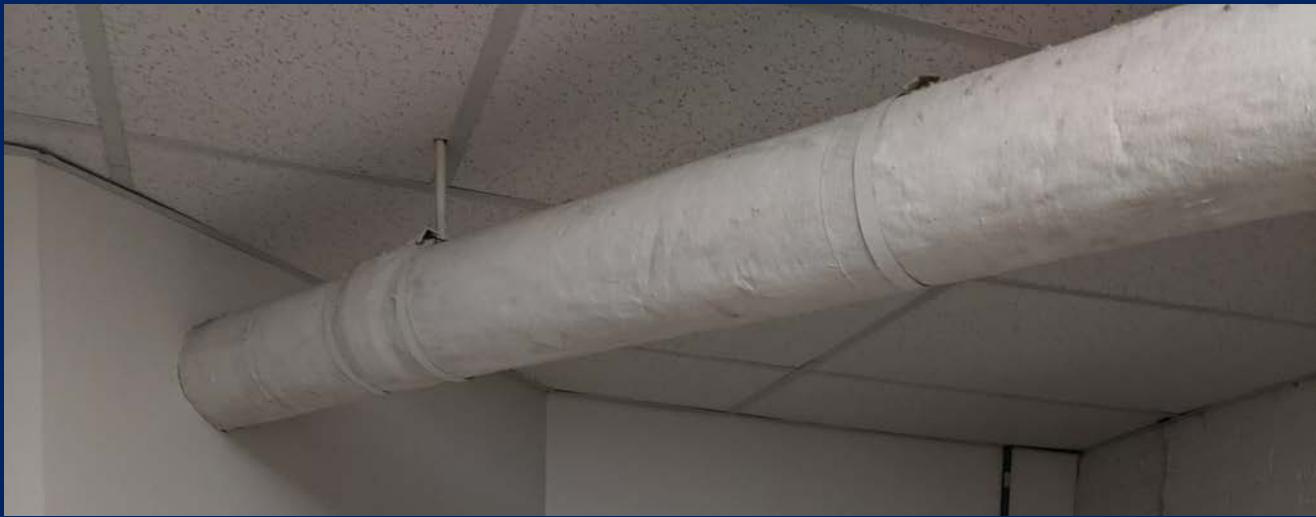
Pipe TSI - Confirmed ACM (Multi-Use Wing - Third Floor Storage Room)

See full Hazardous Materials Summary report (this chapter.)

Remove prior to disturbance.

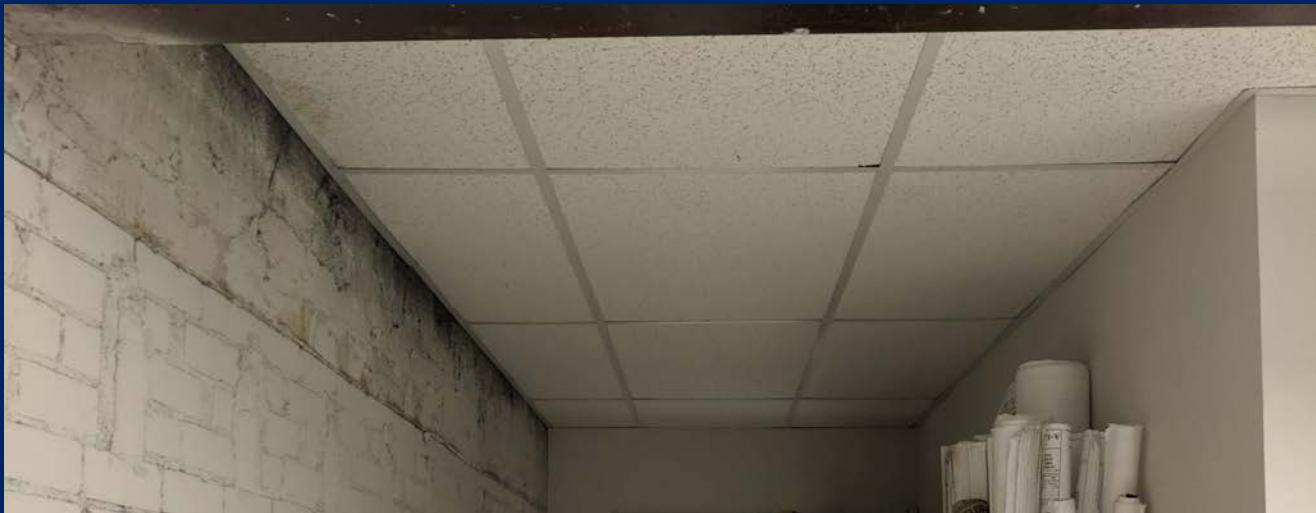
Cement Fabric - Confirmed ACM (Multi-Use Wing - Third Floor Storage Room)

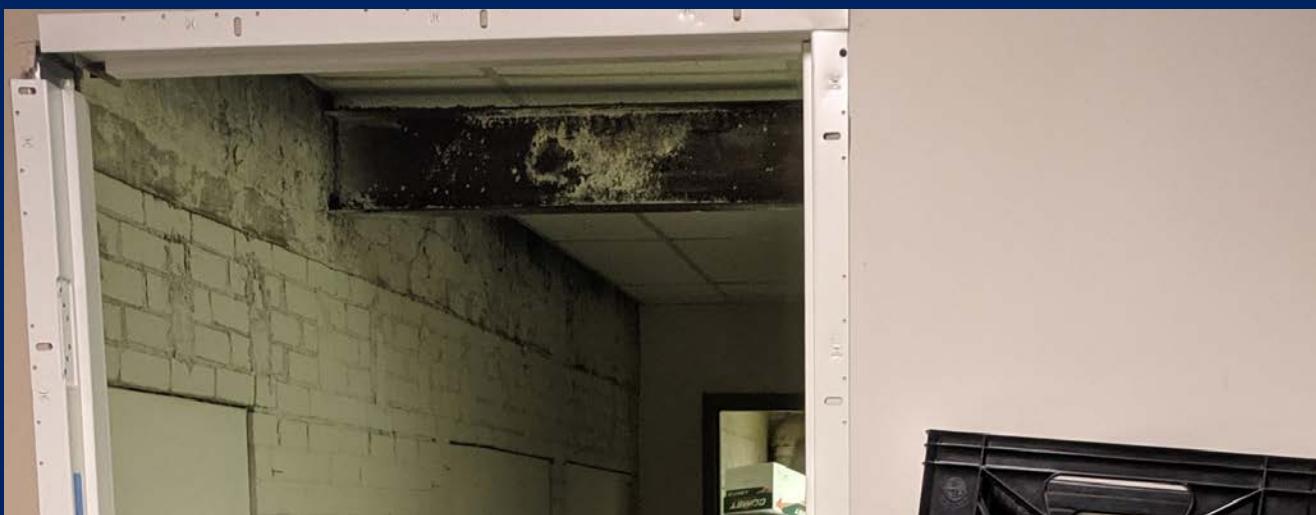
Cement Fabric - Confirmed ACM (Multi-Use Wing - Third Floor Storage Room)

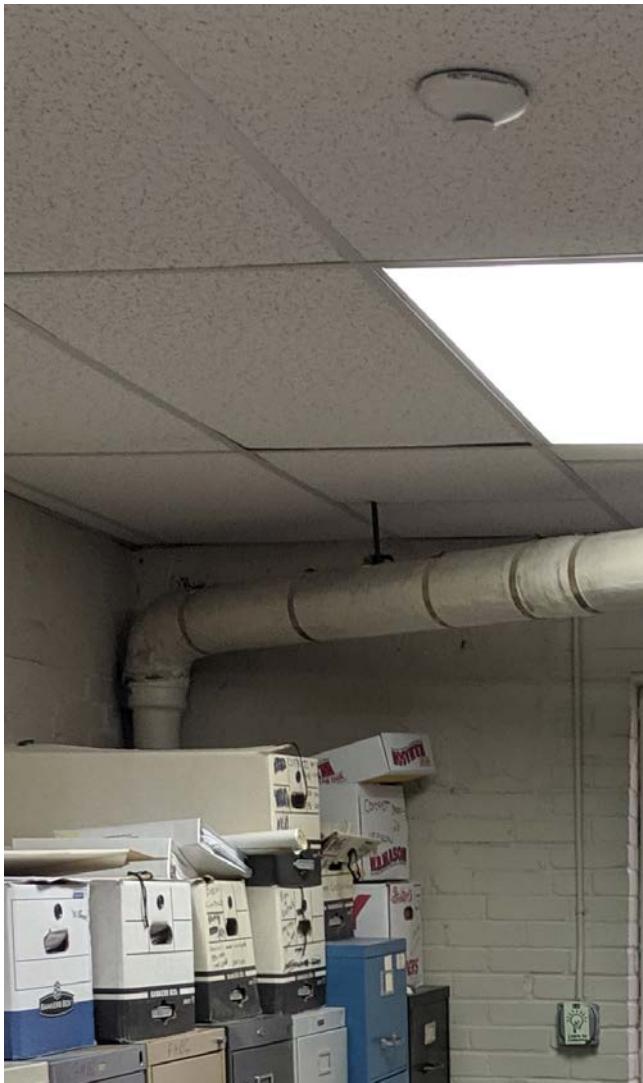
Pipe TSI - Confirmed ACM (Multi-Use Wing - Third Floor Storage Room)

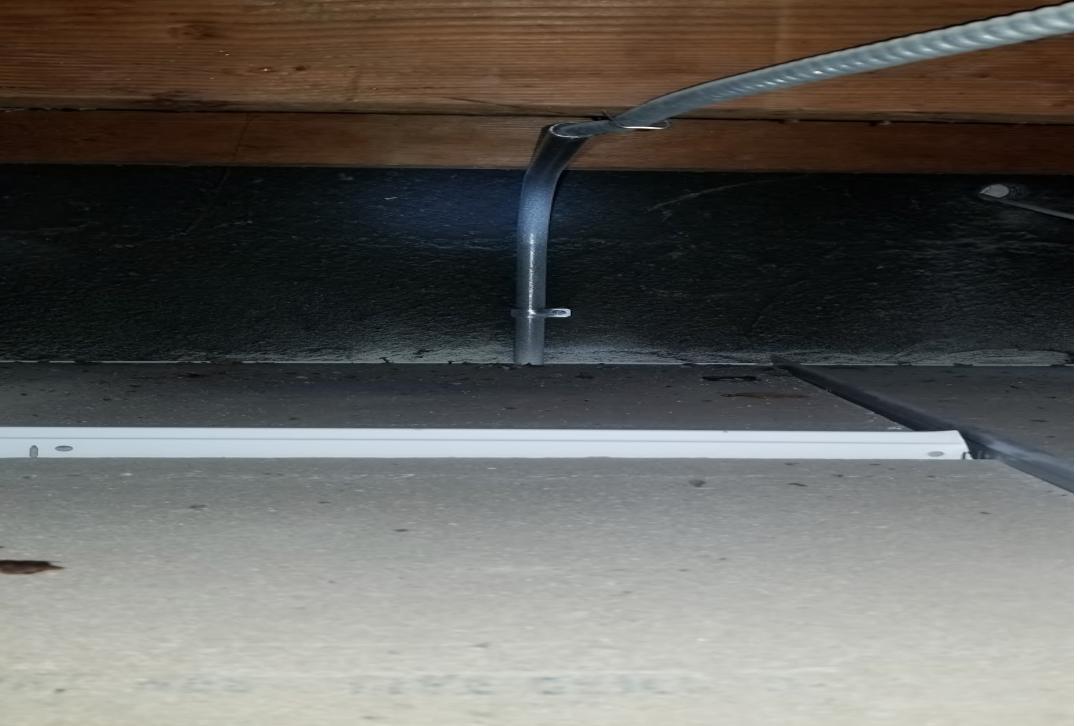
Photo No. 3	Date: 9/13/19

Photo Location: 3rd Floor Room 305 Storage		
Description: Cement Wall Cover/Mastic Confirmed ACM		
Photo No. 4	Date: 9/13/19
