Littleton Town Hall Building & Space Needs Assessment

Volume IV: King Street, Existing Conditions Report

Indian Hill Music Center
36 King Street
Littleton, MA 01460

January 2021

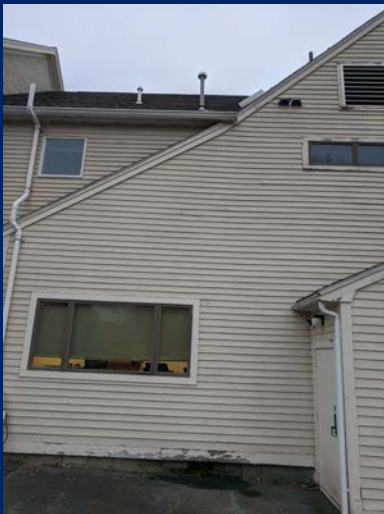
General view of the exterior windows and the various sizes and combinations.

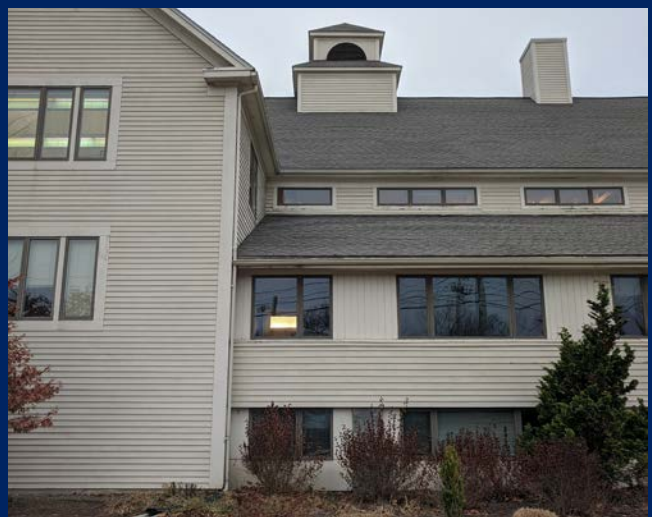
General view of the exterior windows and the various sizes and combinations.

Most of the windows units appear in generally good condition. The exterior Kynar painted finish is showing signs of fading and chalking.

The glazing seals will begin to reach their life expectancy and begin to loosen and fall. These should be monitored for signs of moisture between the panes of glass.

Windows are showing signs of age but can remain in-use; consider replacement during building renovations.

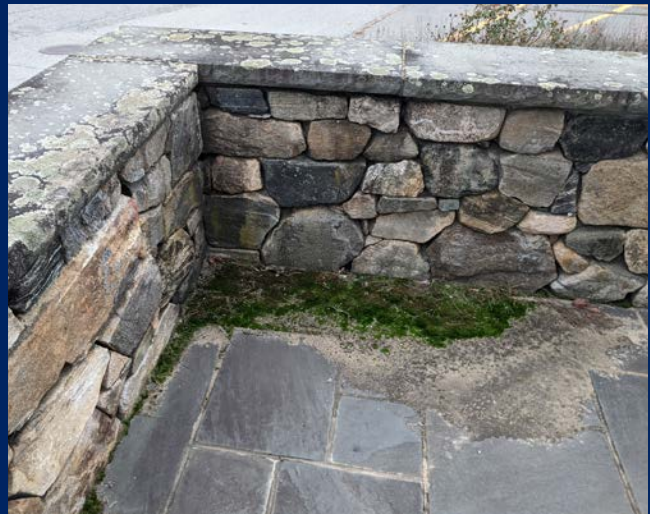
Photograph of the exterior landing, sand and moss should be cleared regularly.

Overall the masonry appeared to be in great condition for its age. The stone caps and stair treads appeared to have some organic growth on them, which could be cleaned with an appropriate masonry cleaner.

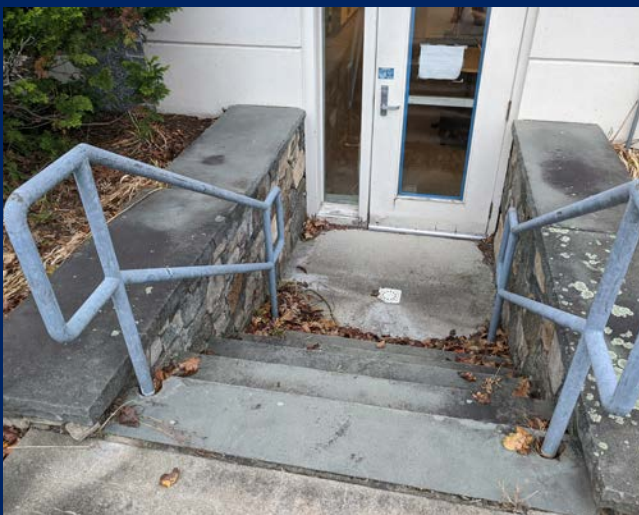
Photograph of the exterior landing and stairs, leaves and lichen should be cleaned regularly.

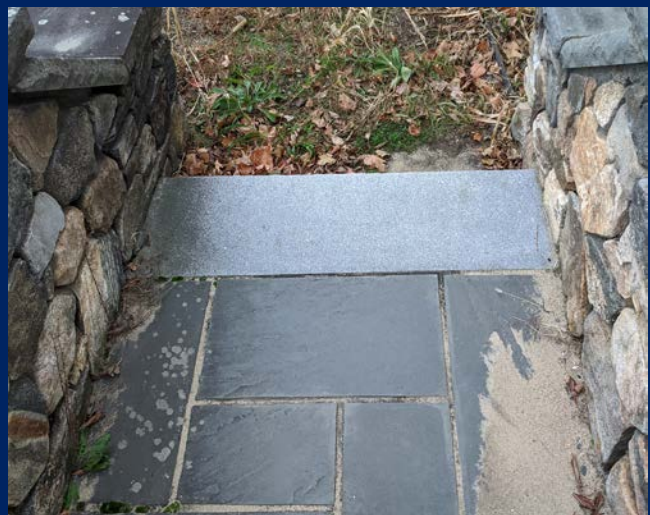
Photograph of the exterior landing and stairs, sand and moss should be cleared regularly.

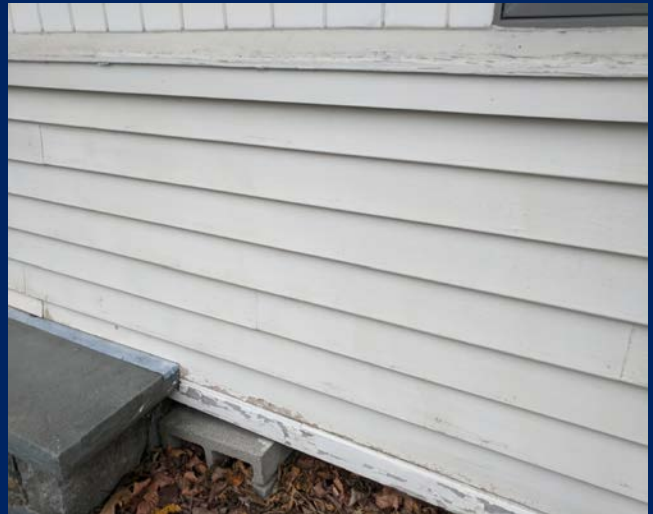
Close up view at a location where paint loss is occurring on the siding.

Generally the clapboard appears to be in good condition. Some clapboards are damaged, either due to aging and natural wood joint movement, and some due to impact or other external forces.

Some clapboard are failing or missing; roughly 2% of the exterior facade will require repair during initial building renovations.

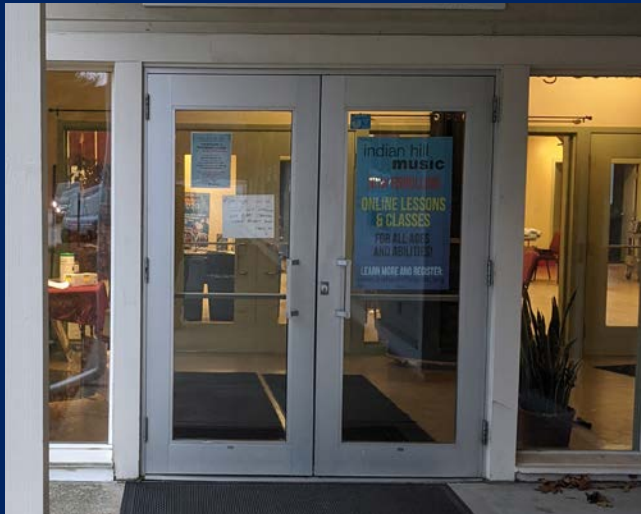
The main entrance doors are covered and is generally in good condition.

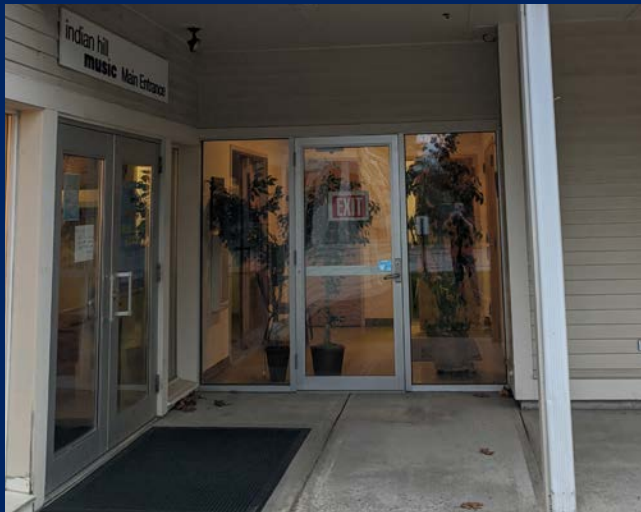
The side exit door from the Auditorium is covered and is generally in good condition.

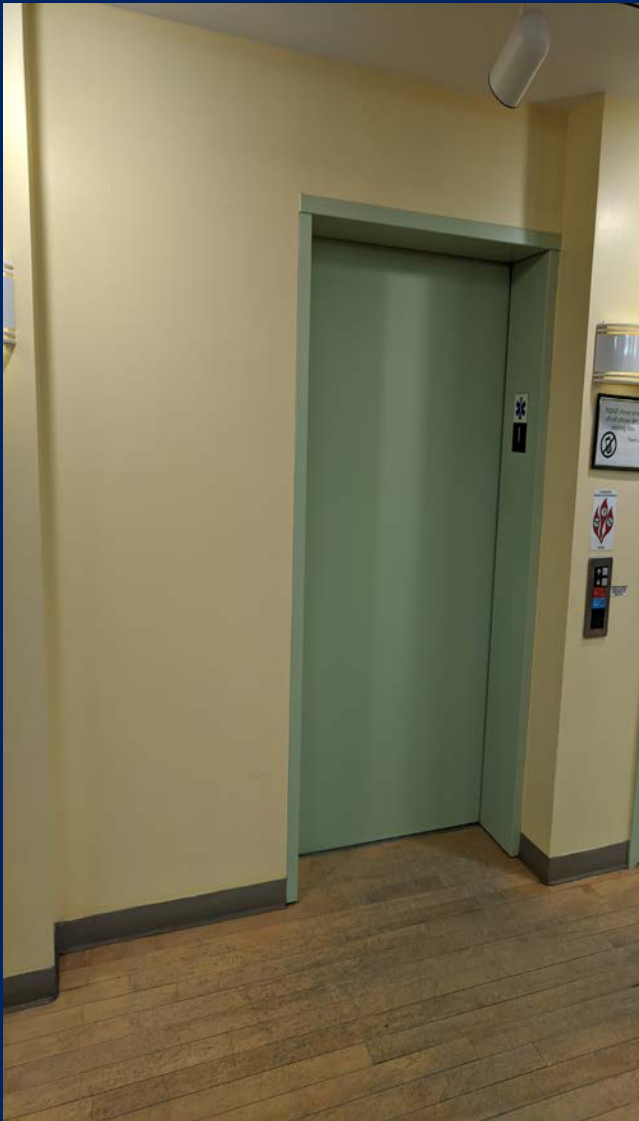
View of existing elevator. (First Floor)

The main elevator is located between the Open Lobby area and Office Wings. The elevator is a one sided passenger model and meets the size requirements for an existing elevator (min. 48"x48") as part of an accessible route. The elevator is operational but dated. Its location anchors the main lobby and open area, but could distrupt future programs as it is not seperated from connecting the open area. This allows the elevator to be shared but makes for highly confusing and complicating way finding. It is recommended that if the building were renovated, that the elevator be closed off of the open area to allow for uninterupted use.

It is recommend that the elevator be further evaluated by a certified elevator maintenance company and maintained or improved based on their recommendations.

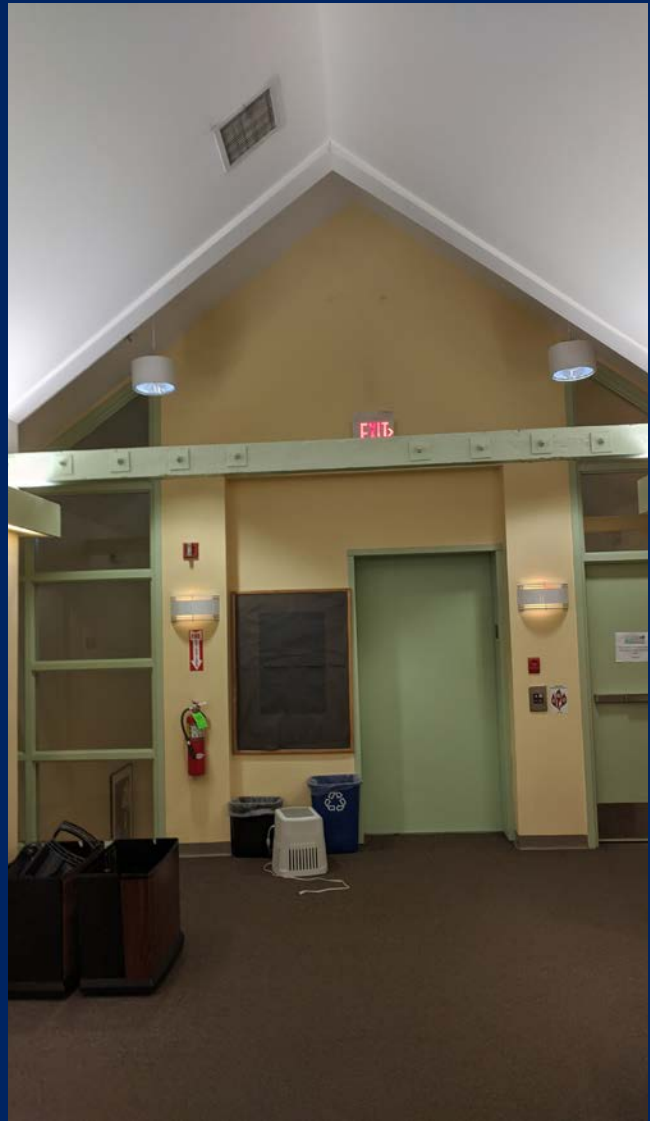
View of existing elevator. (Second Floor)

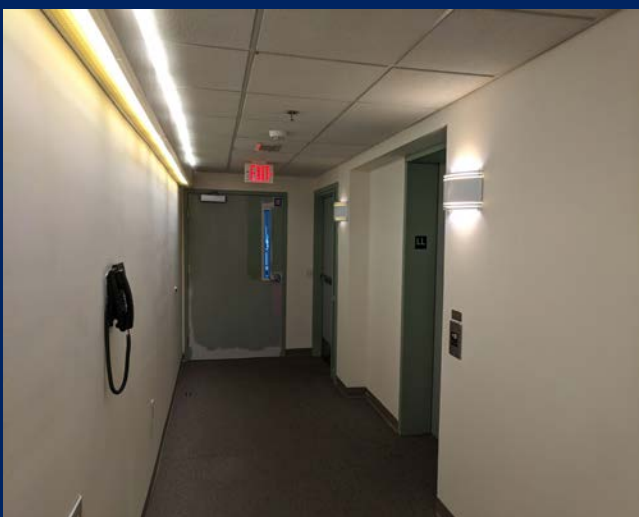
View of existing elevator. (Basement)

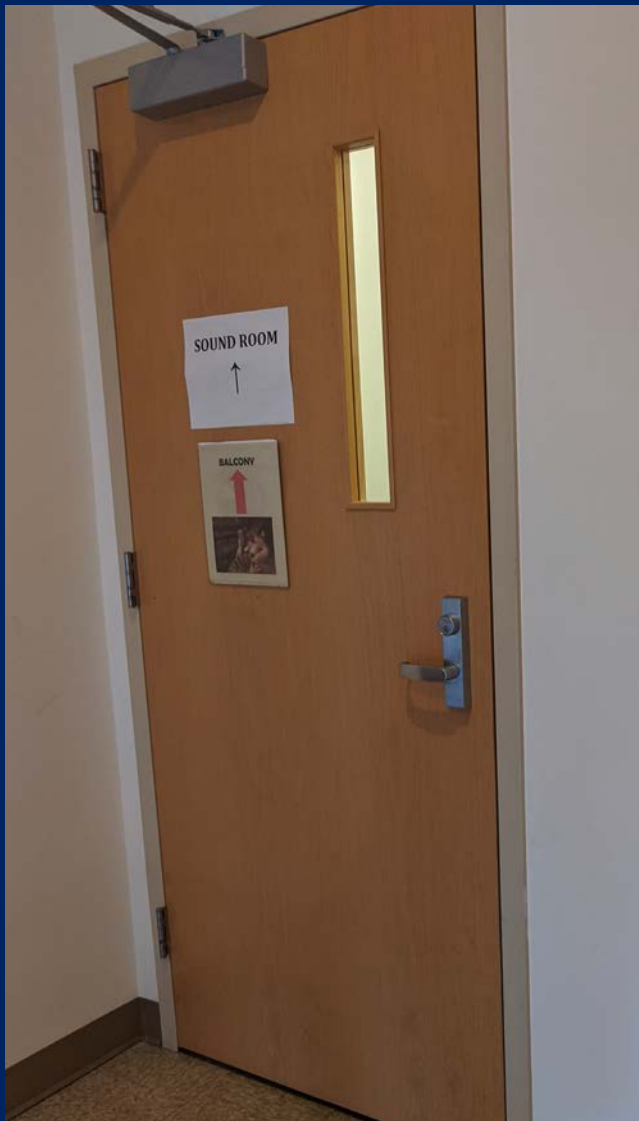
No real building directory, handled by signage taped to doors. (Second Floor)

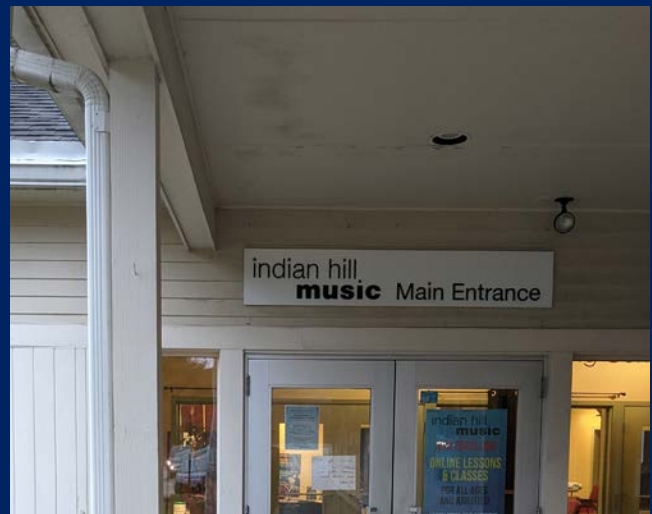
Main Entrance signage under main canopy, hard to determine from the parking lot. (First Floor)

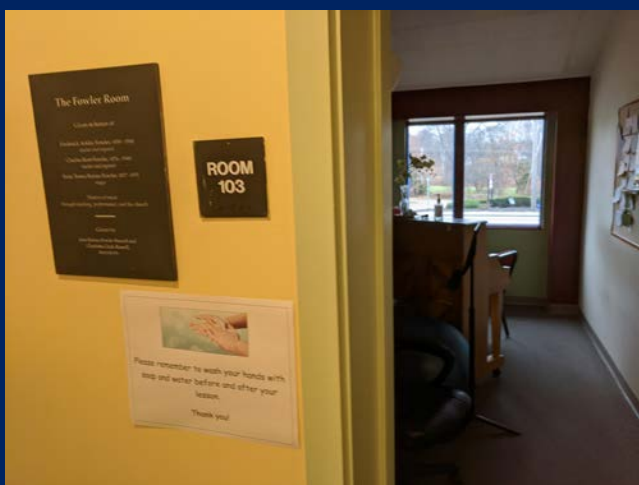
Rooms have Room Designation, Dedication Plaques, and have signs taped to the walls.

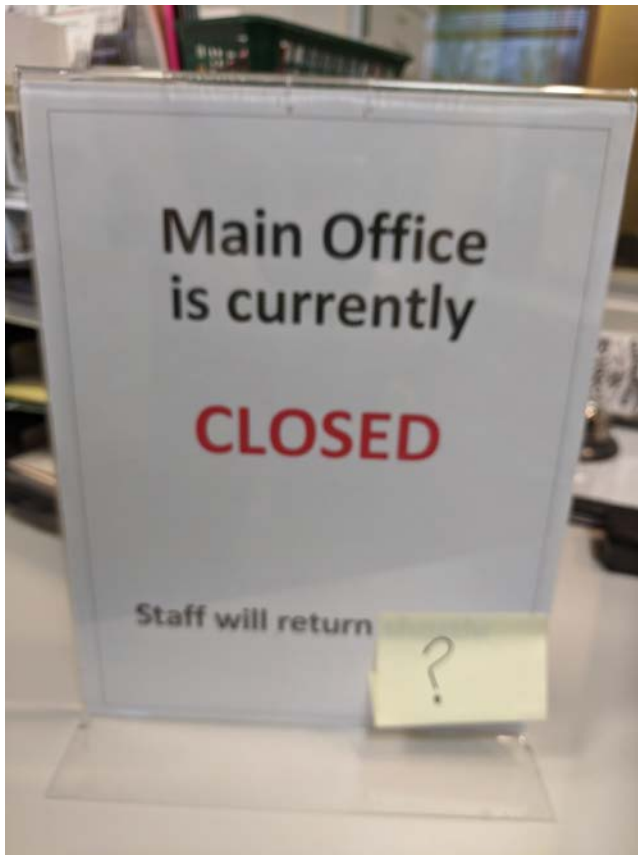
Notice boards at main entrance. (Office Wing-)

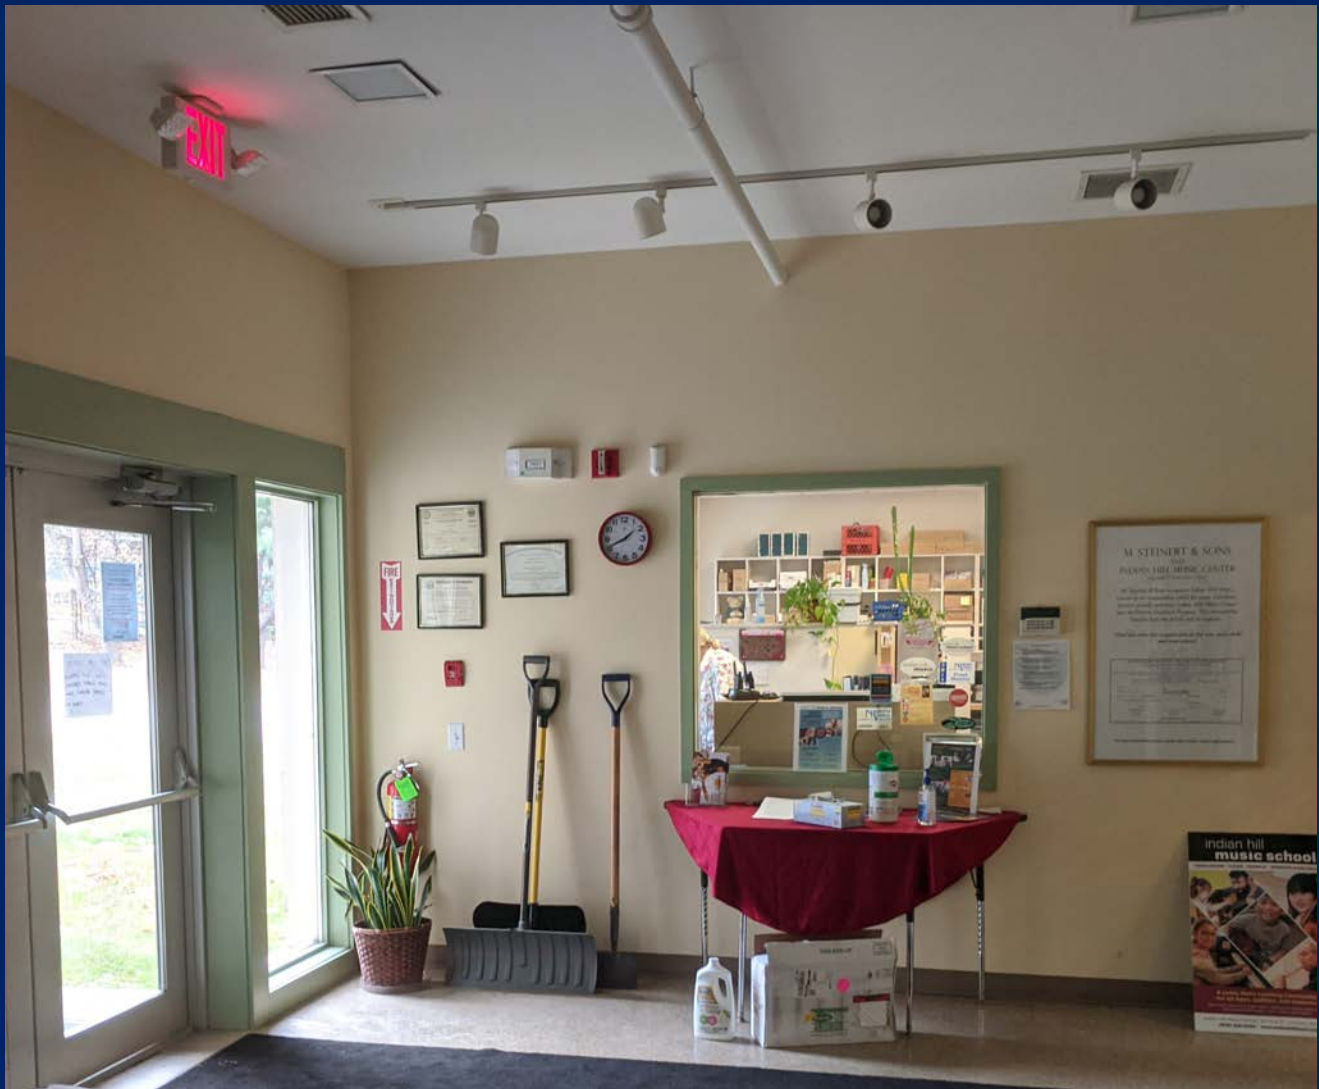
Security devices in the Lobby. (First Floor)

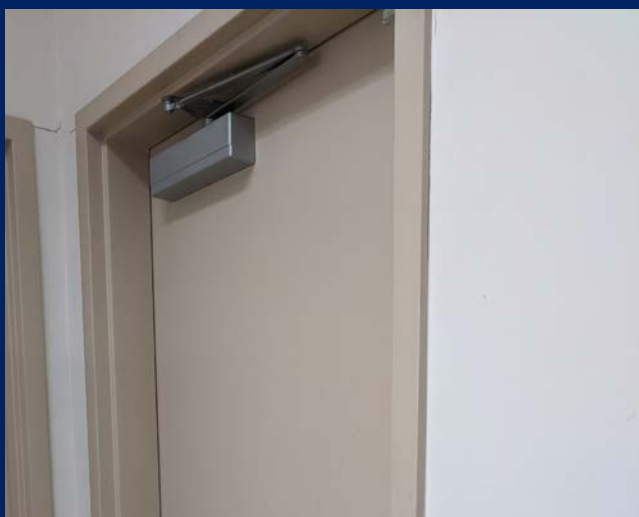
Door contact can be seen in upper right hand corner of this exterior door. (First Floor)

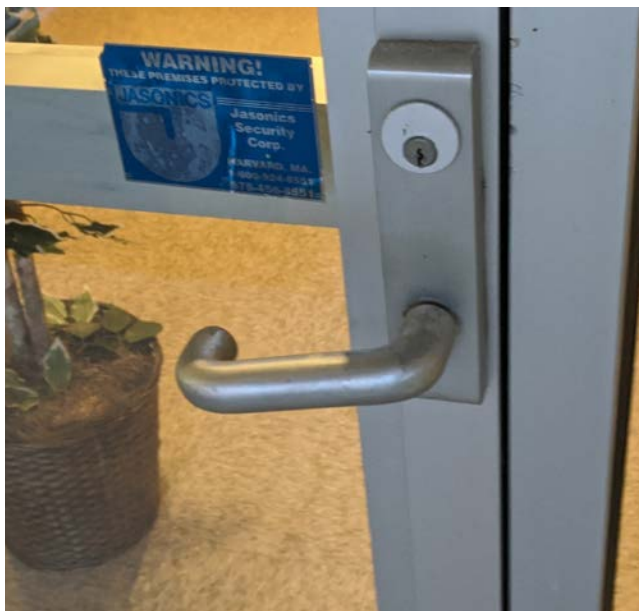
Security notification outside the Main Entrance. (First Floor)

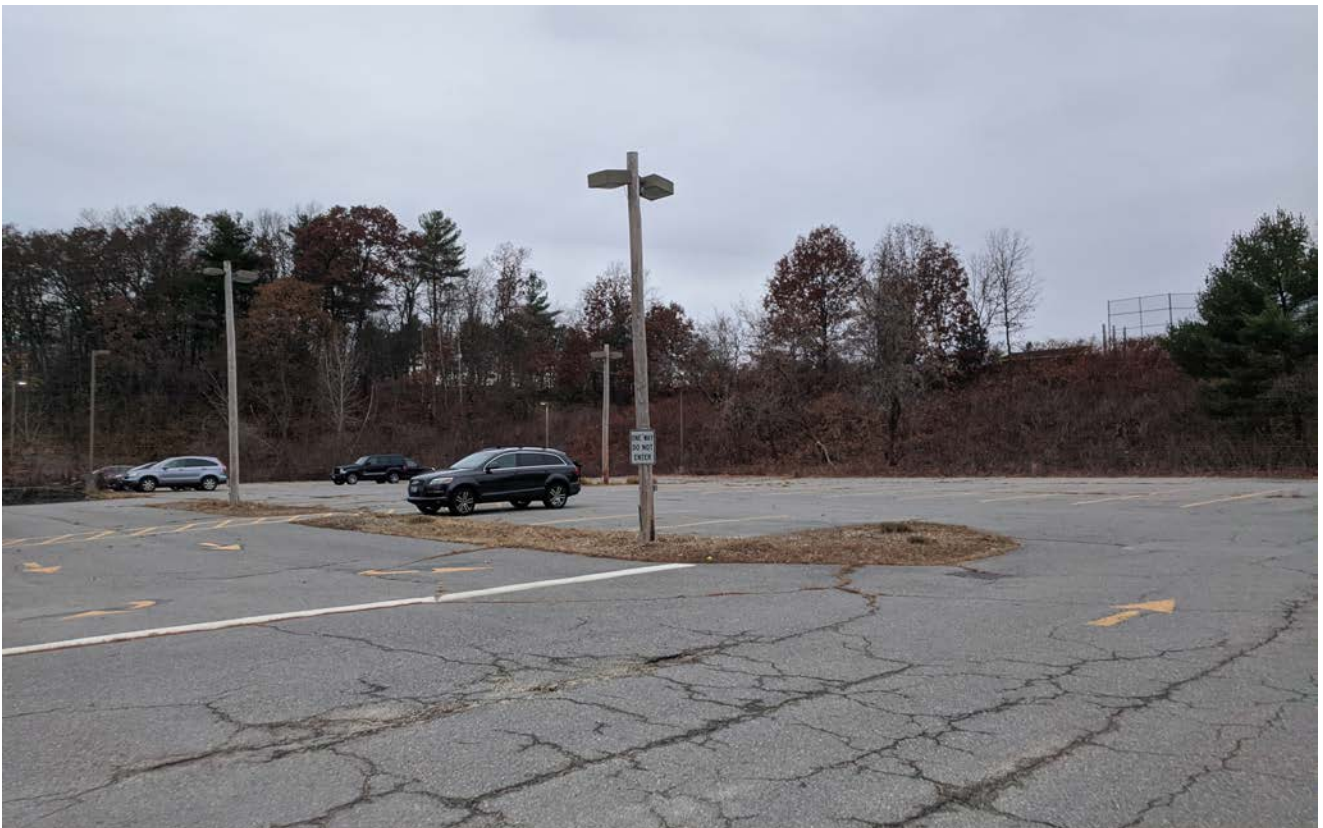
Overall parking lot view, shows
painted vehicular arrows

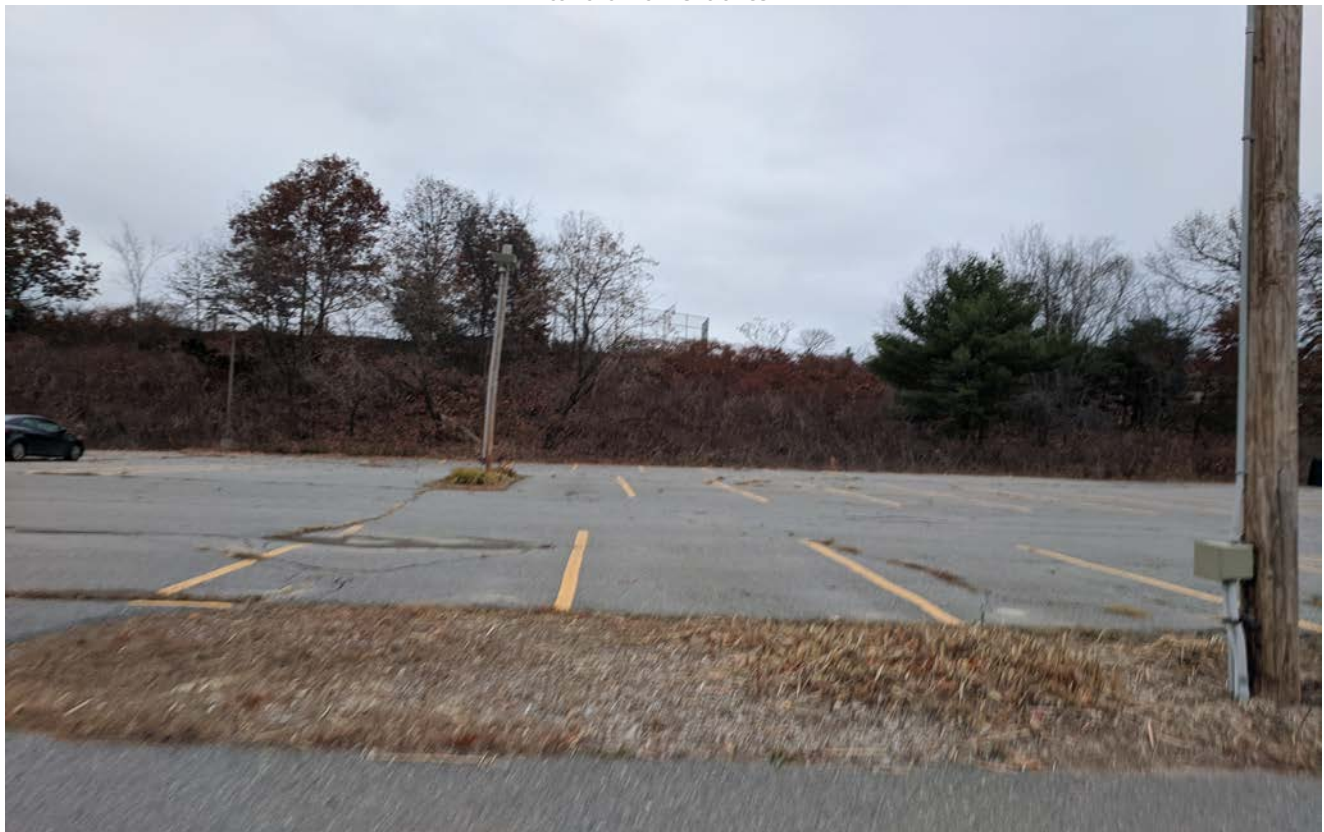
Rear parking lot view

Portions of pavement within the western and eastern driveway entrances as well as the connecting fire lane, the driveway along the east side of the building, and the rear parking lot are cracked, worn, and contain vegetation. These areas should be repaved and regraded as necessary.

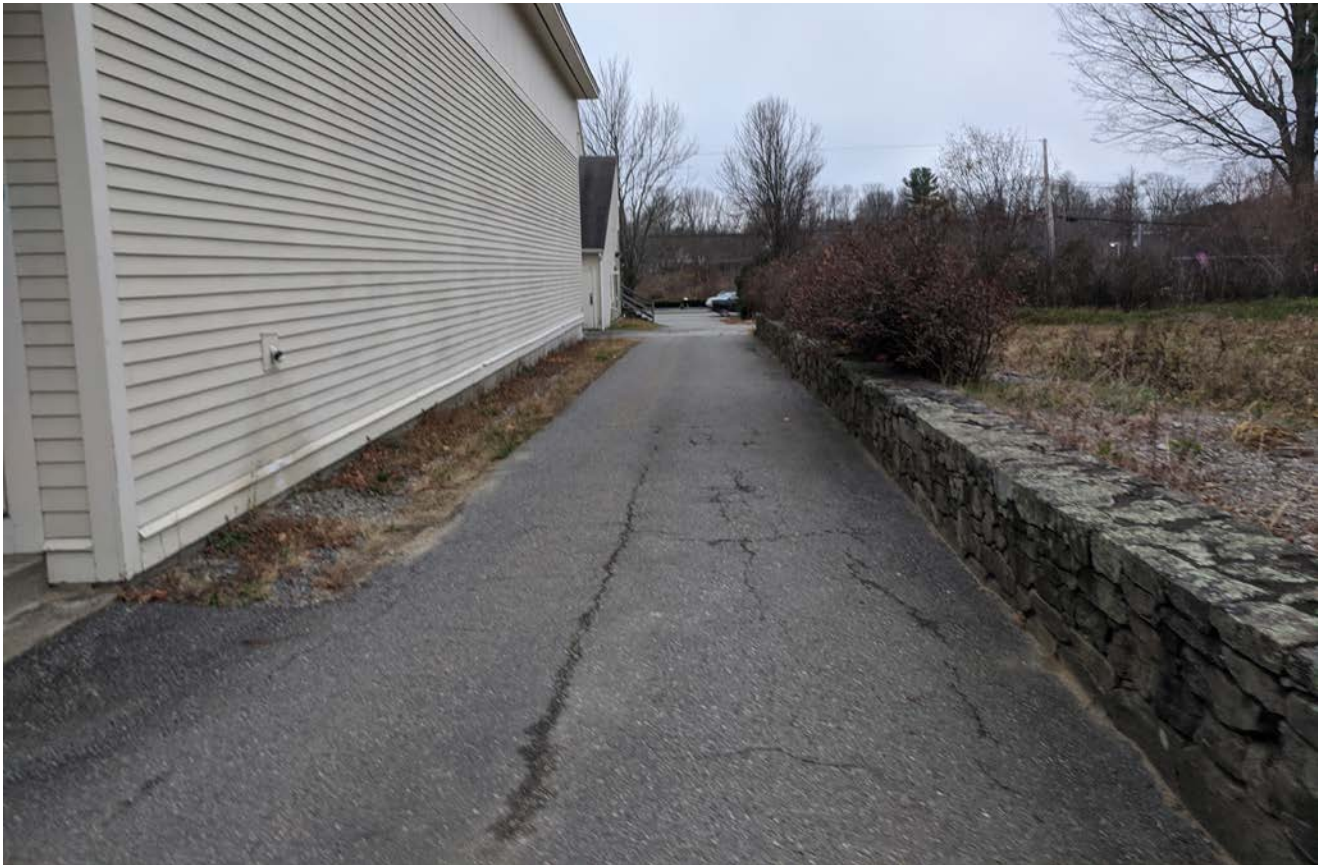
Fire access along side of building

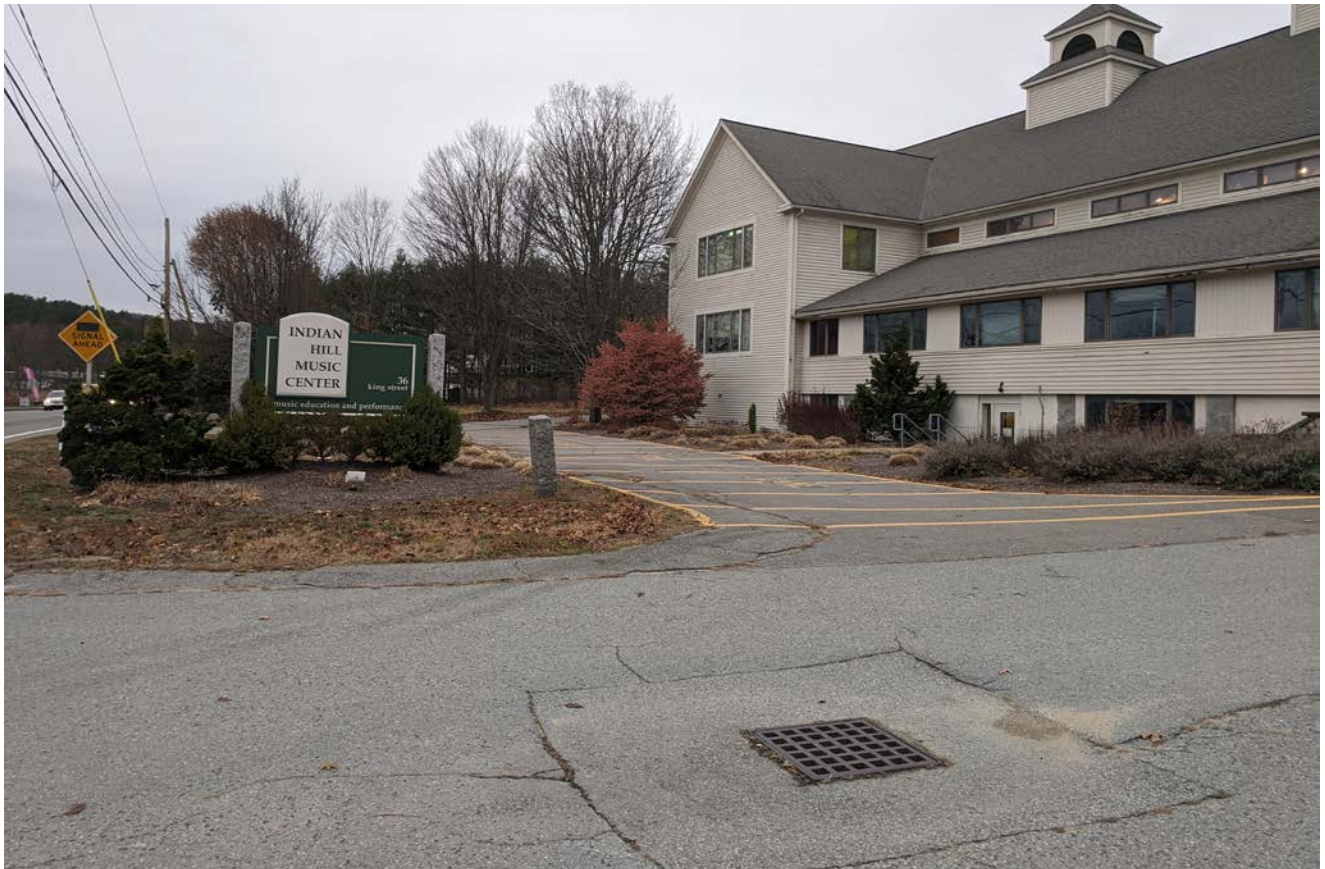
Catch Basin at Main Entrance off King Street

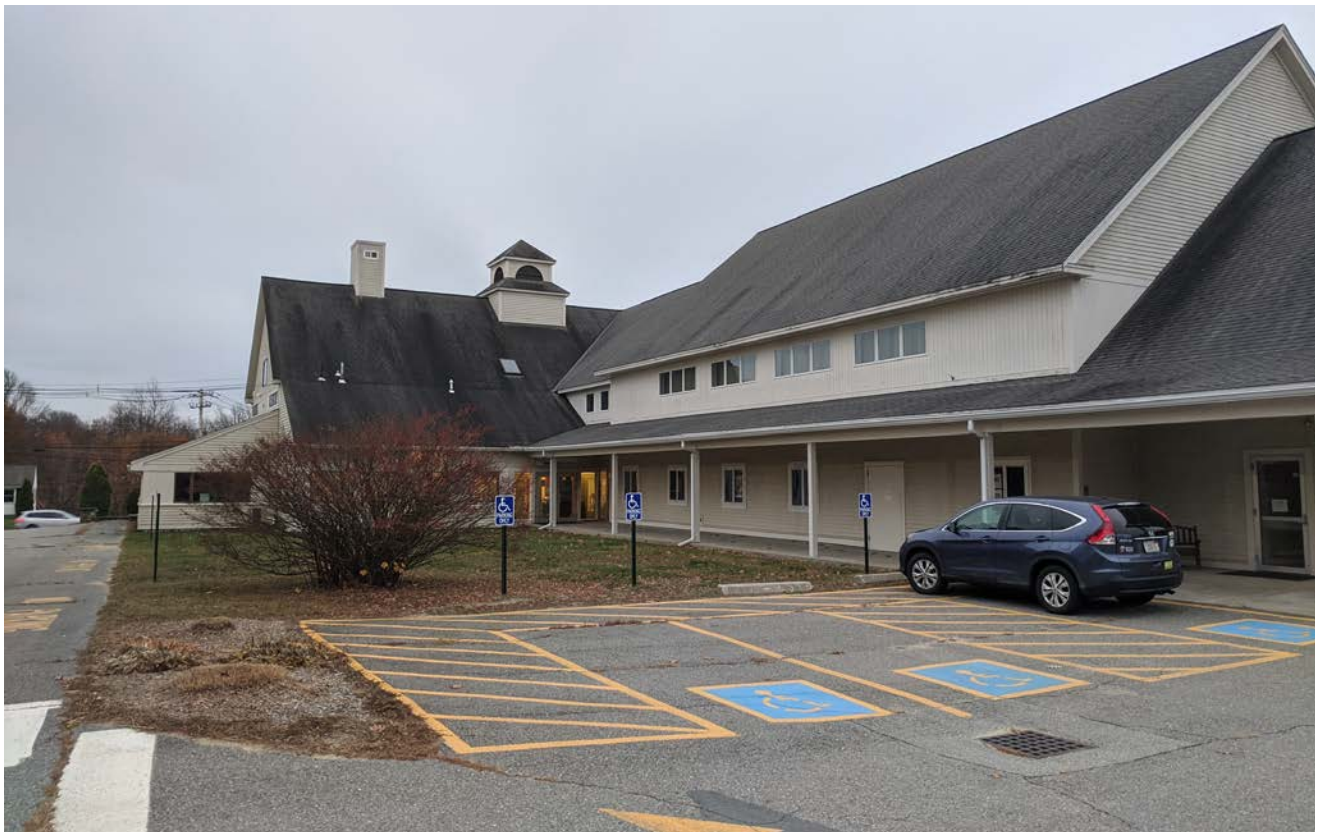
Handicap parking at Main Entrance

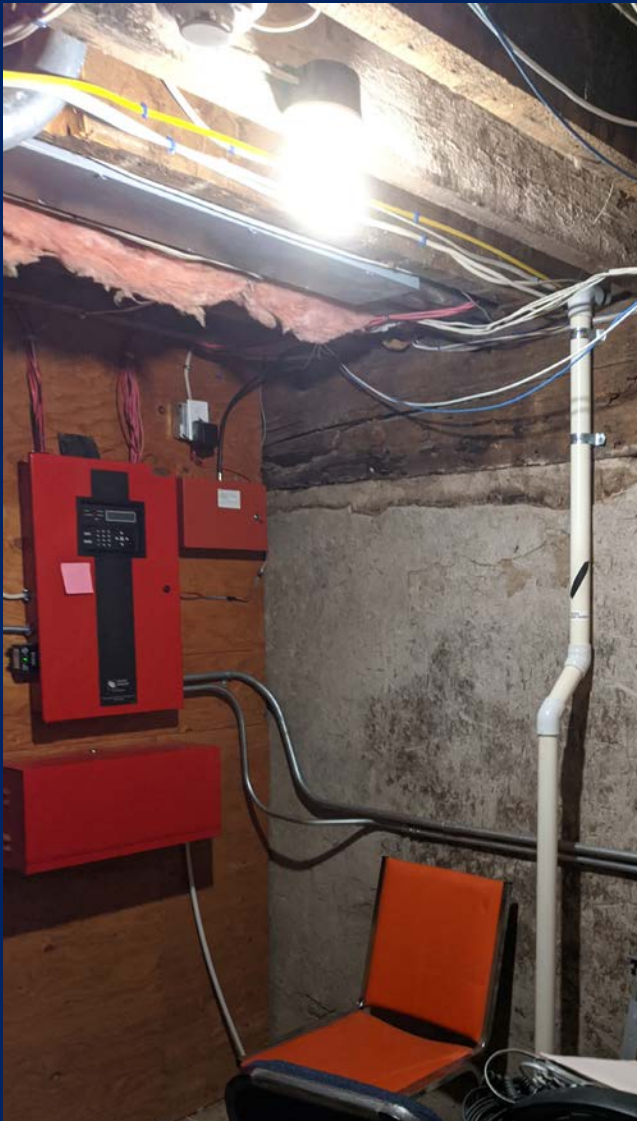
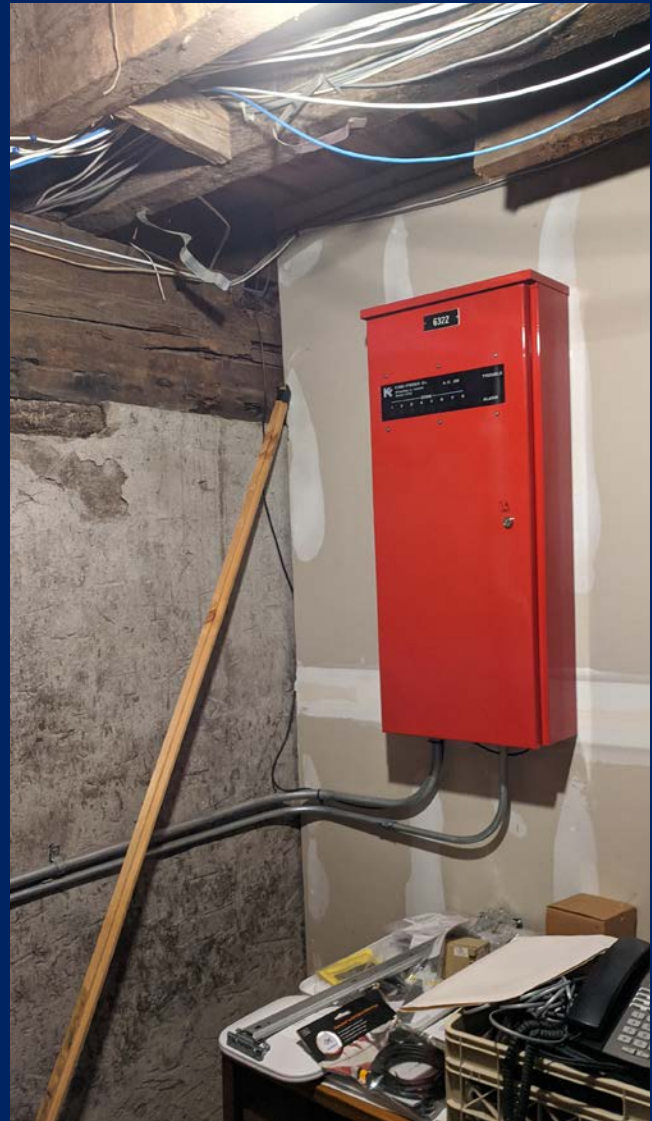
Fire protection system panels. (Basement)

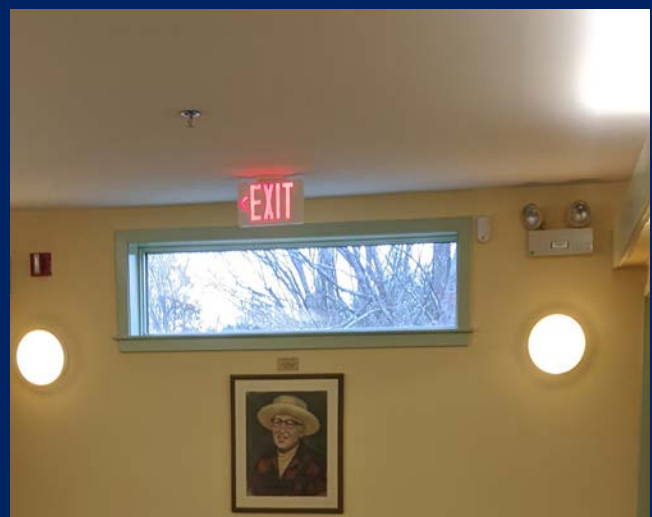
Typical Fire Alarm (strobe/alarms, exit signs and emergency lights) and Sprinklers throughout corridors and offices. (Second Floor)

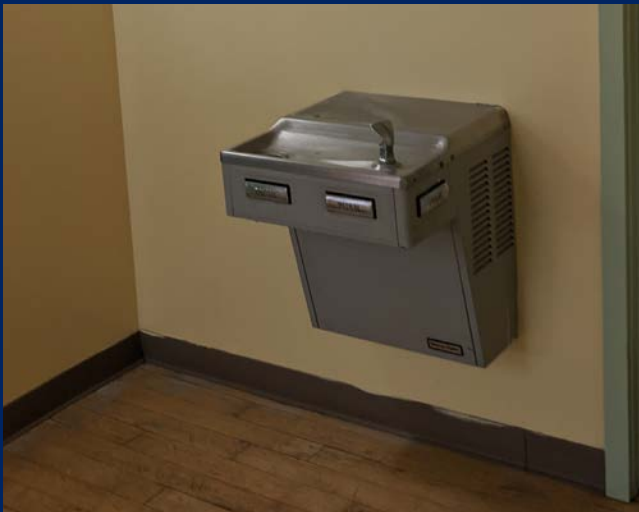
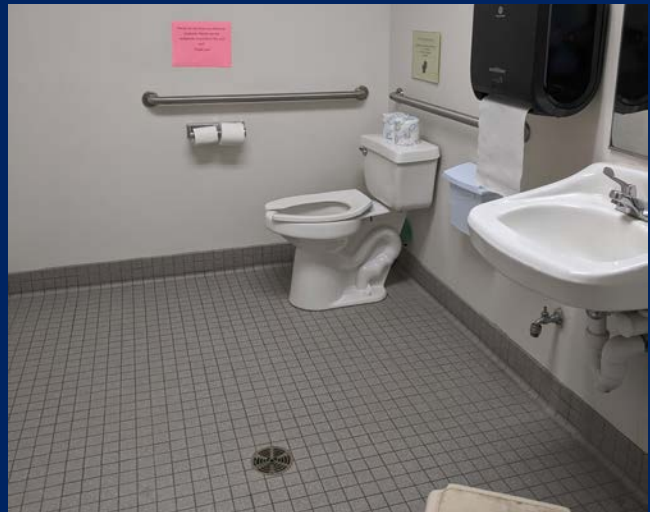
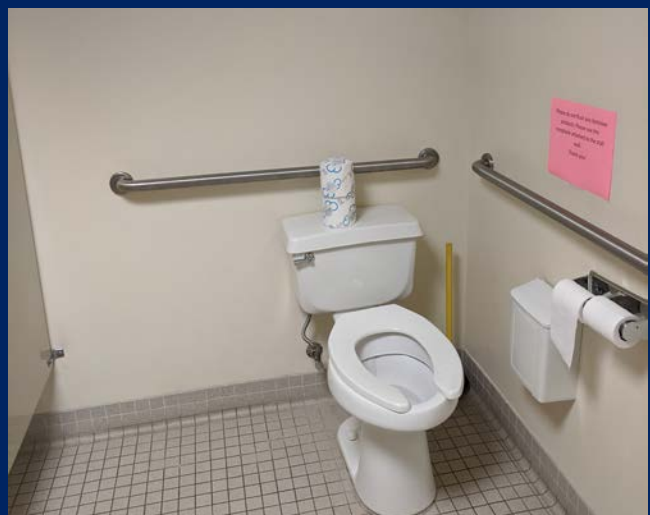
Existing fixtures appear adequate for fixture use. (First Floor)

Existing fixtures appear adequate for fixture use. (Second Floor)

Existing fixtures should be evaluated based on any modifications for new program use of the building. If fixtures are replaced, low-flow fixtures are recommended.

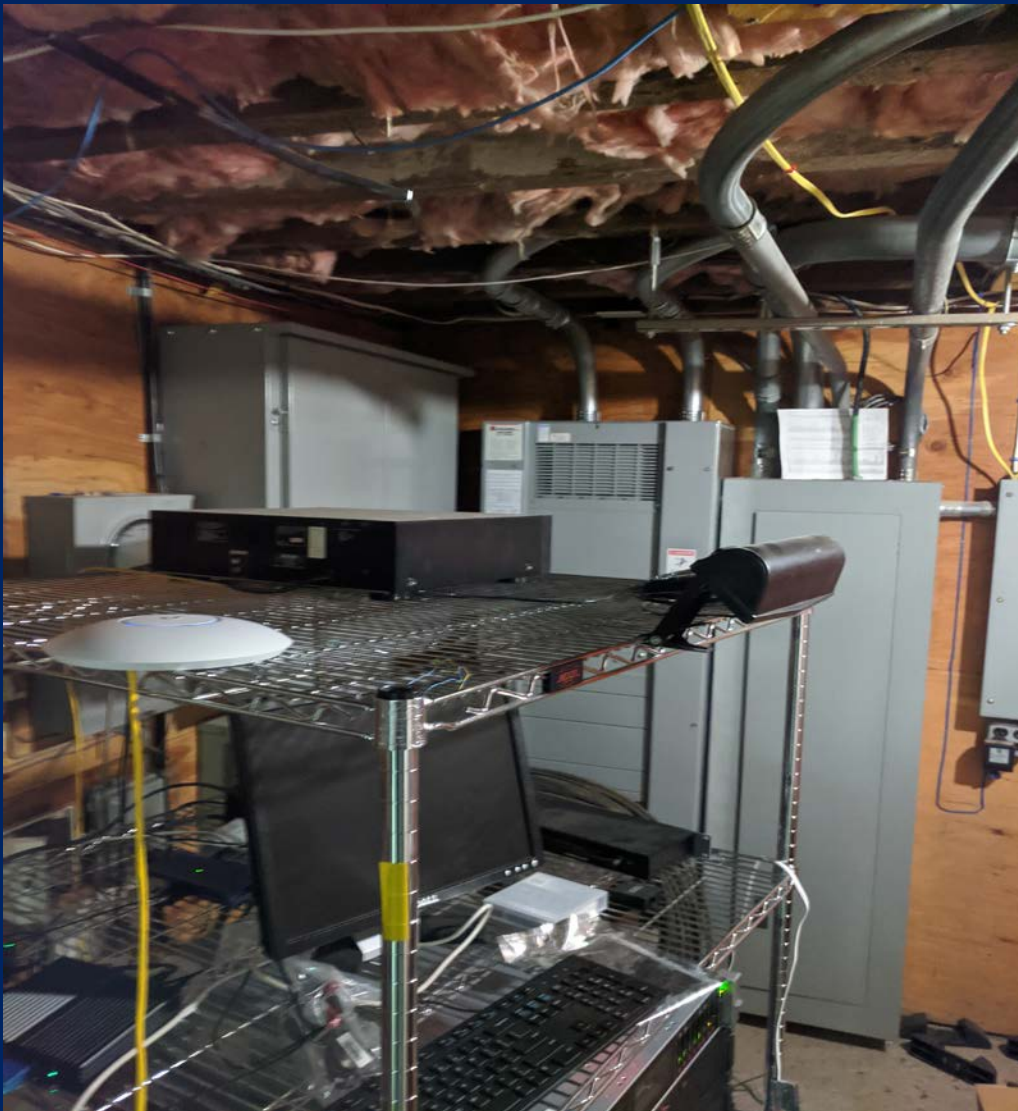
Electrical equipment. (Basement)

The electrical distribution panel is in good condition and may be reused. Existing Panels 'PLL', 'P1B', 'L1B', 'P1C' and 'P2' are old and should be replaced. Panels 'P' and 'PP' are in good condition and may be reused. The existing panelboard feeders may be reused if the new program layout allows the existing panels to remain in the existing locations.

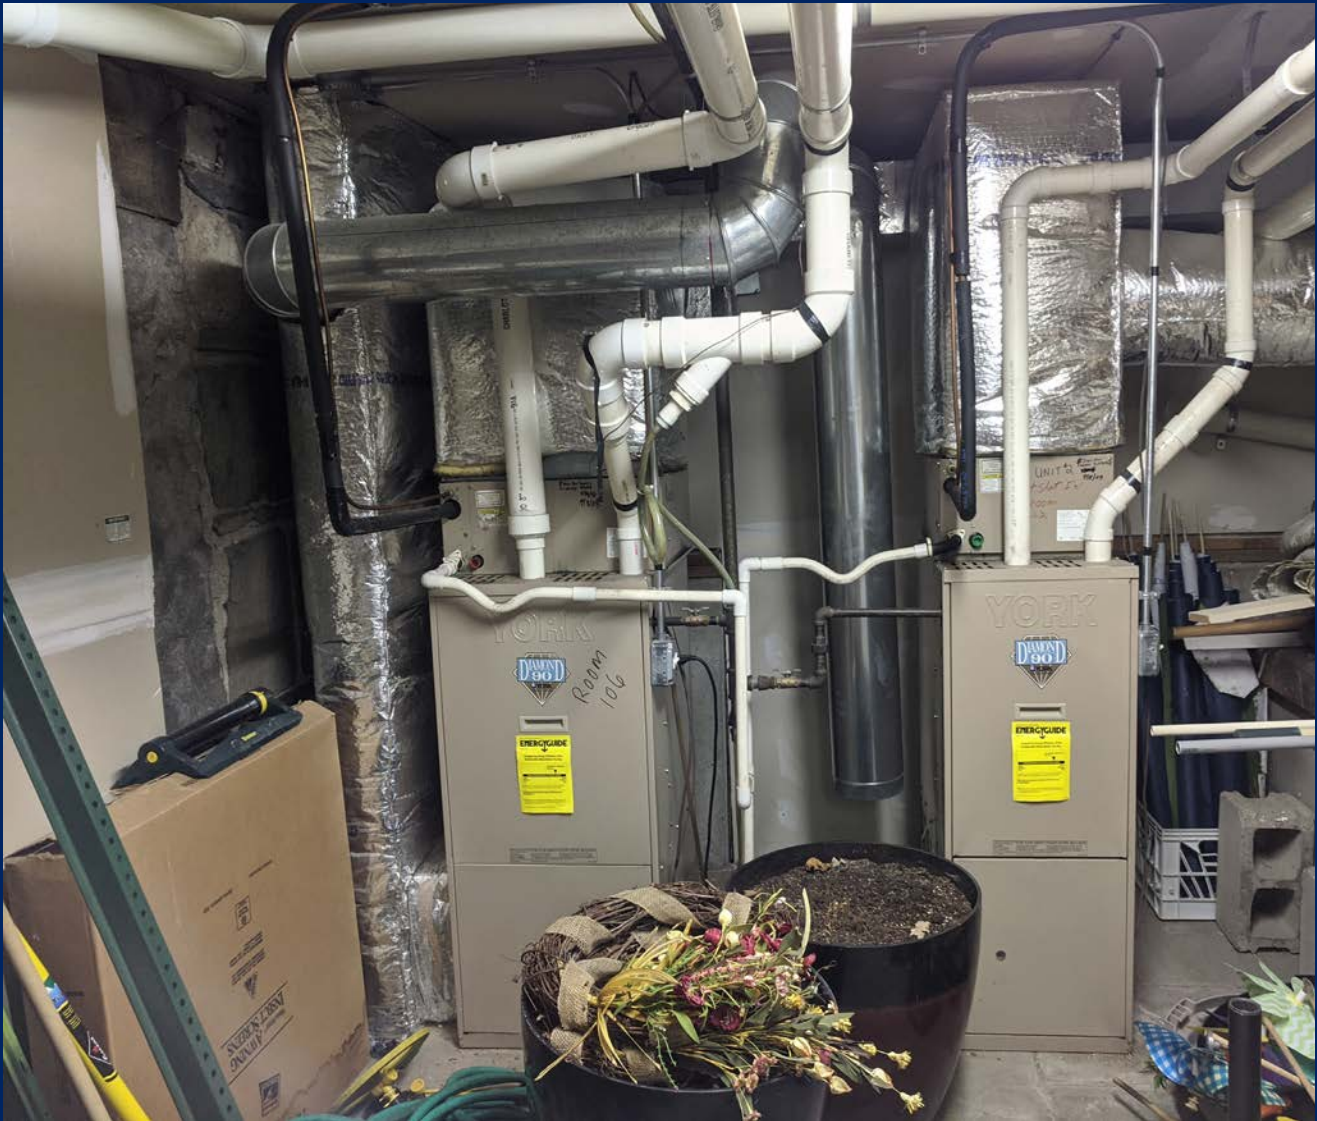
HVAC Equipment. (Basement)

Most of the existing HVAC units are newer and appear to be in good condition and should be useful for another 5-10 years with proper maintenance. Some are in fair condition with respect to the outdoor compressor/condensing units and may be reaching the end of their prospective useful life (< 5 years). Typical annual maintenance for split DX systems with gas furnaces includes outdoor coil cleaning, checking refrigerant charge levels, and checking indoor unit components for proper functionality (blower fans, intake and combustion air path, draft inducers, and flame/combustion integrity). Quarterly maintenance should include filter changes.
