# Littleton Town Hall Building & Space Needs Assessment

## Volume III: DCU Office, Existing Conditions Report

DCU Office & Retail Branch Building  
255 Great Road  
Littleton, MA 01609

October 2019

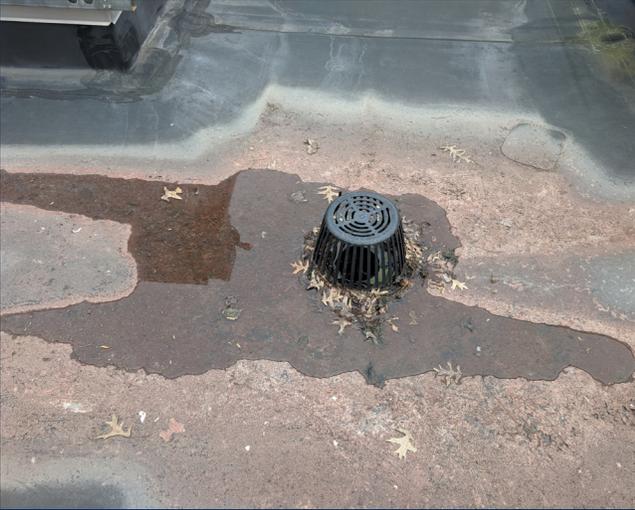
Ponding on roofing at roof drain.

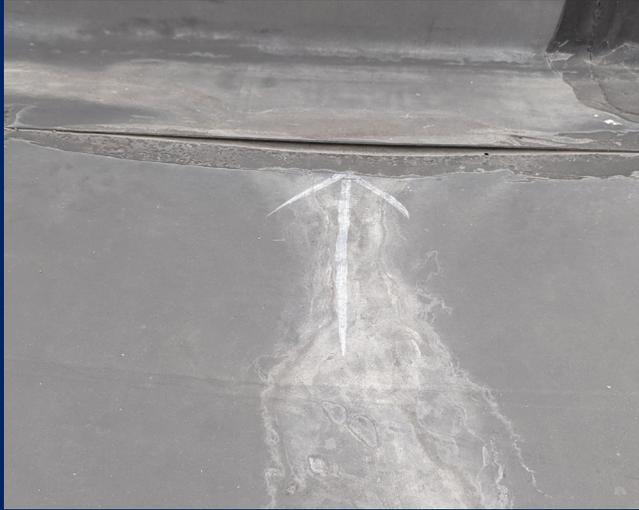
Evidence of ponding of water near mechanical unit. Gap in base flashing, chalk arrow (placed by others) points toward gap.

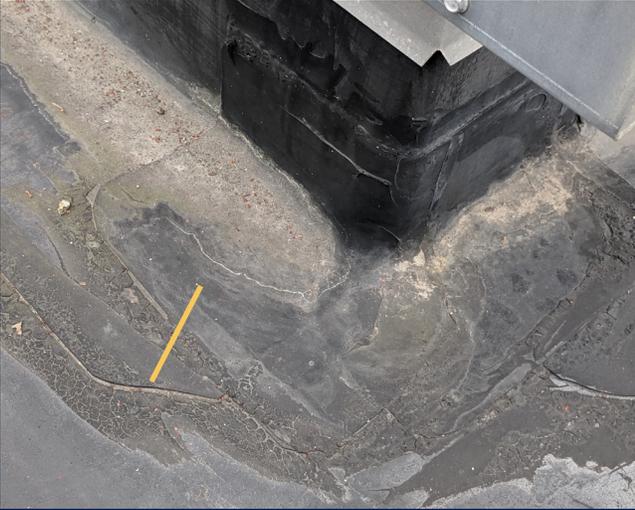
Evidence of water ponding, signs of aged flashings can be seen where membranes separate, or "pull back".

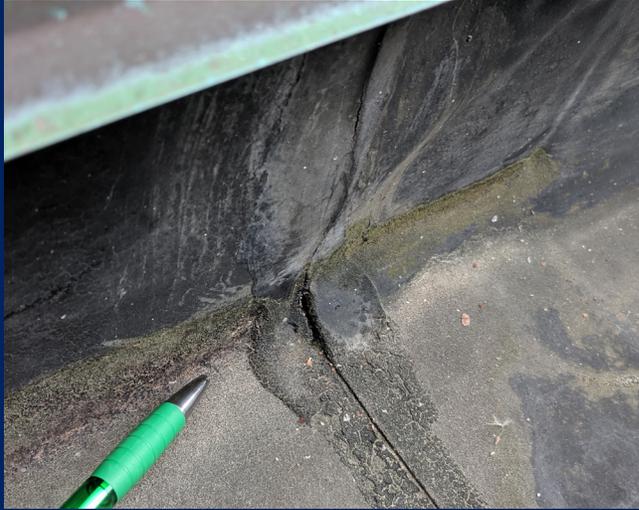
Organic growth around base flashing and gap in flashing.

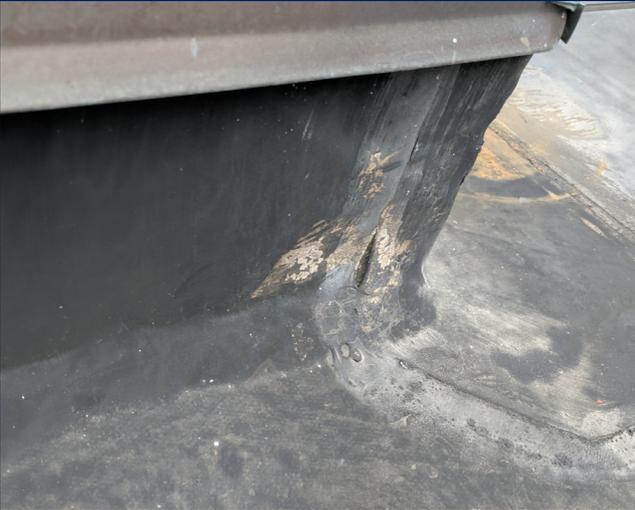
Gap in base flashing.

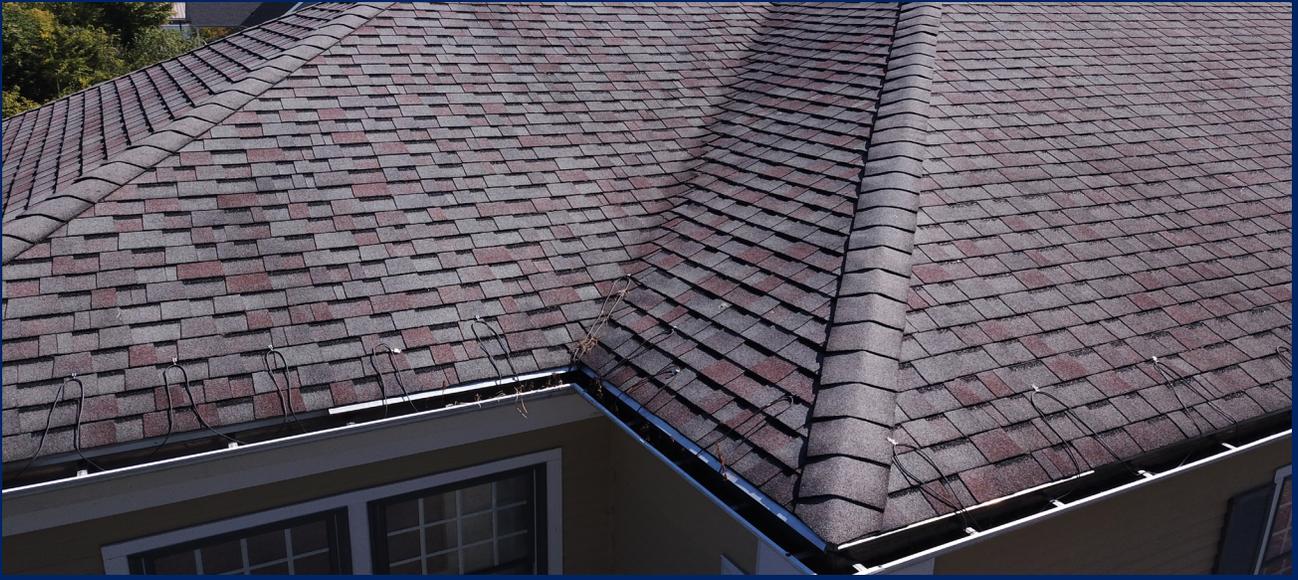
Example transition conditions at interior and exterior ridges, note rolled white trim at intersection of gutter and shingle.

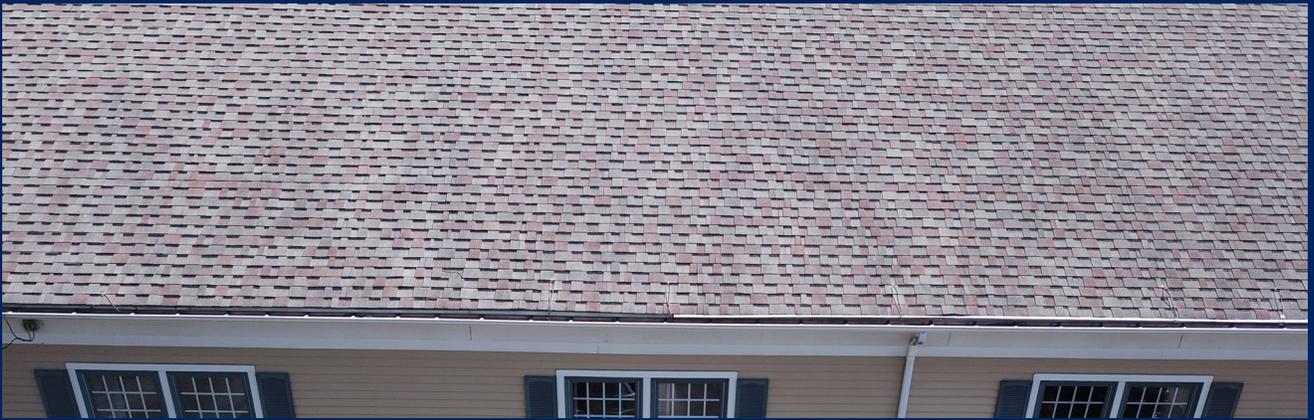
Example asphalt shingle roof, note rolled white trim at intersection of gutter and shingle edge, west facade.

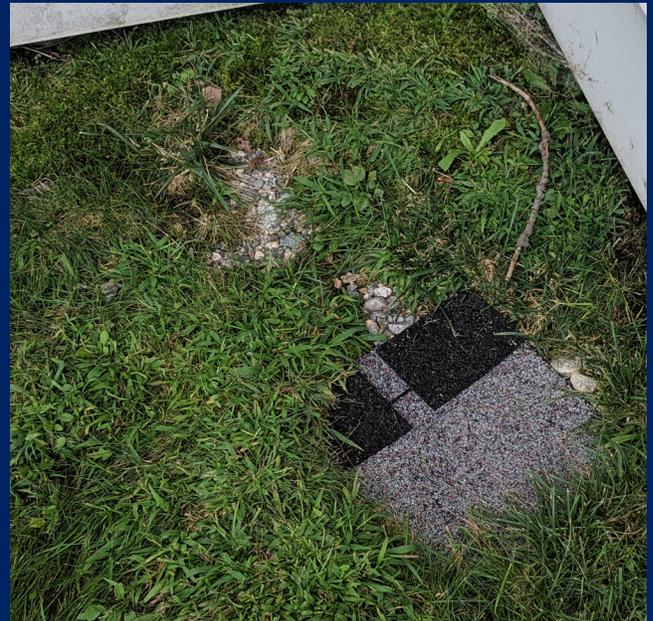
Fallen piece of asphalt fiberglass shingle on northeast.

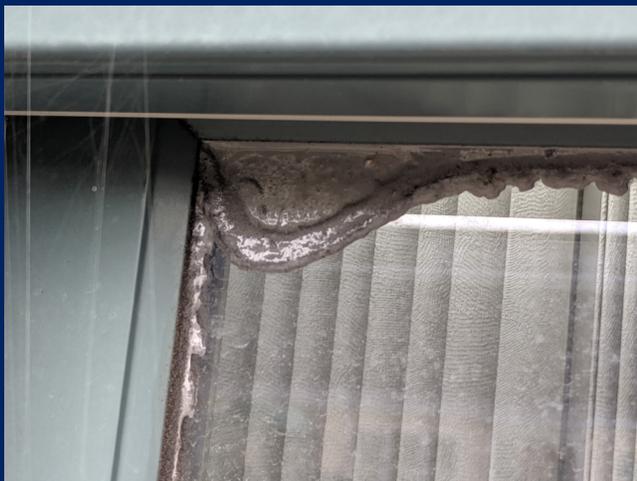
Evidence of sealant failure at sash head.

**Recommendation:** Windows should be repaired or replaced during the initial building renovations to prevent leaks, however this failed sealant joint is typically installed in a factory setting- and therefore full window replacement is most likely required.

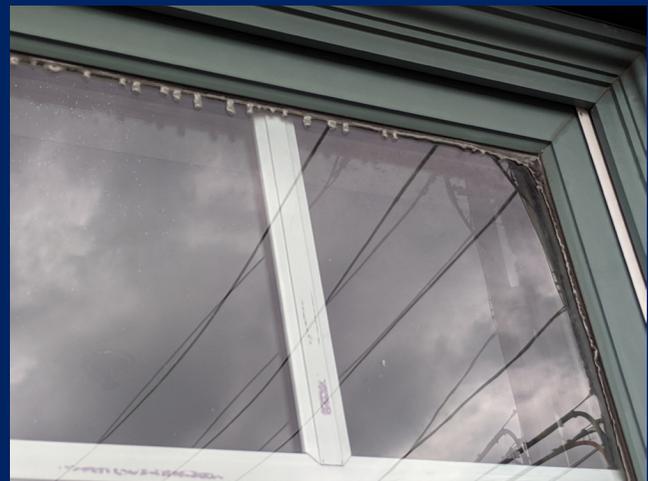
Evidence of sealant failure, typical.

Numerous window sash sealants show evidence of failure due to sagging/seeping sealant between the Insulated Glass Unit (IGU) and the sash frame. This is a case of severe sealant squeeze out. This sealant is butyl sealant that most window manufactures use as a sealant between glass and frame. Excessive heat can cause it to ooze out more. This appears to be an extreme case. It can usually be cleaned up and life can go on, but since there is so much coming out/visble, there may not be much left keeping the window/glass sealed.

All glazing gaskets and sealants should be removed and replaced during the initial building renovations. Any rust at window headers should be cleaned and the headers resealed to prevent further oxidization. Damaged interior finishes should be removed and replaced. With these repairs and regular maintenance, the curtain wall and window units should last another 15-20 years until they have reached their end of life and will need to be replaced.

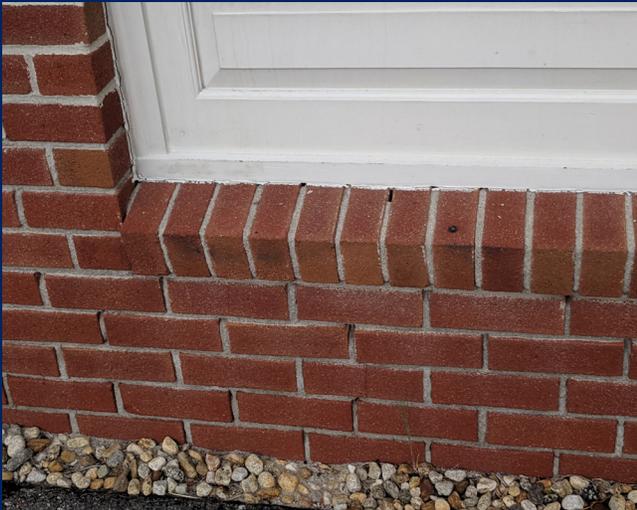
Visible mortar missing at window sill, and poor toothing of joints on vertical surface joints, lack of weeps low on the wall.

Most significantly, there are portions of missing sealant and mortar under the existing window sills on the South facade. These sections present significant potential for water infiltration and subsequent damage to the building and interior walls and insulation. Further investigation beyond the scope of this report will be required to assess the current situation and confirm the extent of repairs required in these areas, both externally and internally.

**Some mortar joints are failing or missing; roughly 5% of the exterior facade will require repointing during initial building renovations.**

At a minimum, we suggest adding sealant to the open joints to ensure a weather tight building envelope in the interim.

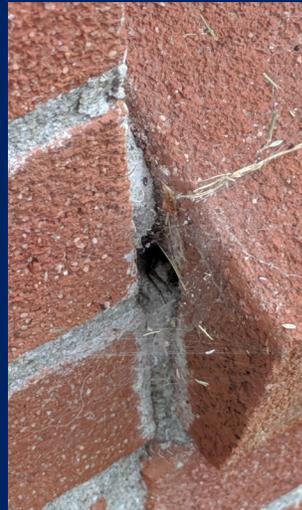
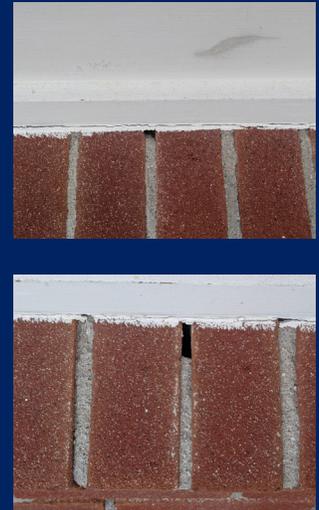
Various points of missing mortar at the exterior sills.

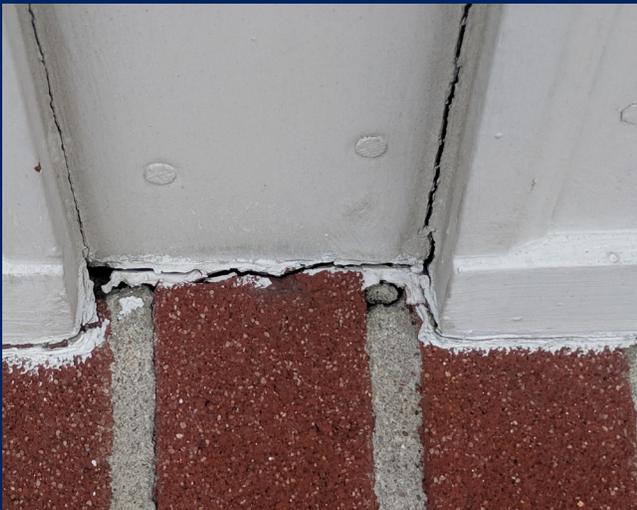
Evidence of missing mortar and lack of sealant, this is a source of potential water infiltration. .

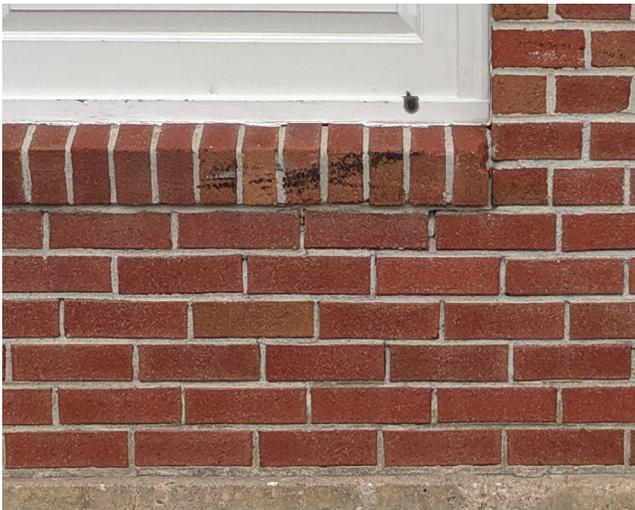
It appears as though the building sustained vehicular impact, you can see crack lines in the mortar.

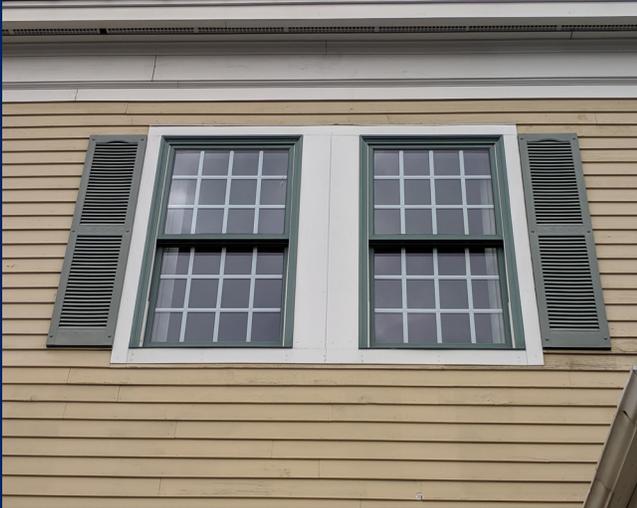
Evidence of damaged & deteriorated paint finish.

**Some clapboard are failing or missing; roughly 5% of the exterior facade will require repair during initial building renovations.**

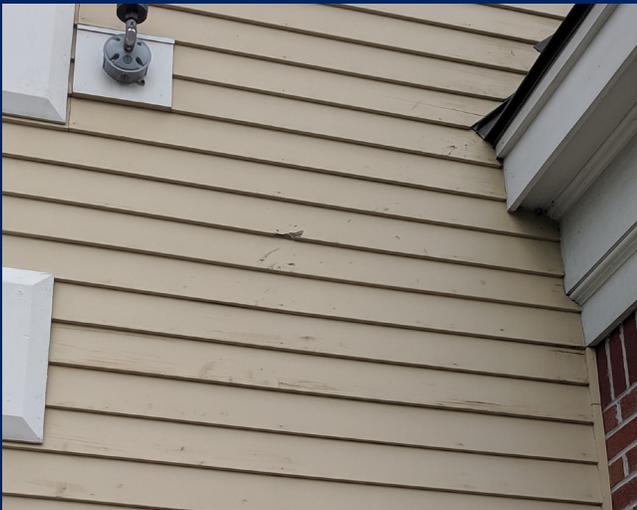
Evidence of damaged & deteriorated paint finish.

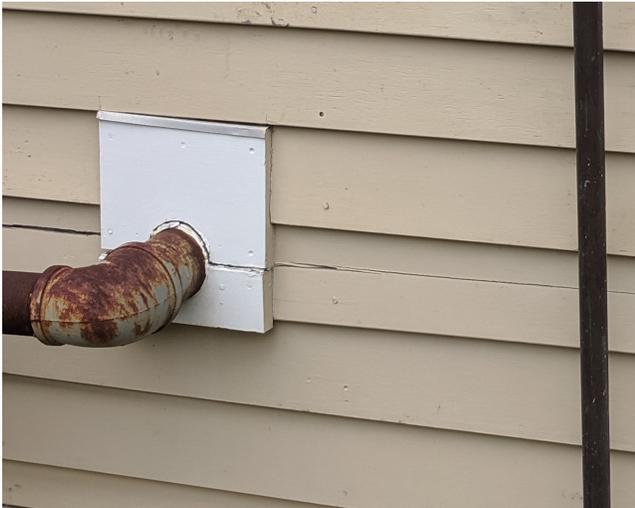
Visible horizontal crack in clapboard siding and trim at pipe penetration.

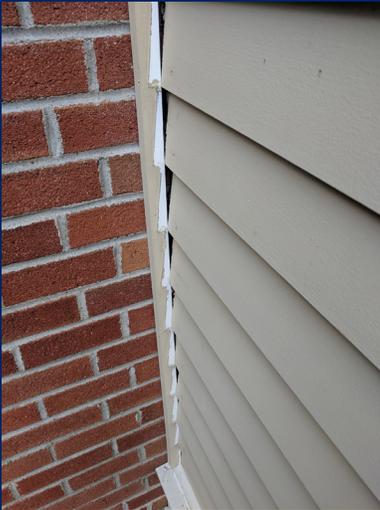
Observed vertical wall trim board.

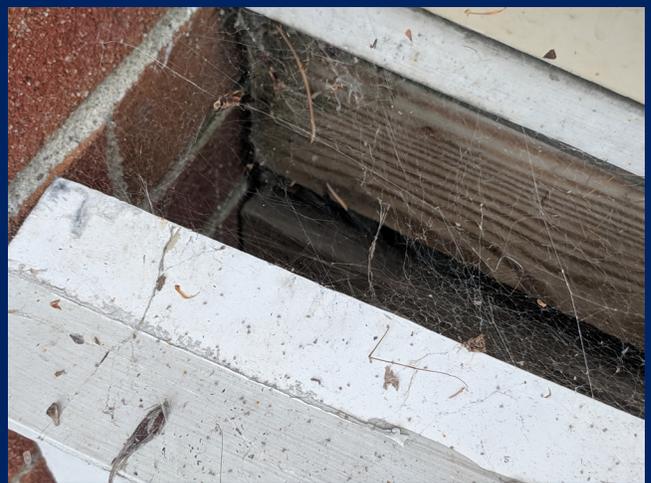
Closeup at horizontal trim board separation, exposing wall back up.

Most significantly, there are some trim boards that are failing or buckeling and will need to be repaired to prevent water infiltration and damage. These sections present significant potential for water infiltration and subsequent damage to the building and interior walls and insulation. Further investigation beyond the scope of this report will be required to assess the current situation, why it occurred and confirm the extent of repairs required in these areas, both externally and internally.

**Some trim is failing and exposing the backup wall system to water infiltration. Other trim is damaged and should be replaced.**

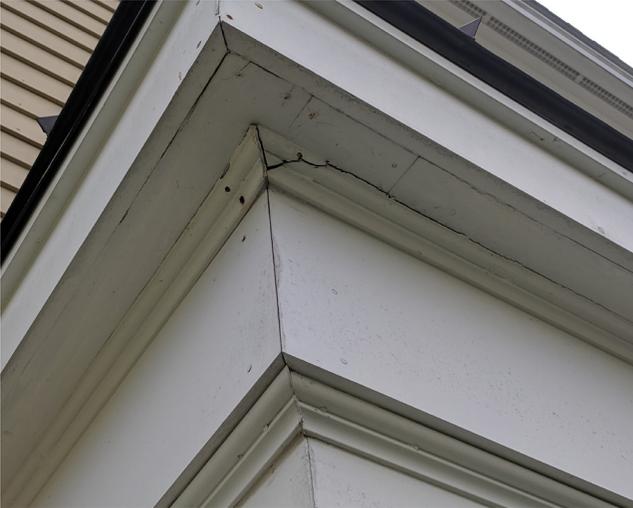
Observed horizontal cracked eave trim at corner, appears to start at mid trim and travels horizontally at upper edge.

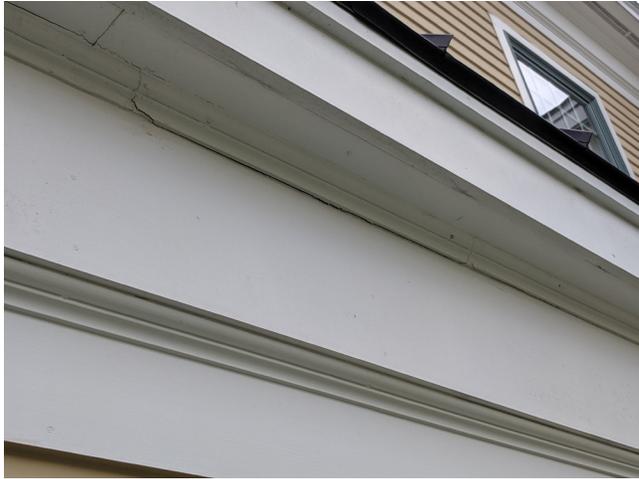
Observed horizontal cracked eave trim. Note, you can follow the crack from the upper edge, through the trim, to the bottom.

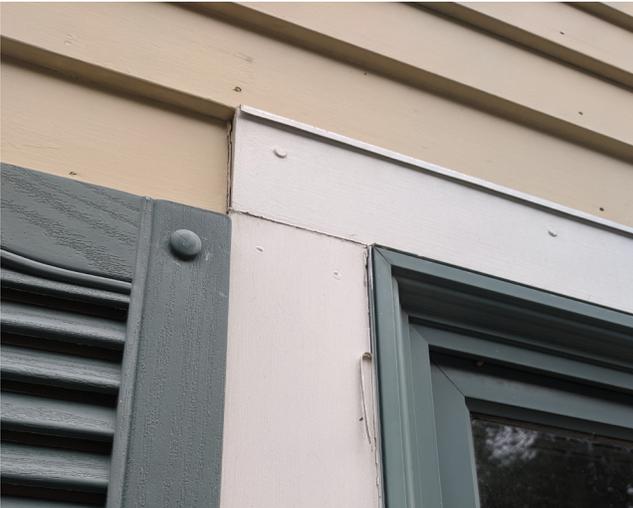
Closeup at vertical window trim board. Note sealant (or paint) failure at frame.

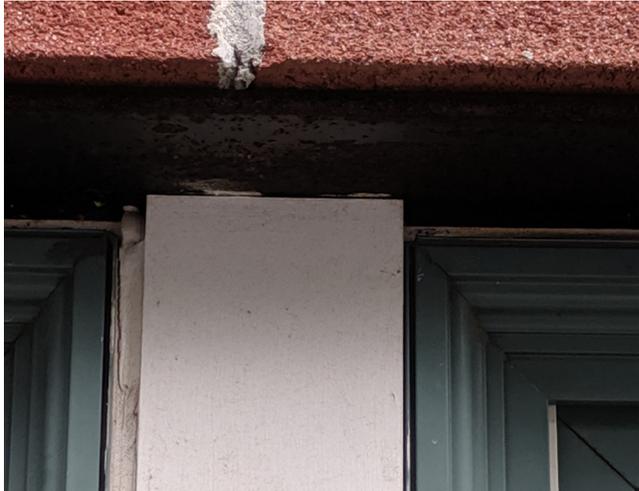
Closeup at vertical trim board between windows, note separation of sealant (L), no evidence of a sealant joint (R).

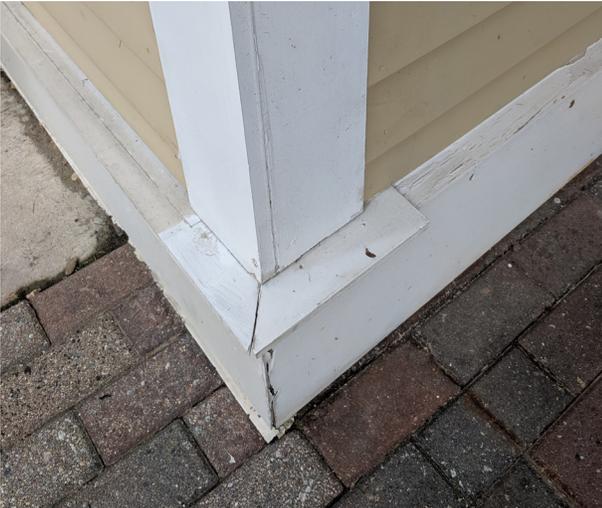
Observed horizontal wall trim board separated at corner.

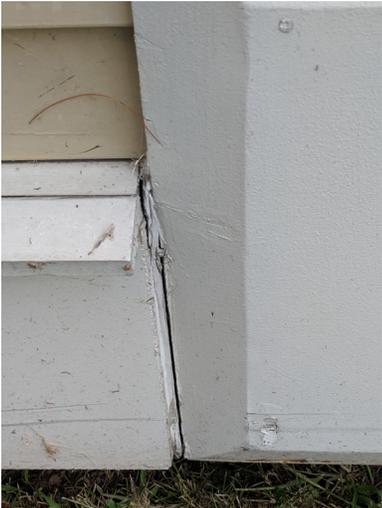
Closeup at horizontal trim board end abutting quion. Note sealant joint has failed and is separated.

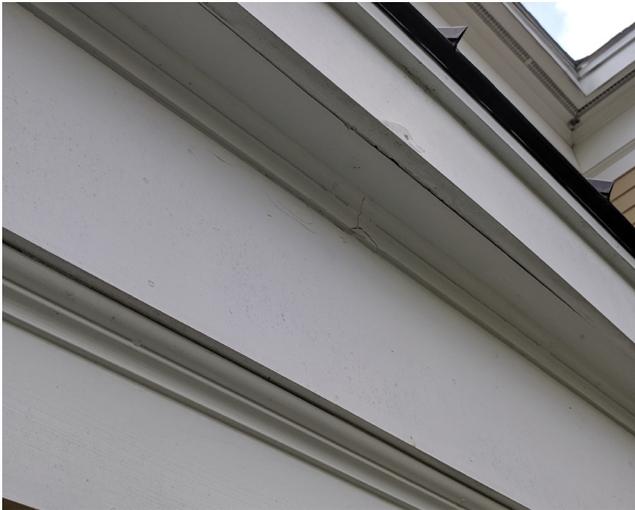
Observed cracked eave trim. Note, you can follow the crack from the upper edge, through the trim, to the bottom. Also you can see the bowed vertical fascia creating a gap.

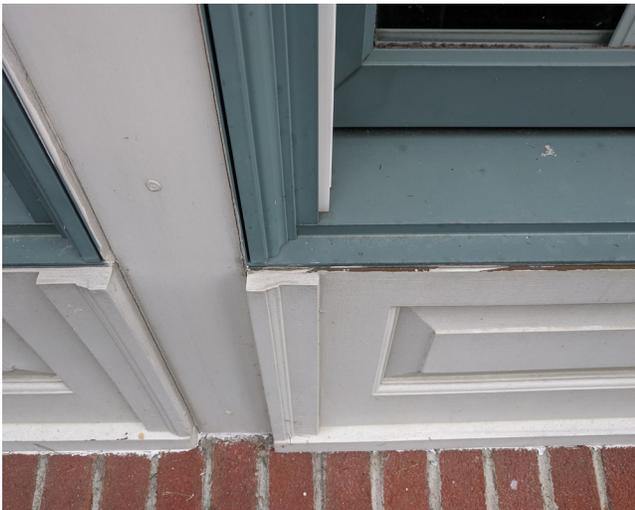
Closeup at top of window infill panel, note advanced weathering of unflashed horizontal edge (R), as well as lack of sill flashing.

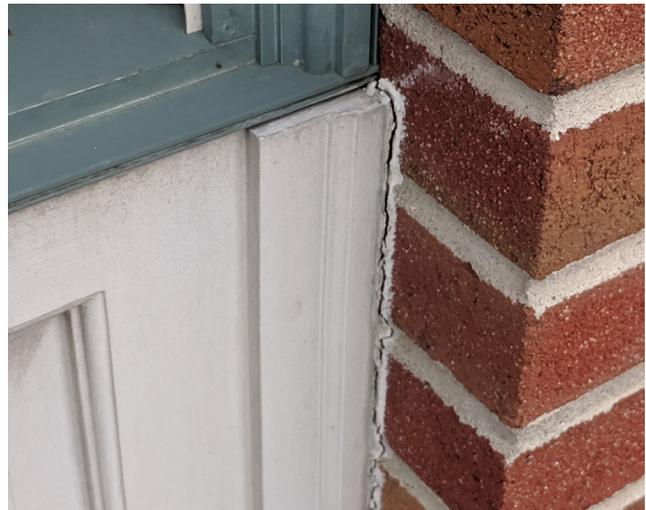
Closeup at vertical trim board at window infill panel. Note separation of a sealant joint at brick.

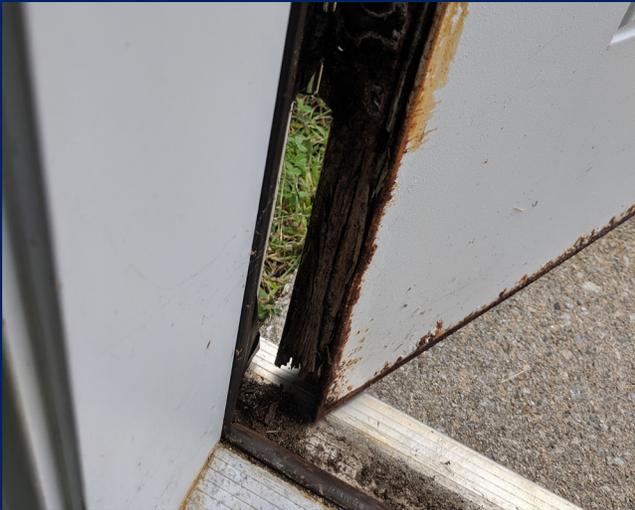
Evidence of damaged & deteriorated paint finish, and rotting (loss) of core material.

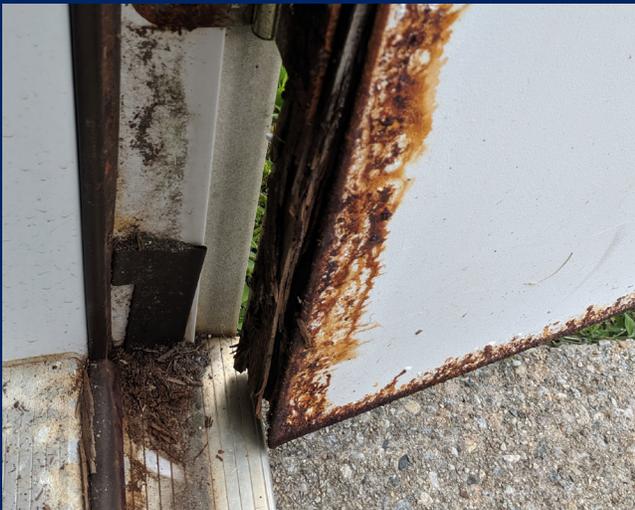
Evidence of damaged & deteriorated paint finish, and rotting core material.

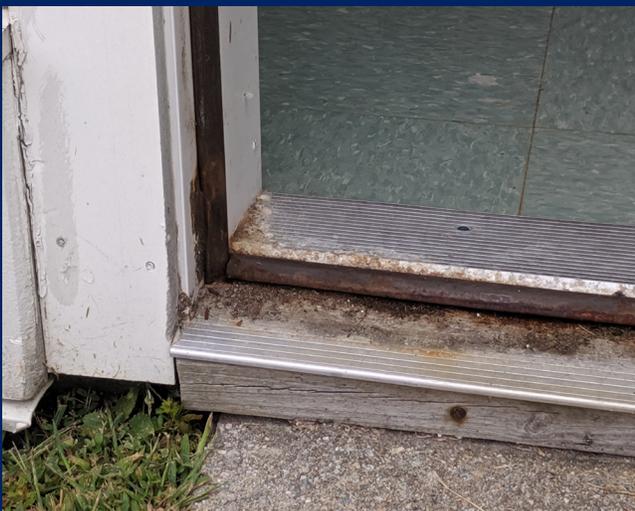
Evidence of damaged and rusting sill.

Most significantly, the three painted insulated steel doors on the East facade are deteriorating. These doors if not replaced, will continue to deteriorate and may present significant potential for water infiltration and subsequent damage to the building and interior walls and insulation.

**Exterior Doors on the east facade are in poor condition and should be replaced.**

At a minimum, we suggest replacing the exterior steel doors with more appropriate doors to ensure a weather tight building envelope.

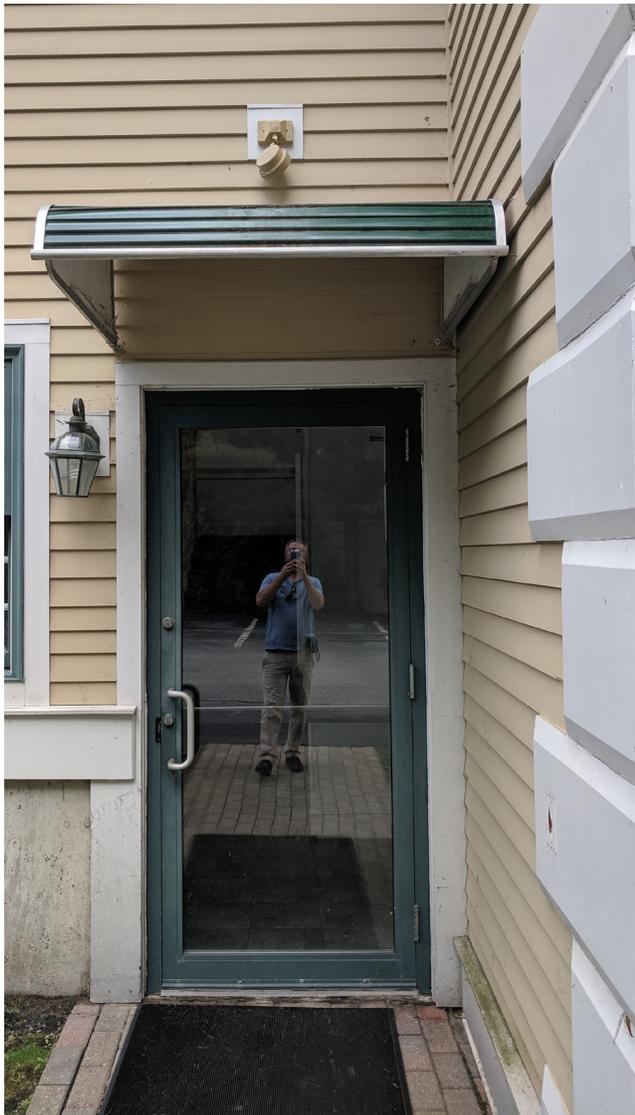
Overall view of aluminum and glass door at northwest corner.

The existing aluminum storefront with insulated glass occurs on the west facade. Generally the doors appear to be in good condition. Some white chalking of the finish can be seen, this is typical of similar finishes of this age in this environment. Salts and other ice prevention materials used near the entrances has shown to wear on the concrete foundation, as seen in the image below.

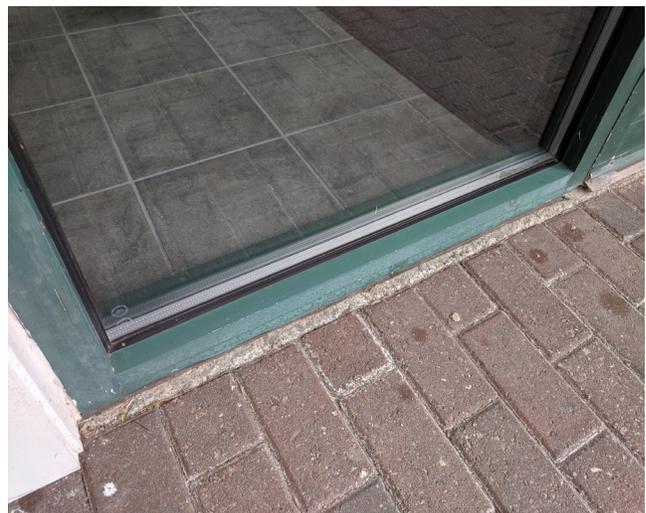
Closeup of aluminum sidelight sill at main entrance.

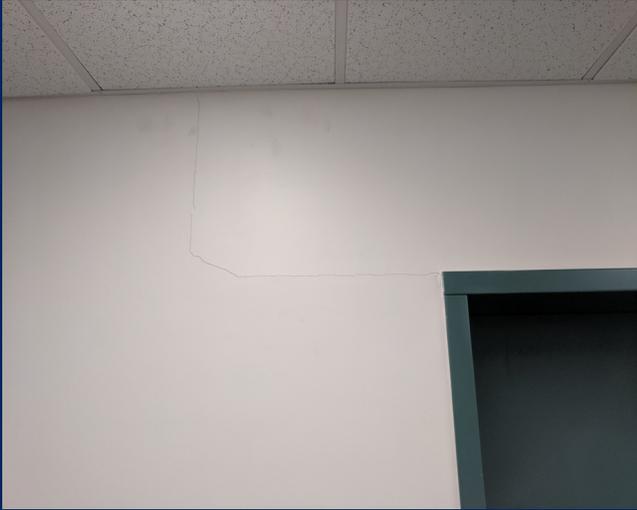
Observed crack above elevator door head, second floor.

Most of the observed cracks appear to be less than 1/8" and therefore generally might be considered harmless, or superficial.

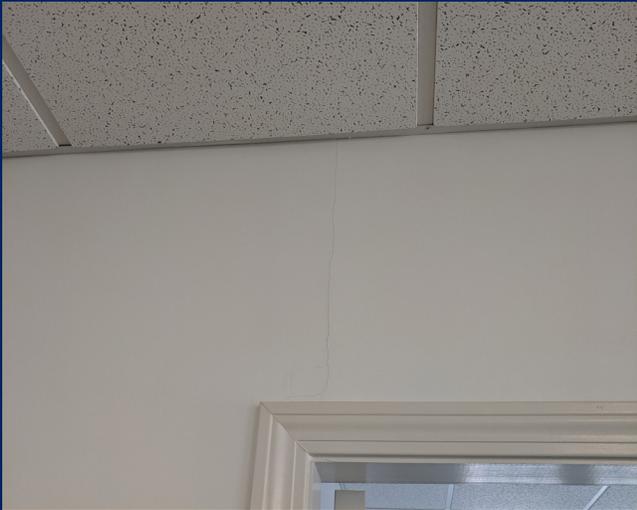
Observed crack at interior wall above door, first floor north.

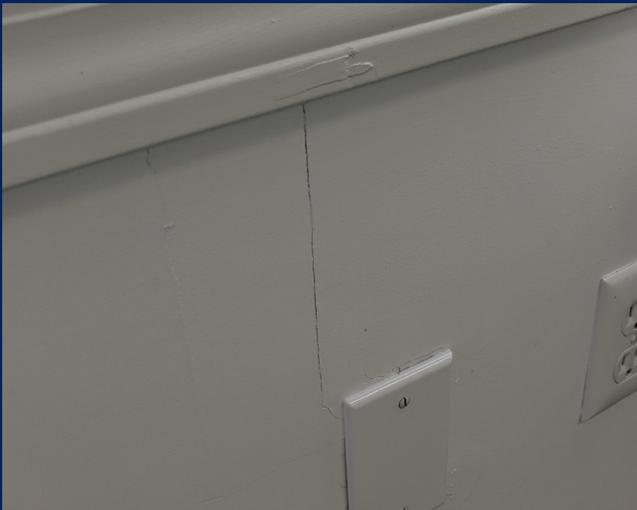
Observed crack at exterior wall below window, first floor east.

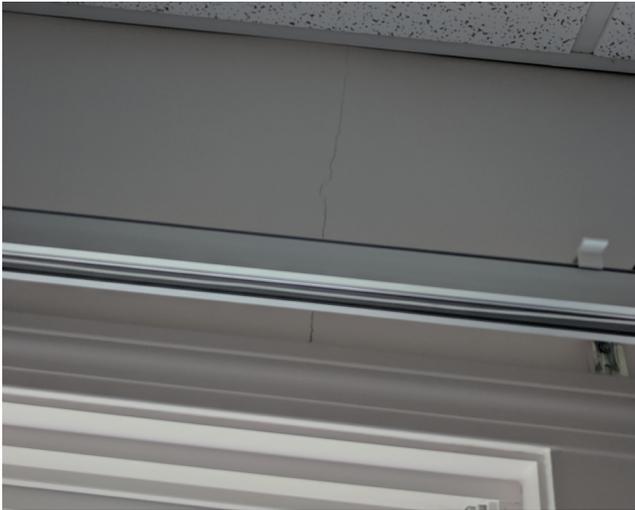
Observed crack above window head, second floor east wall.

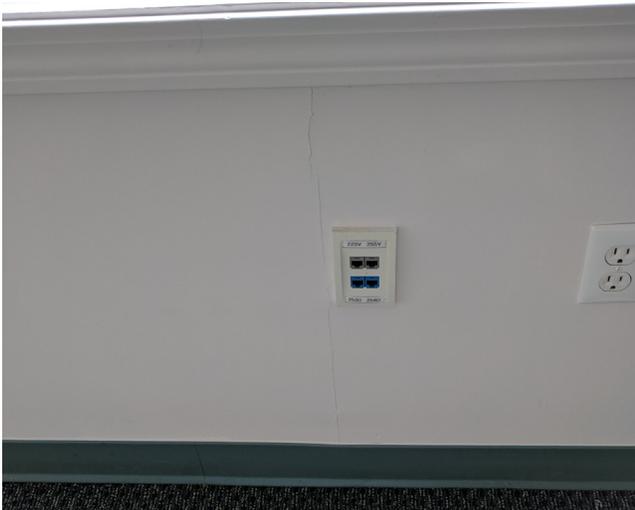
Observed crack below window sill, second floor east wall.

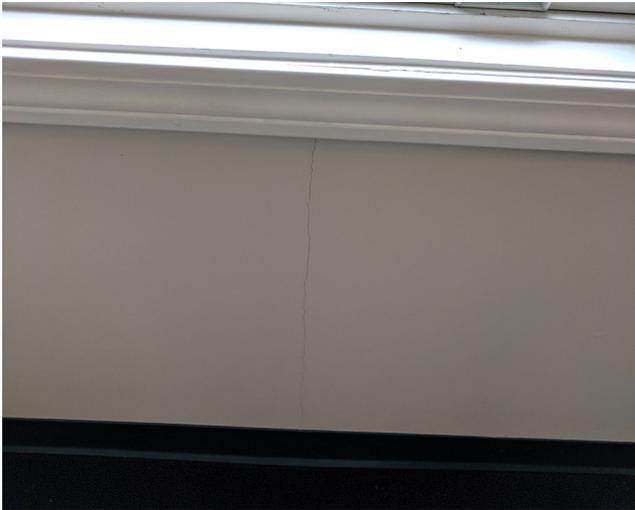
Closeup at bottom of window showing crack, second floor, east exterior wall

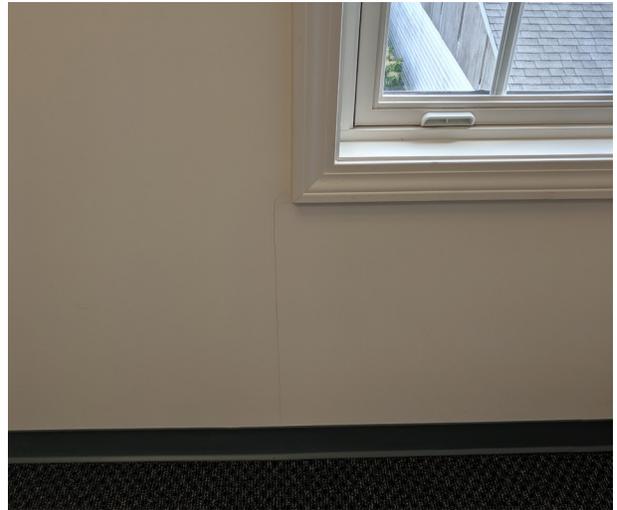
Closeup at bottom of window showing crack, second floor, east exterior wall.

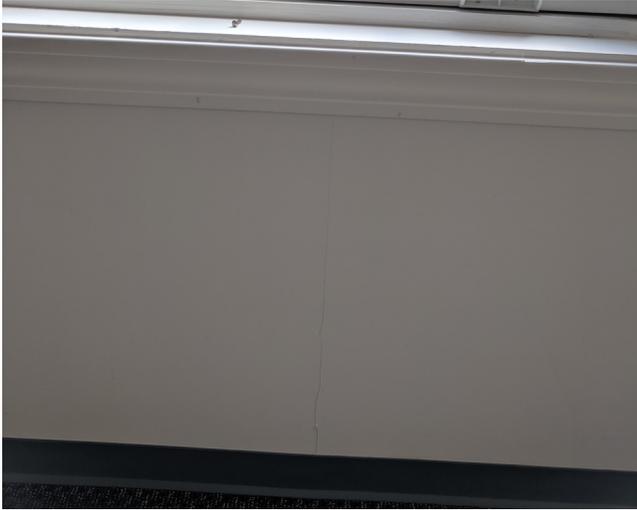
Closeup at bottom of window showing crack, second floor, east exterior wall.

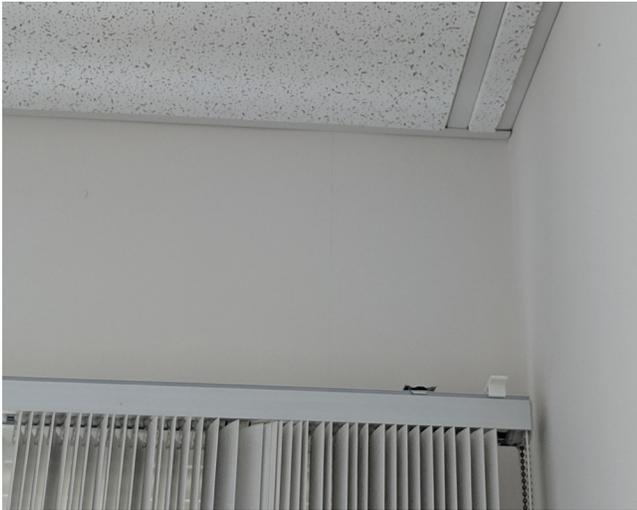
Closeup at top of window showing crack.

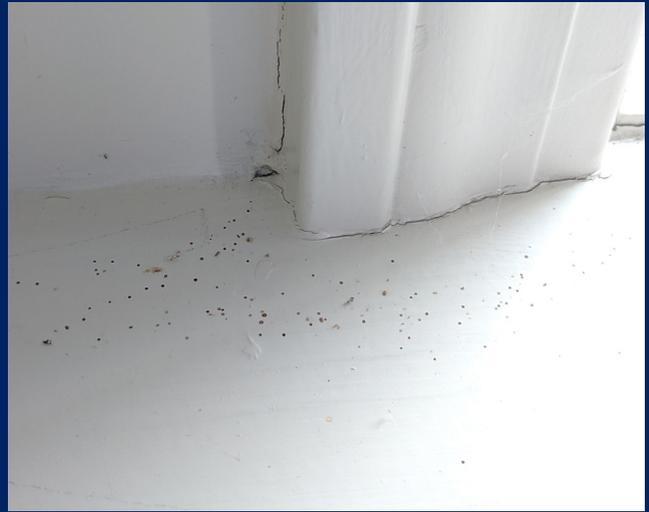
Visible evidence of pest activity at East window sill, first floor.

Testing for pests was not a part of this facility assessment however we did observe some conditions that were that presented themselves as potential pest damage. Generally we observed what appears to be frass, whether that was from termites or carpenter ants needs to further determined by an expert.

We suggest having a professional pest control company evaluate the existing conditions and offer solutions.

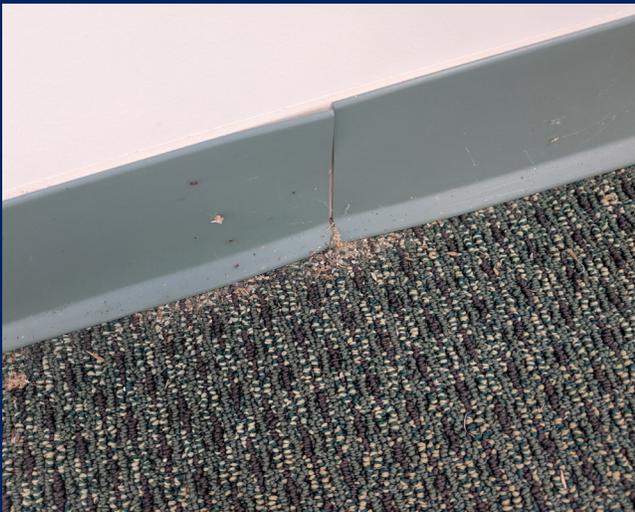
Evidence of what appears to be frass, first floor East wall at joint in wall base.

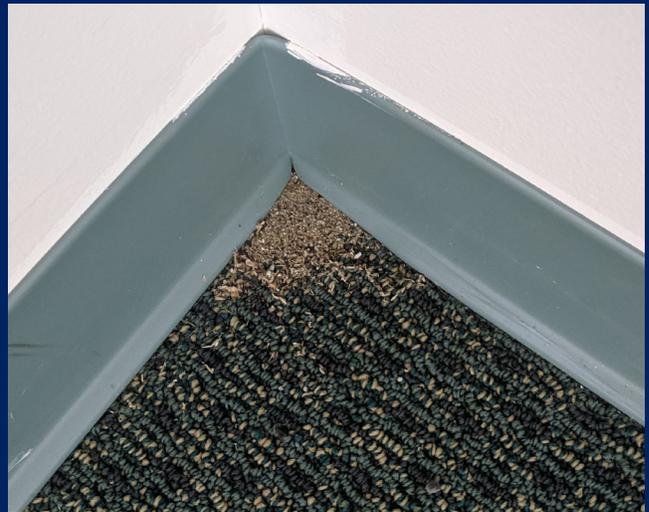
Evidence of what appears to be frass, first floor East corner at wall base corner.

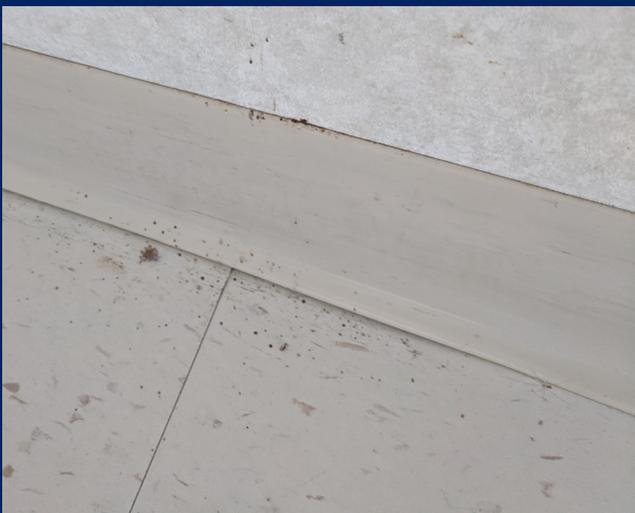
Evidence of what appears to be frass, first floor Southeast wall at joint in wall base.

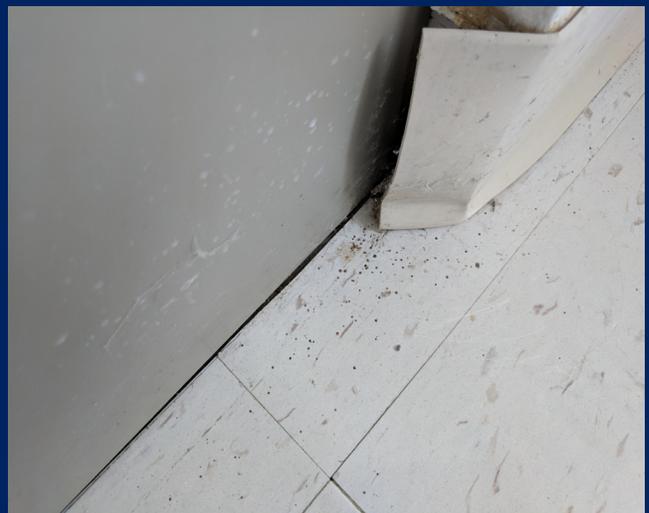
Evidence of what appears to be frass, first floor South corner at wall base corner at ATM infill.

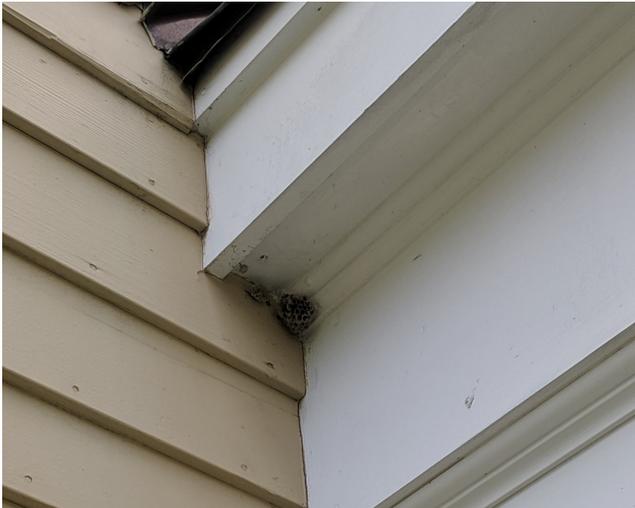
On the exterior we observed flying insect nests, one near the main entrance and one on the northeast soffit.

Visible flying insect nest at underside of roof eave.

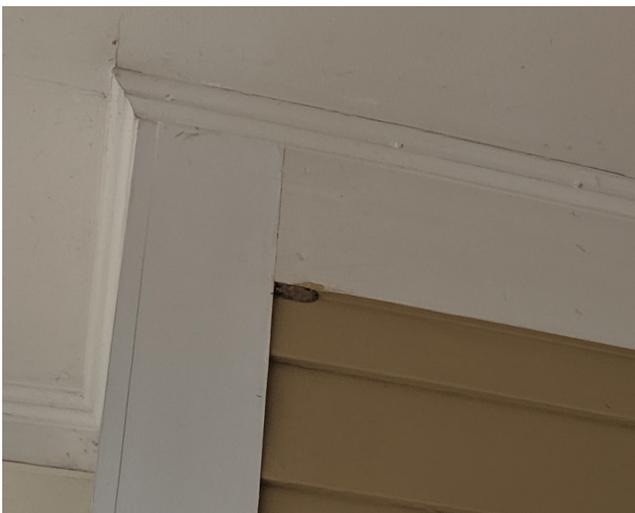
Visible flying insect nest at underside of trim at main entrance.

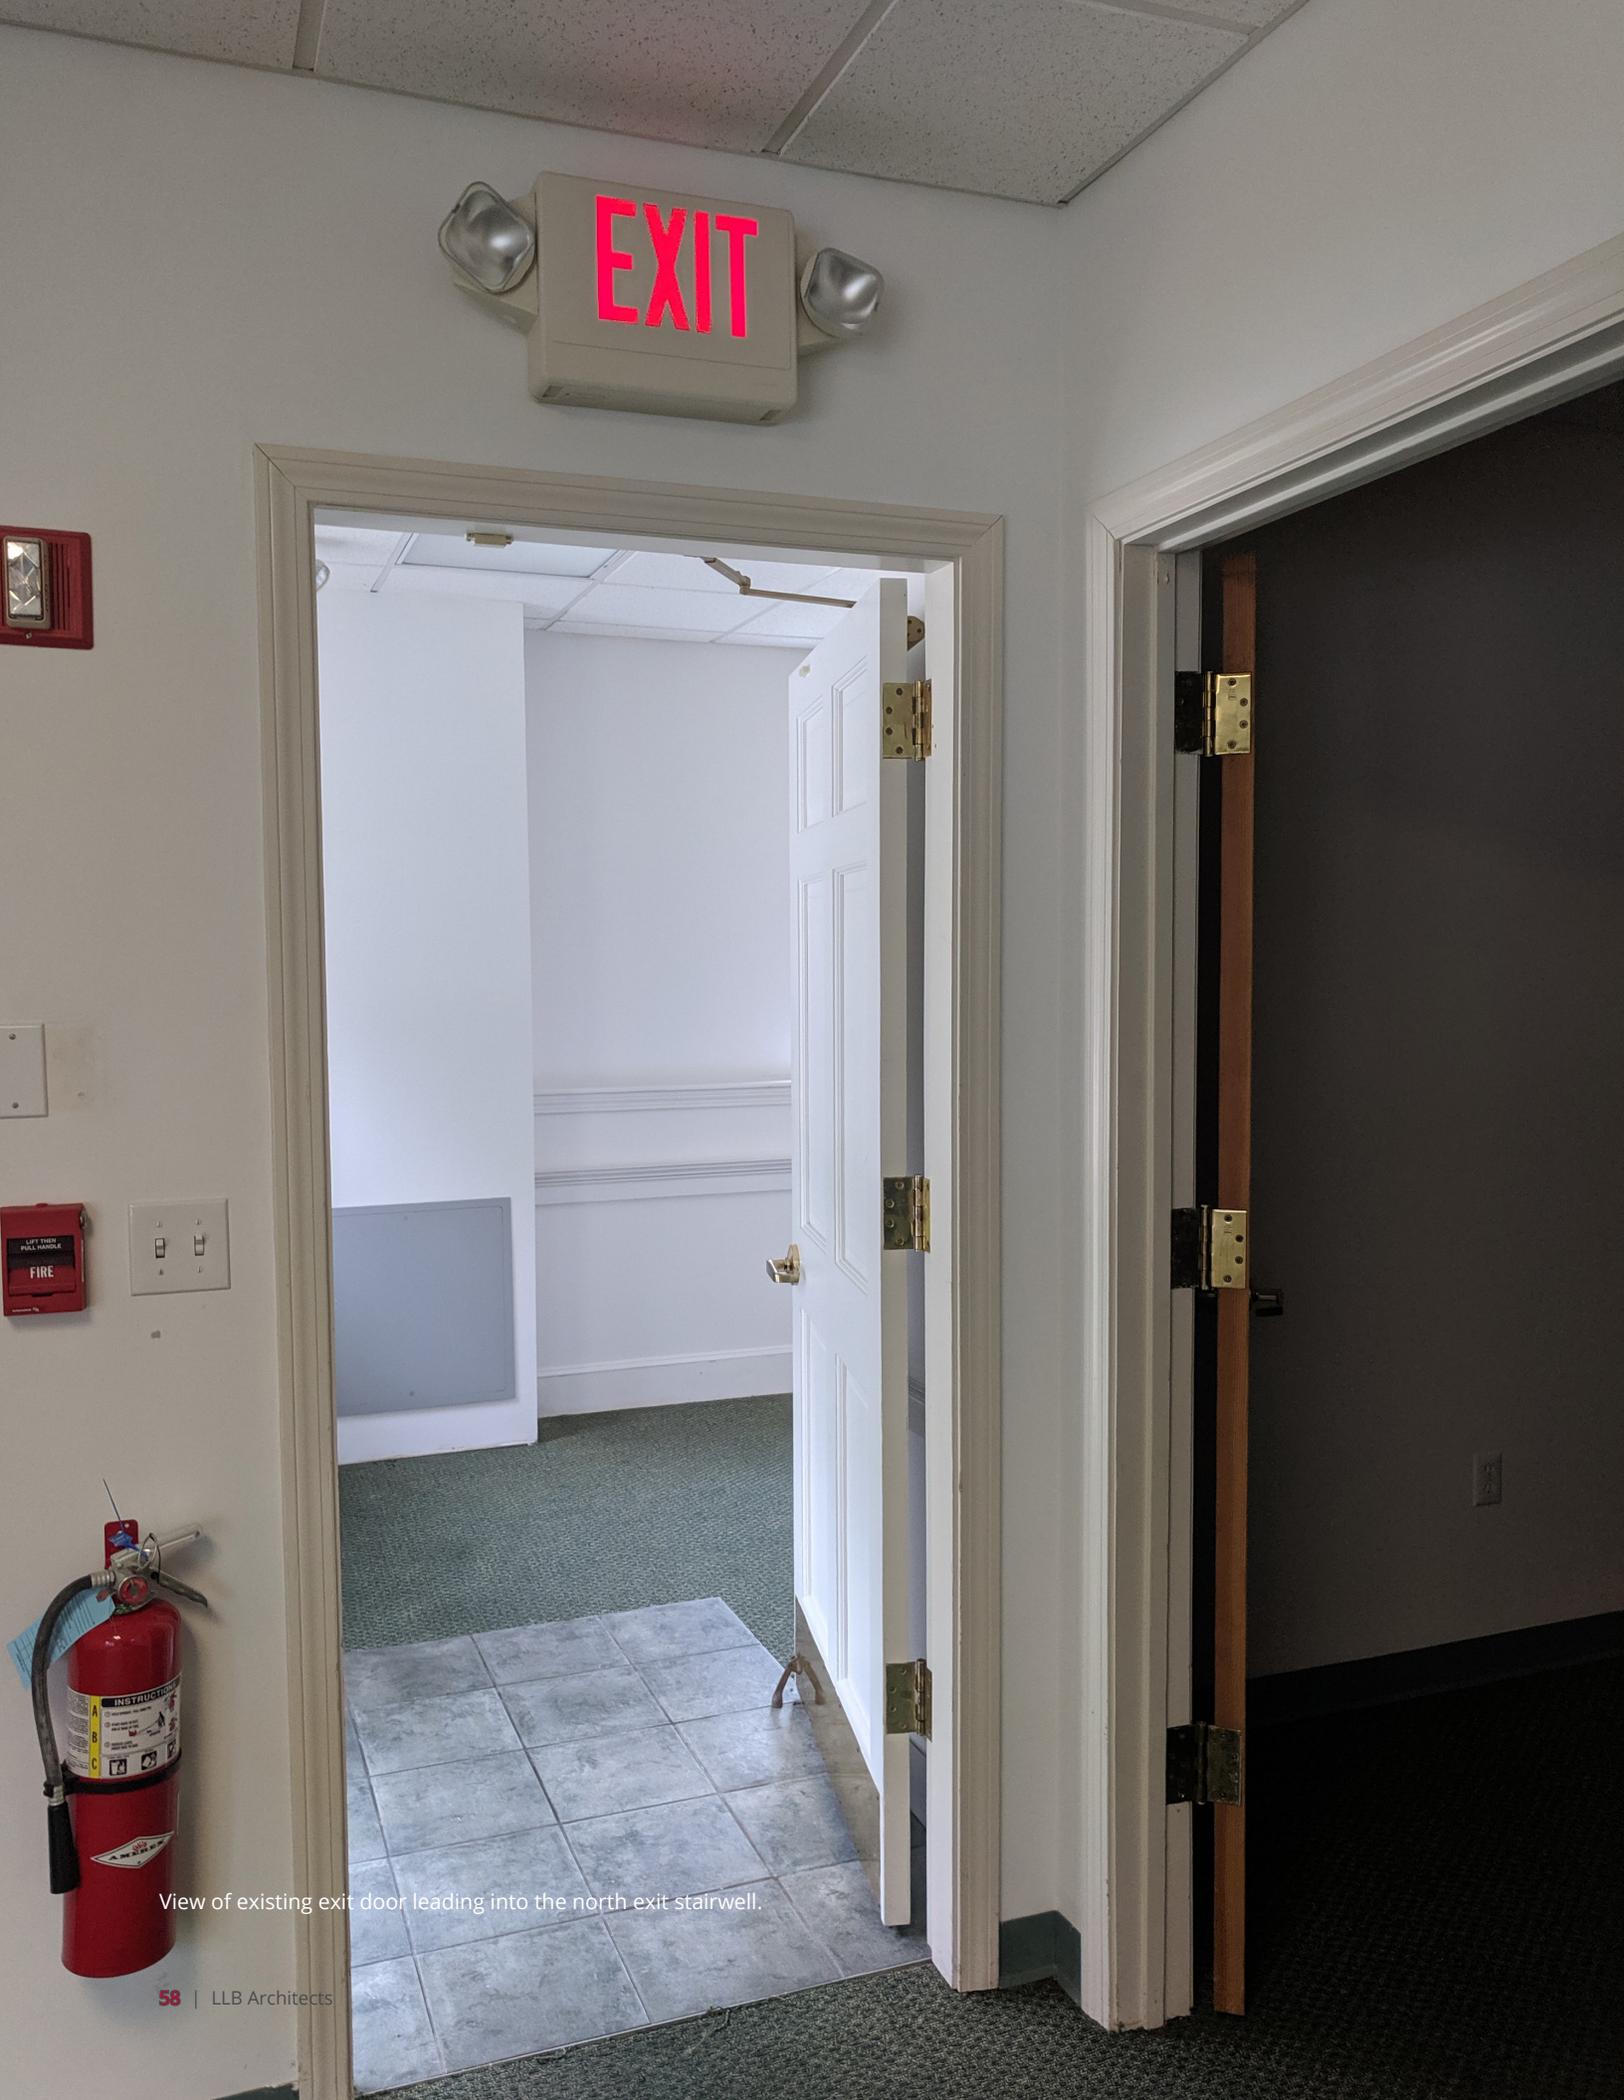
View of existing exit door leading into the north exit stairwell.
